6S R10W

EVALUATION AND RESTORATION OF LAND SECTION CORNERS

One-quarter Corner common to Sections 10-11, W.M.,
Tillamook County, Oregon

CORNER RECORD (PERPETUATION)

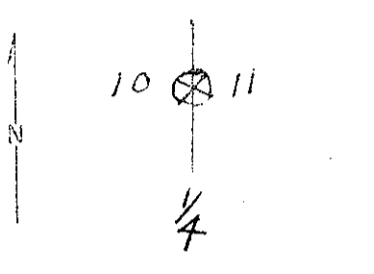
CORNER DIAGRAM

DESCRIBE CORNER MONUMENT FOUND
 FOUND A REMNANT OF THE ORIG. POST IN A ROTTED
 CONDITION. AT THE CORNER POINT I FOUND A
 STONE IMPLANTED BENEATH THE SURFACE OF THE
 GROUND. See Below

DESCRIBE BEARING TREES OR OTHER OFFICIAL ACCESSORIES FOUND
 FOUND 26" HEM., S. 25° E., 15² FT. WITH A SCRIBE
 MARK "S" SHOWING IN A PARTIAL HEALED FACE.
 FOUND THE S.W. BT LYING ACROSS A RAVINE IN A ROT-
 TED CONDITION.

DESCRIBE CORNER LOCATION RELATIVE TO NEAR-BY FEATURES, ALSO HOW TO REACH CORNER
 AT THE UPHILL SIDE OF THE STONE A REMNANT OF
 THE ORIG. POST IS FOUND EXTENDING 18" INTO THE GR-
 OUND.

MONUMENT: DESCRIBE NEW MONUMENT SET, OR WORK DONE TO PRESERVE EXISTING MONUMENT
 I SET A 3" X 3" SPRUCE LIMB MKD. S10 ON W. AND S11 ON E. SIDES.
 I MARK ONE NEW BT. Witnesses: N. Meana
G. Tilton
 30" SPRUCE, N. 46° W., 30 FT. MKD. 1/4 S10 BT.
