RESTORATION OF THE $\frac{1}{4}$ CORNER OF SECTION 20 AND 29, T1S, R10W, W.M.

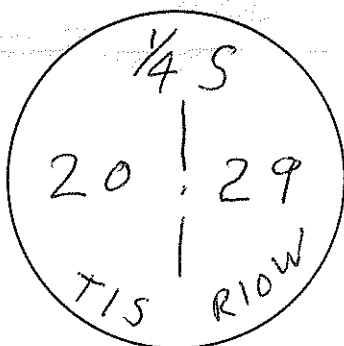
The top of the lead plug is marked as follows:
