OREGON PUBLIC LAND CORNER REPORT / RESTORATION REPORT
Tillamook County Surveyor's Office

SECTION: 13 and 18		TOWNSHIP: 1 South	RANGE: 10 West and 11 West	
COUNTY: Tillamook			DATE: 3/4/2025	
CORNER DESIGNATION: Witness corner to the South 16 th corner common to Sections 13, Township 1 South, Range 11 West and Section 18, Township 1 South, Range 10 West; Willamette Meridian			(Please check one)	
			<input checked="" type="checkbox"/> Condition Report Only	
			<input type="checkbox"/> Restoration	
			<input type="checkbox"/> Rewitness	
			<input type="checkbox"/> Unrecorded	
			<input type="checkbox"/> Reset at surface	
			<input type="checkbox"/> Referenced Out	
Previous Rewitnesses, Restorations and Surveys, etc... Map B-3831 (2017)				
History, condition, and sources In 2017 (Map B-3831) while surveying the boundary for the United States Fish and Wildlife Cape Meares wildlife refuge Stuntzner Surveying set the Witness corner to the South 16 th corner common to Section 13, T1S, R11W, and Section 18, T1S, R10W. Stuntzner set a 3 ¼" brass cap stamped "T1S R11W S13 T1S R10W S18 S1/16 WC LS 62978 2017" and established 3 bearing trees. In 2025 (Field Bk. MR 12 Pg. 45-48) the Tillamook

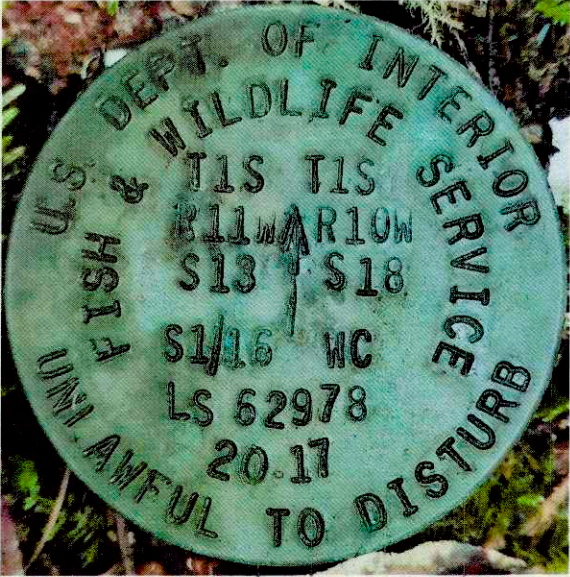
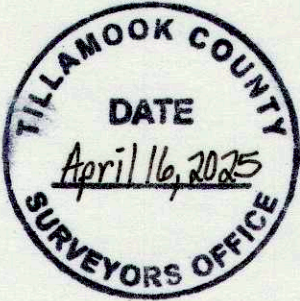
New accessories set: Monument was tied conventionally using GPS established control in Oregon North Zone NAD 83/91 grid coordinates in US Survey feet. Coordinates provided hereon are given in WGS 84 Latitude and Longitude. Latitude: 45°28'54.58940" Longitude: -123°58'05.43091"			Pictures of Found Monuments:
