# OREGON PUBLIC LAND CORNER REPORT / RESTORATION REPORT Tillamook County Surveyor's Office

## BOOK 8 228.

SECTION: 5	TOWNSHIP: 1 North	RANGE: 10 West
COUNTY: Tillamook		DATE: 6/12/2025
CORNER DESIGNATION:  The intersection of the Centerline of First Avenue and the Centerline Victoria Street		(Please check one)
		Condition Report Only
		Restoration
The intersection of the Centerline of First Avenue and the Centerline Victoria St		X Rewitness
		Unrecorded
		Reset at surface
		Referenced Out

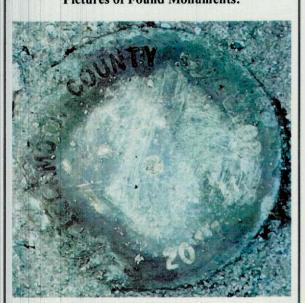
### **Pictures of Found Monuments:**

Found 2" Tillamook County Surveyor Brass cap at surface of pavement in concrete marked "2011" as described on Map B-3456.

Referenced and reset found 2" Tillamook County Brass cap marked "2011" in a 10" dia. cast iron monument box with lid set at surface of asphalt in concrete.

Location: Centerline of the as-built intersection of First Ave. and Victoria Street
