Estuary/Floodway Development Permit Request #851-26-000111-PLNG: McCoy Marsh Tidal Project

NOTICE OF ADMINISTRATIVE REVIEW Date of Notice: May 22, 2026

McCOY MARSH TIDAL RECONNECTION PROJECT DRAFT 60% BASIS OF DESIGN REPORT

McCOY WETLAND DESIGN PROJECT HYDRAULIC ANALYSIS REPORT

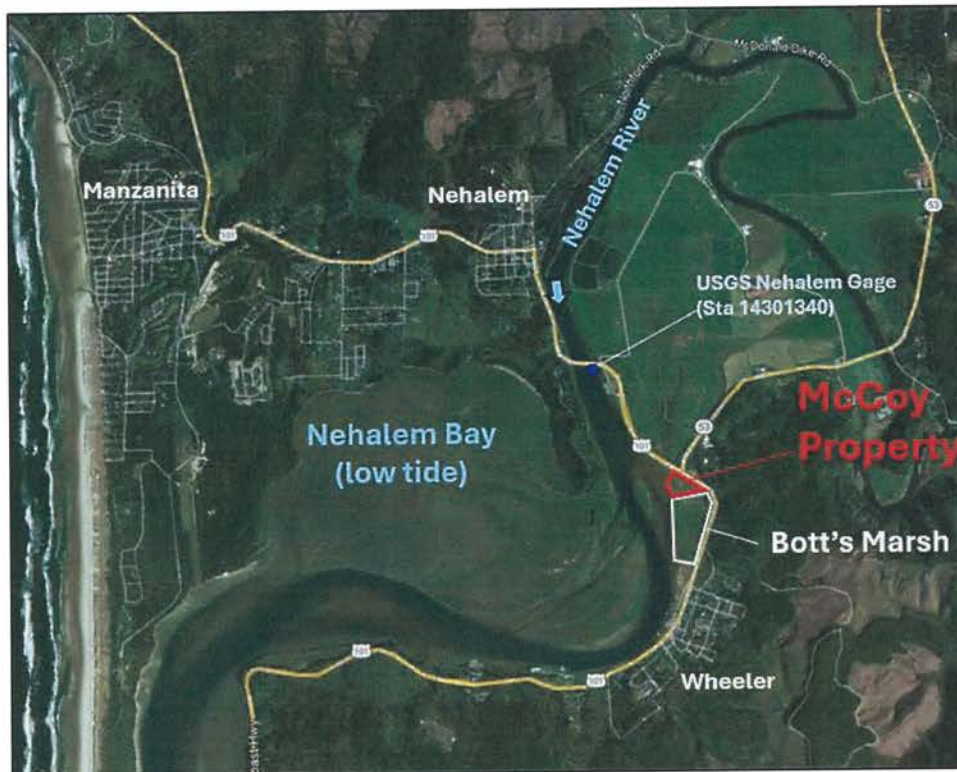
Figure 1. Location of Project Area within Nehalem Bay, Shown at Low Tide (from Google Earth).
