## TECHNICAL MEMORANDUM

### WEST CONSULTANTS, INC.

**Company:** Kellington Law Group  
**Date:** 27 February 2023  
**From:** Chris Bahner, PE, D.WRE  
**Subject:** LUBA Comments on Pine Beach and Ocean Boulevard Properties Revetment Design

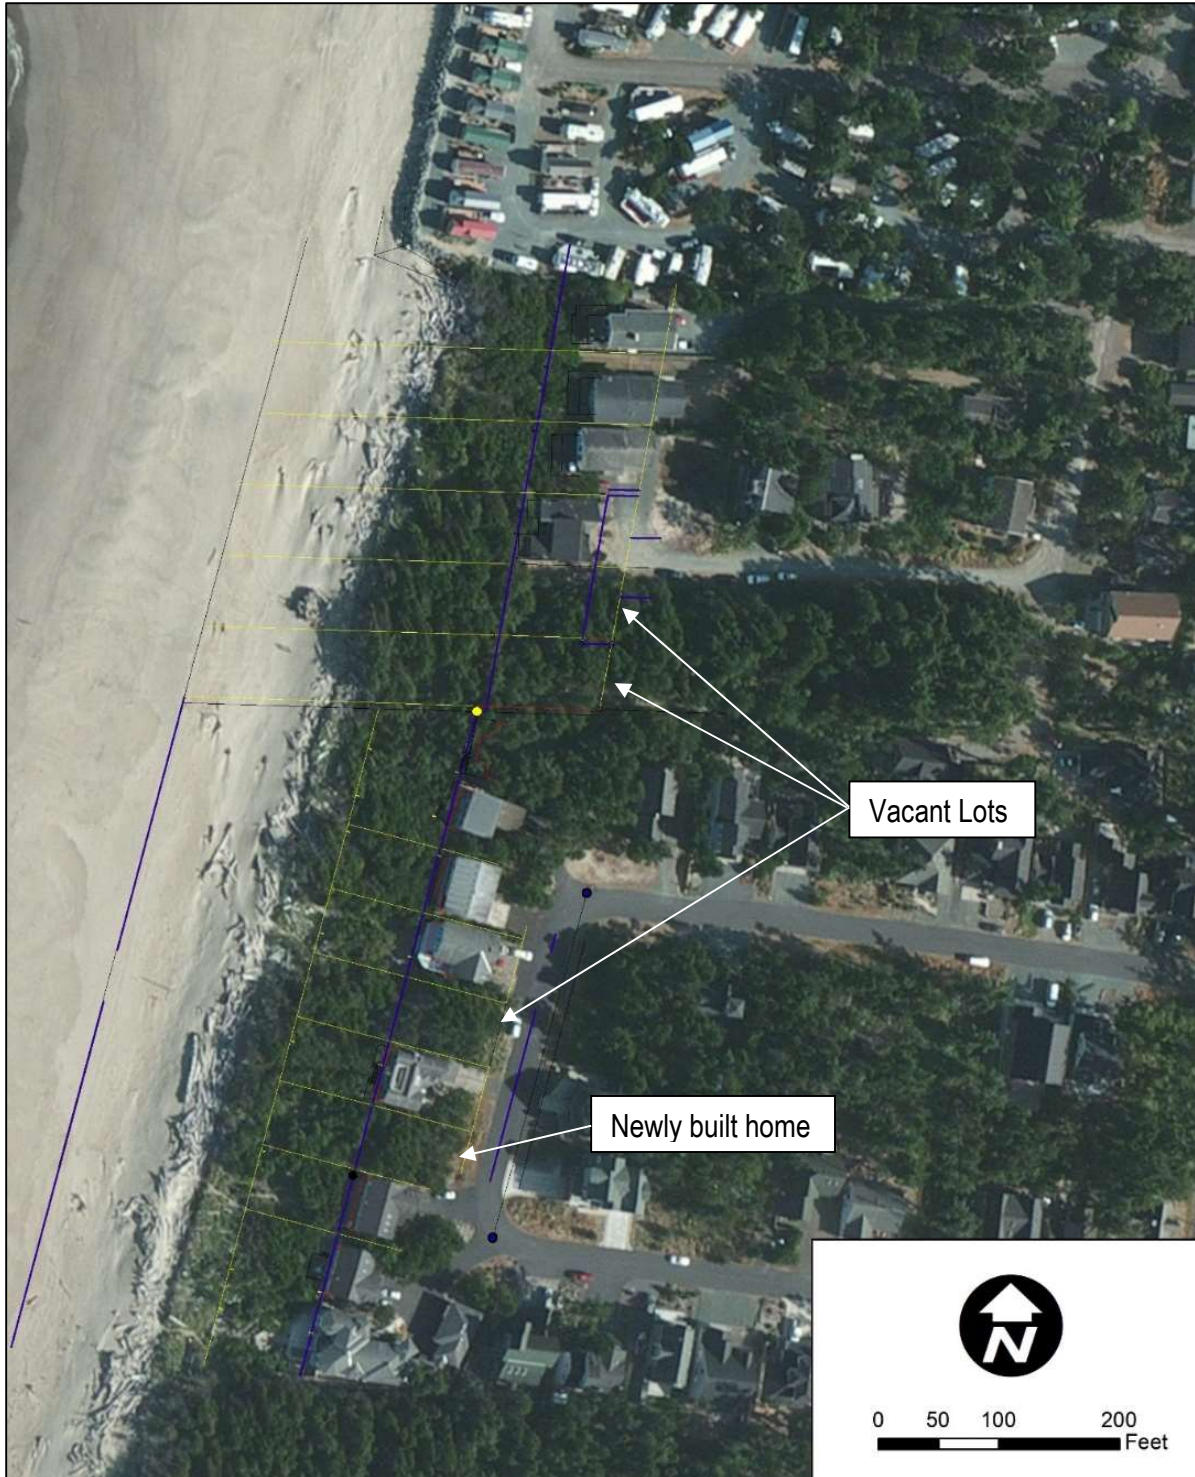
Figure 2. Map of vacant lots

design of the revetment took this fact into consideration. That home is now nearly completed. Figure 2 shows the location of the three vacant lots and one lot with the newly constructed home.

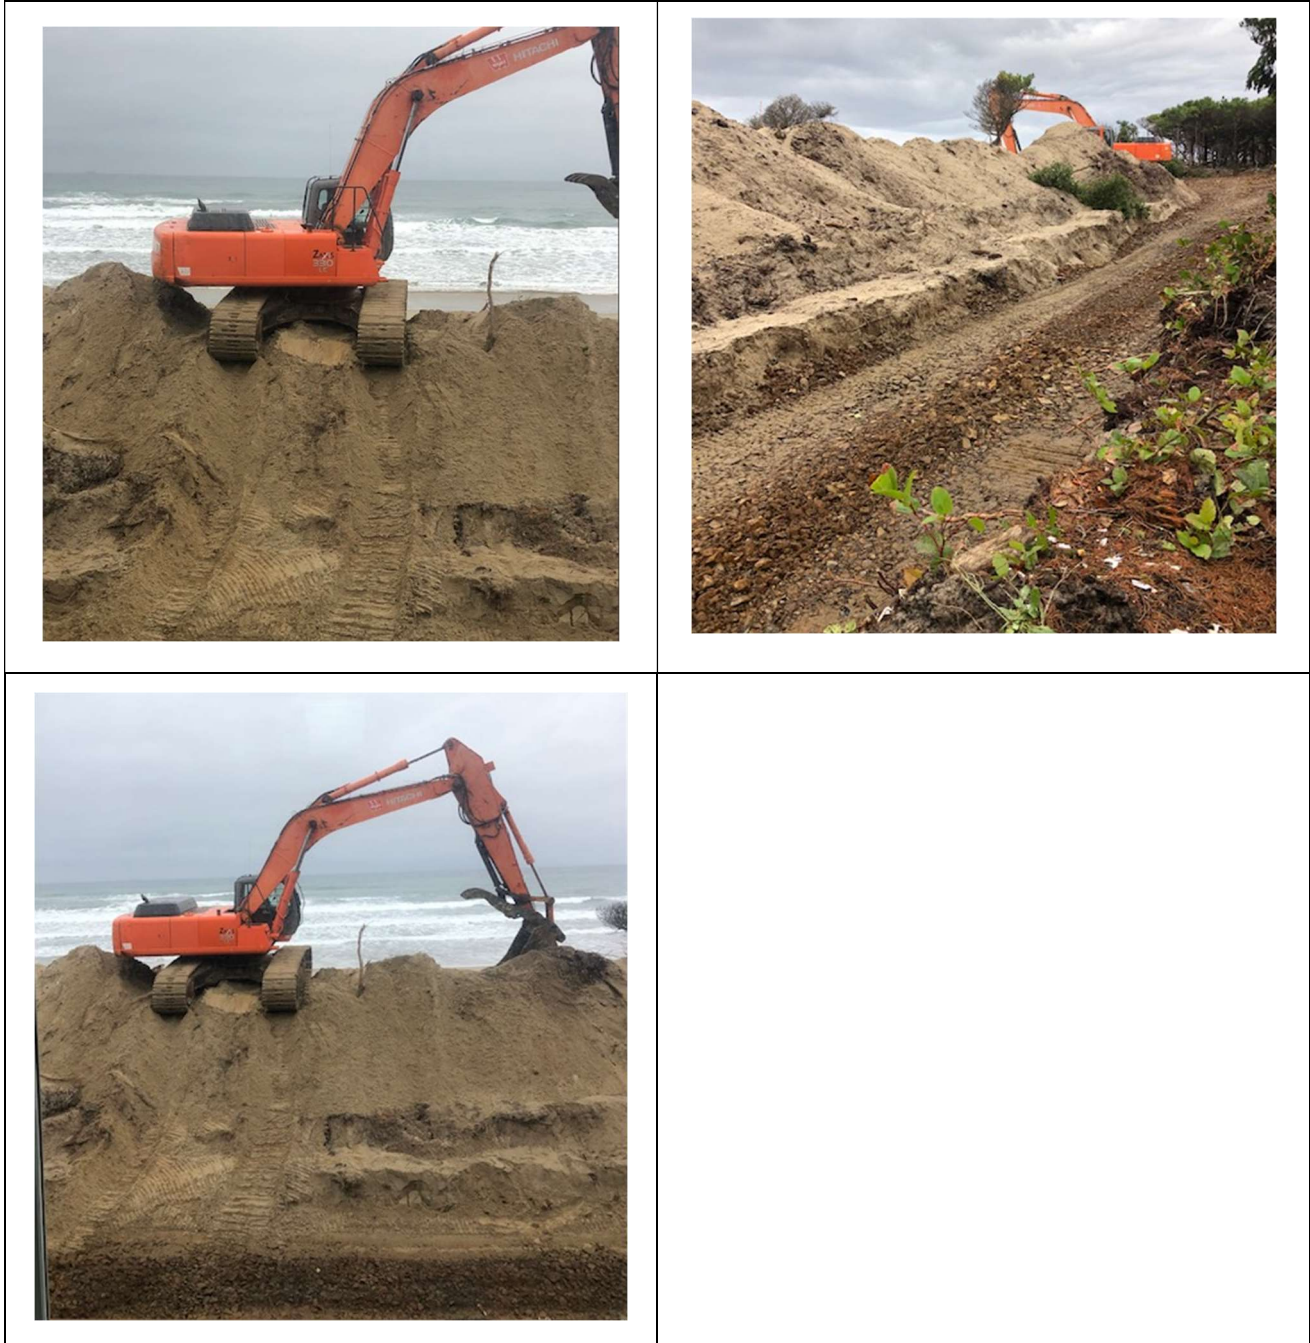
**Figure 4. Photos of construction of shoreline protection revetment**

The contractor built the structure in segments of three properties at a time to reduce the potential for coastal erosion and flooding during the construction. For each segment, the contractor dug the designed trench to put the revetment's rock into at a point that was 10 feet +/- east toward the houses. He left the vegetated dune in front of these lots intact with the vegetation that had previously existed. As the contractors dug the trench, they deposited the excavated sand on top of the westerly dune. That made the westerly dune temporarily much taller than its normal size, thereby preventing potential flood damage during construction. The trench was backfilled with the sand from the excavation, and excess sand was hauled away. That process increased the flood protection of the sites that had previously existed because the deposited sand provided a barrier that had not previously existed. That excavated sand was then distributed into a berm on the ocean side of the revetment. The berm provided a higher level of protection against coastal flooding than had previously existed even had a storm event occurred when the structure was being built, which it did not. No unusual storms occurred during construction. Images of the temporary construction of the revetment are provided at Figure 4 below.

As mentioned above, the applicants installed the approved revetment between November 13, 2021 and December 4, 2021. The installation process was completed without increasing the potential for flood damage. The Subject Property owners selected a contractor who had experience building the same type of shoreline protection structure that was constructed at the Subject Property. The contractor implemented a construction risk management plan that included procedures and methods to reduce the impact of risk to the contractor and the public during construction. The proposed structure took less than a month to construct.

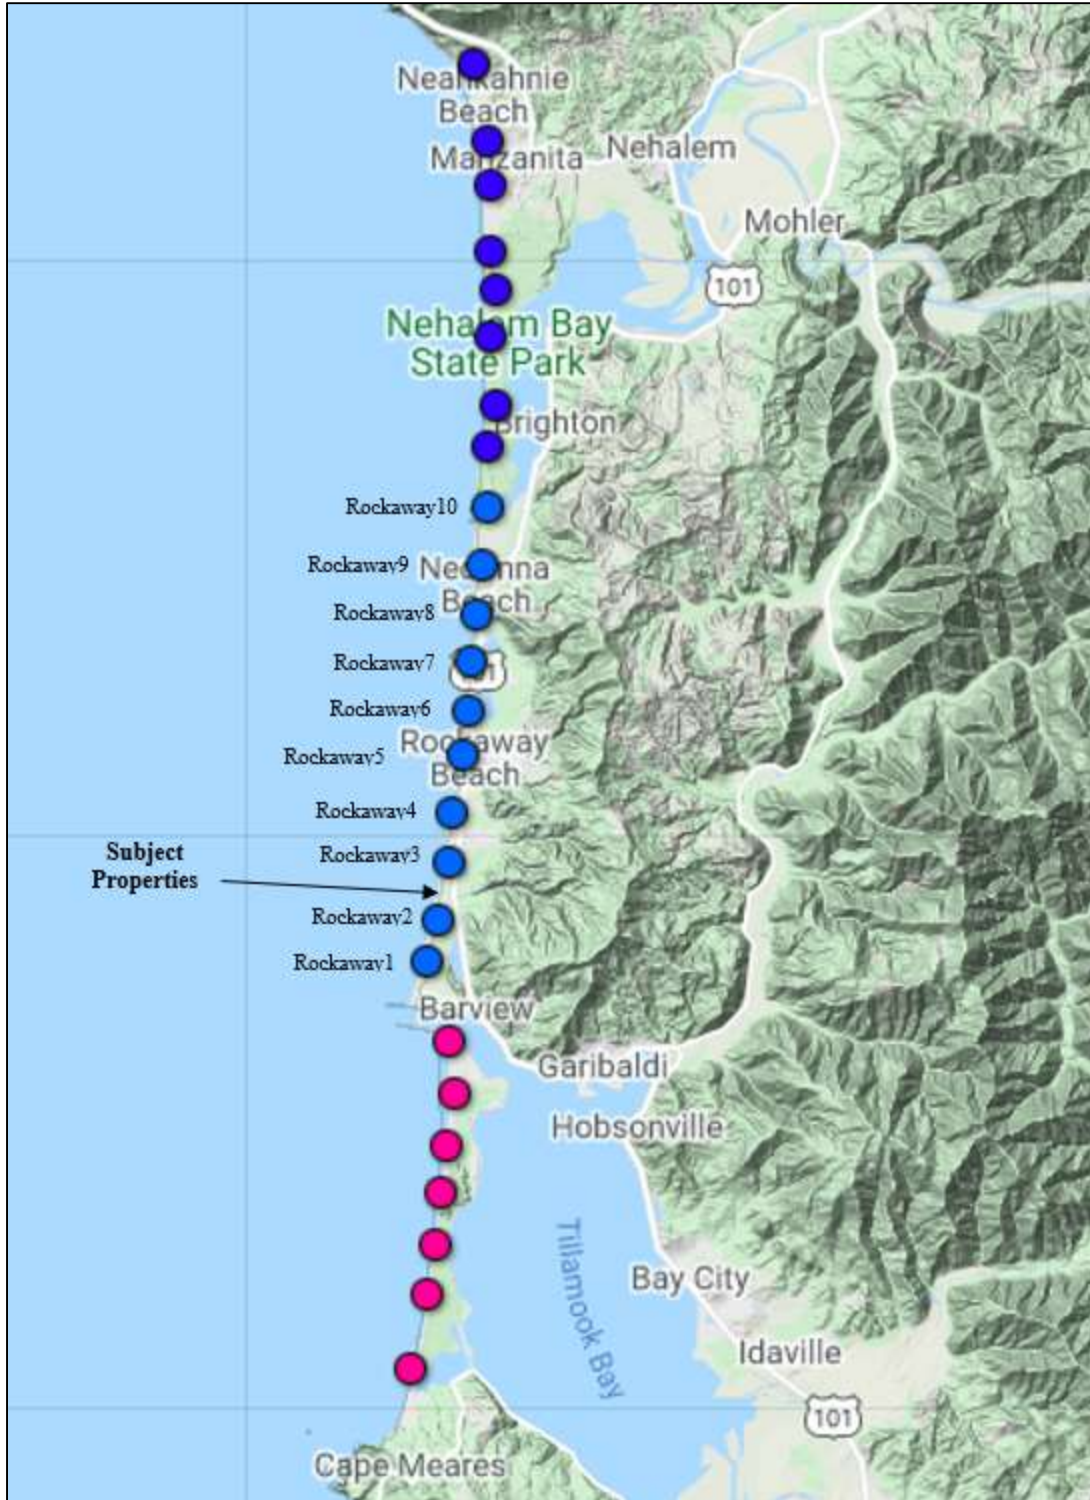
Figure 5. NANOOS monitoring locations in Rockaway littoral cell

Concerns related to the beach profile are addressed by reviewing the beach profile changes reflected in the ongoing beach monitoring data available from the Northwest Association of Networked Ocean Observing Systems (NANOOS) website (NANOOS, 2021) for the period from 1997 to the present. Figure 5 shows the monitoring locations within the Rockaway Beach littoral cell. Rockaway2 is the closest monitoring location to the project site, and it is located about 1,400 feet south of the Pine Beach Development. Figure 6 shows the beach profiles for selected days,  $\pm 1$  standard deviation ( $\sigma$ ) profiles to capture the 68% of natural variability, and maximum/minimum based on all available survey data. The top figure shows the conditions in early 2021 and the bottom figure shows the conditions in late 2022. Figure 7 shows the contour change plots (heights of 3, 4, 5, and 6 meters). A review of these plots for Rockaway2 indicate: (1) the beach profile has a high level of natural variability, (2) variability is most pronounced at elevation 10 feet and decreases up to elevation 16 feet with no variability existing at elevation 20 feet; (3) the 10 feet contour shoreline has high variability around the mean that has remain relatively constant since 2008; (4) the beach profile has a general parabolic shape with steeper slopes near the beach/dune intersection; and (5) the March profile is to the west of Nov/Dec profile. For references, the MHHW tide level is about 8.3 feet and average water level for the period from 1/2018 to 12/2020 has an average elevation of about 6.1 feet.
