**NATURAL RESOURCE ASSESSMENT REPORT
FOR**

Pine Beach and Ocean Boulevard Properties

T1N R10W Sec.7DD TL 114-123
T1N R10E Sec.7DA TL 3000, 3100, 3104, 3203, & 3204
Tillamook County, Oregon

January 2023

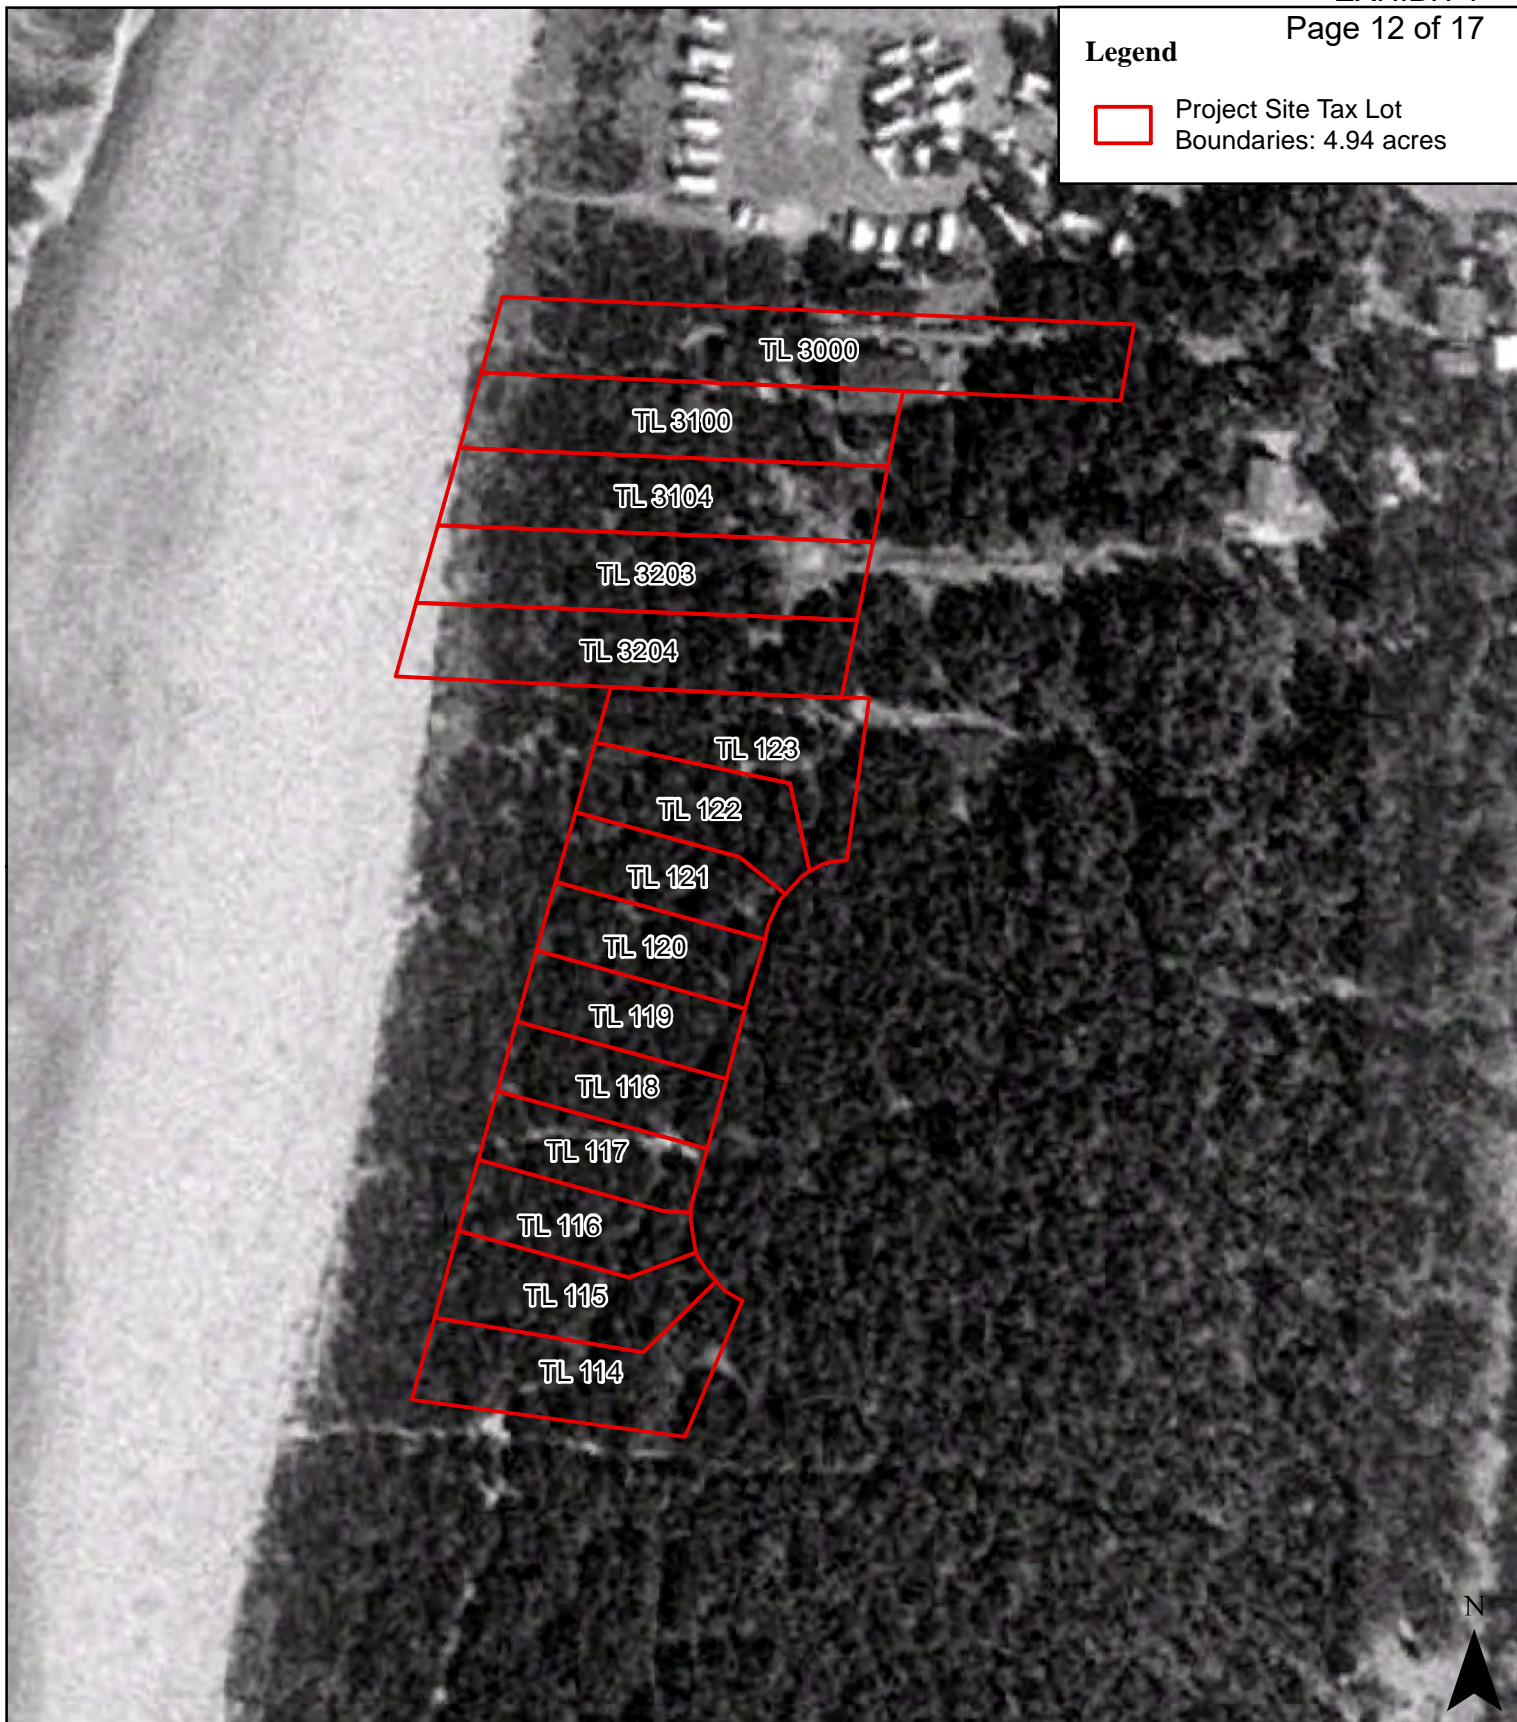
Figure 3b. Historical Aerial Imagery - Spetember 3, 1994

In the early 1990s, the coastal pine forest extended approximately 330 feet to the west from where Pine Beach Loop was constructed, and sand was actively being deposited on the beach. In the mid to late 1990s, this trend suddenly reversed, resulting in rapid erosion of the beach. By the year 2011, nearly 100 feet of the pine forest had been eroded up and down the coastline in this area. Around 2005, a protective wall of exposed rip-rap was constructed to protect the trailer park north of the subject properties. This rip-rap has stopped the erosion along its frontage, but the erosion has continued adjacent to the subject properties and to the south. The trailer park now juts out approximately 100 feet west of the existing forest edge.

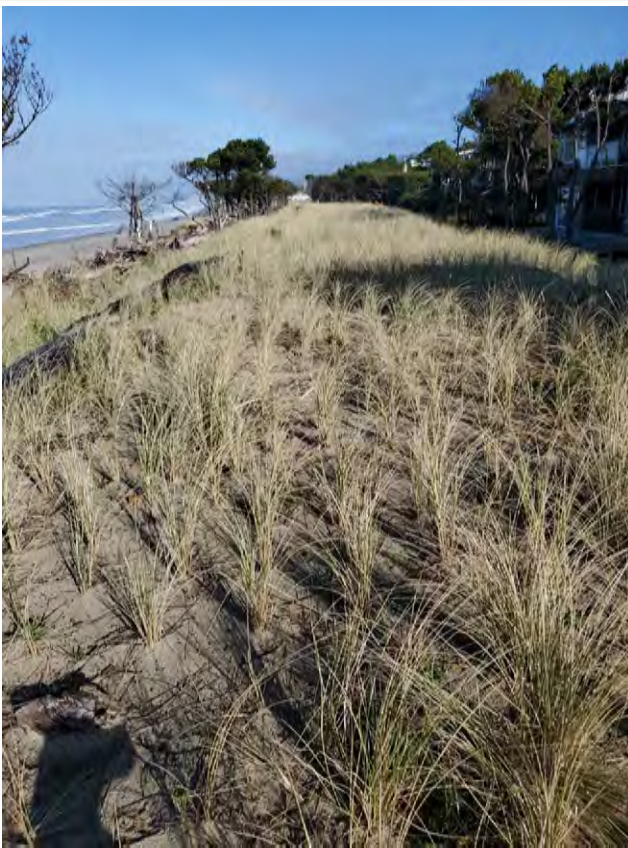
Facing North along revetment.

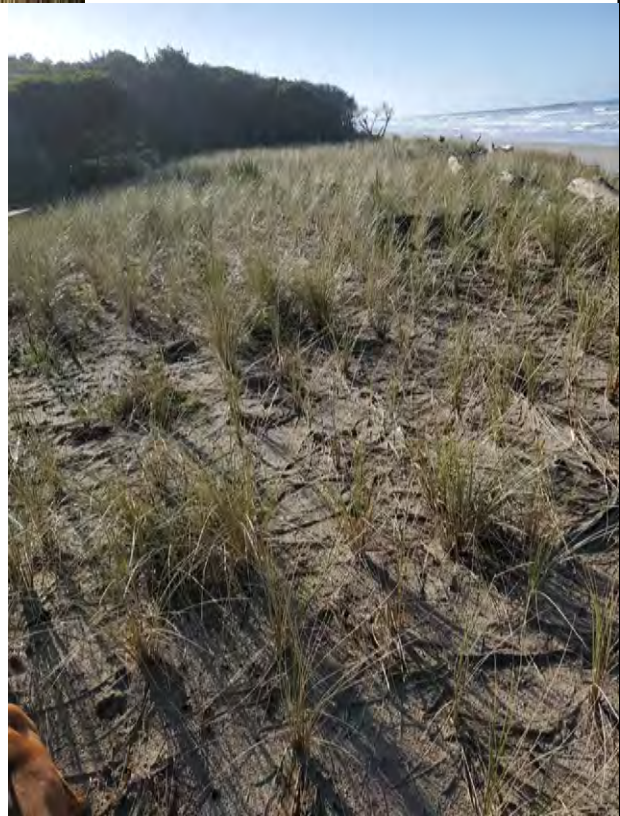
Facing South along revetment.

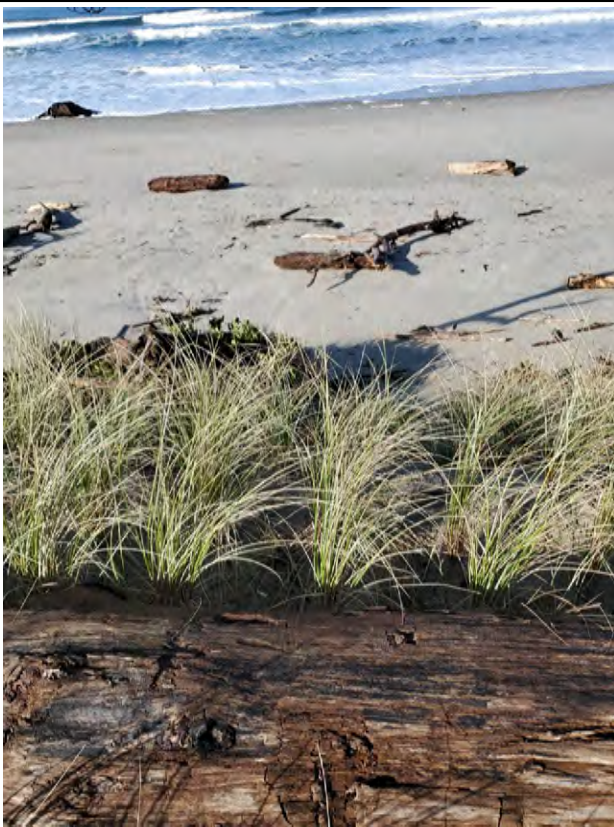
Facing West to beach.

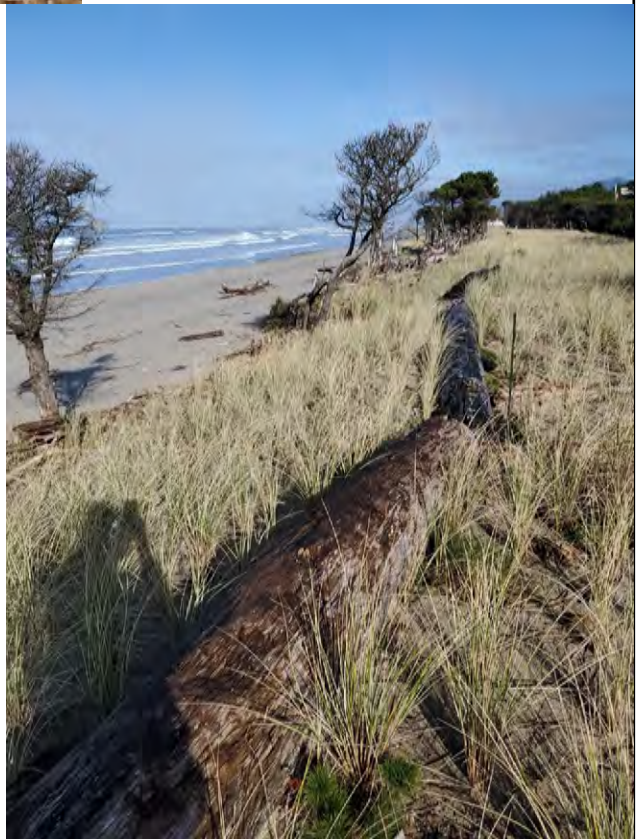
construction it was replanted with a variety of native species. At the time of the site visit it was approximately 30% vegetated, the predominant cover being beach grass (*Ammophila sp.*) with approximately 1% each of shore pine (*Pinus contorta*), Sitka spruce (*Picea sitchensis*), salal (*Gaultheria shallon*), evergreen huckleberry (*Vaccinium ovatum*), Pacific wax myrtle (*Myrica californica*), volunteer bentgrass (*Agrostis sp.*) and lupine (*Lupinus sp.*). The beach grass is a stabilizing species which forms stiff, hardy, clusters of grass that can reach nearly four feet in height. The rhizome mat formed by the plant facilitates fast colonization over the immediate area. One small clump can produce 100 new shoots annually. It is known for its ability to trap sand and thereby increase the height and stability of the dunes it inhabits.

Facing Northwest showing revetment slope
