## Neskowin Coastal Hazard Area Permit #851-21-000054-PLNG: Erickson

### NOTICE OF ADMINISTRATIVE REVIEW

**Geologic Hazards and Geotechnical Investigation  
Tax Lot 1900, Map 5S-11W-36BC  
49670 Surf Road,  
Neskowin, Tillamook County, Oregon**

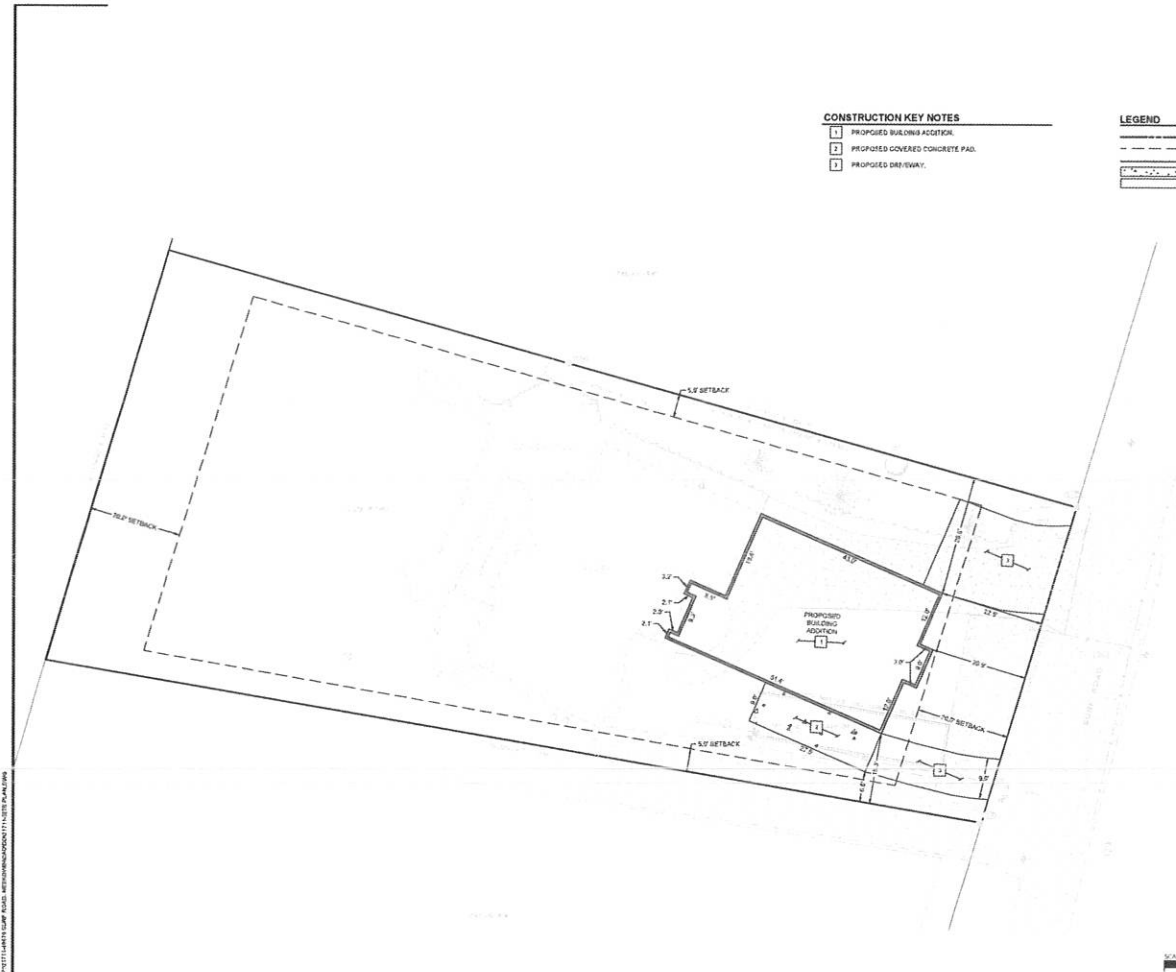
- CONSTRUCTION KEY NOTES**
- 1 PROPOSED BUILDING ADDITION
  - 2 PROPOSED COVERED CONCRETE PAD
  - 3 PROPOSED DRIVEWAY

- LEGEND**
- PROJECT BOUNDARY
  - PROPOSED SETBACK LINE
  - PROPOSED BUILDING
  - PROPOSED CONCRETE
  - PROPOSED DRIVEWAY

The site plan already exceeds the proposed 40-foot foredune/revetment setback. The addition will be constructed in an existing parking and lawn area, meaning that no slope issues can preclude or otherwise impact development. The addition is to be constructed on native soil similar to the original house, which will meet the recommendations of the Geologic Hazard Report. Therefore, the Director can find that all of the Geologic Hazard Report's recommendations can be implemented through construction, and therefore, find that this criterion is met.

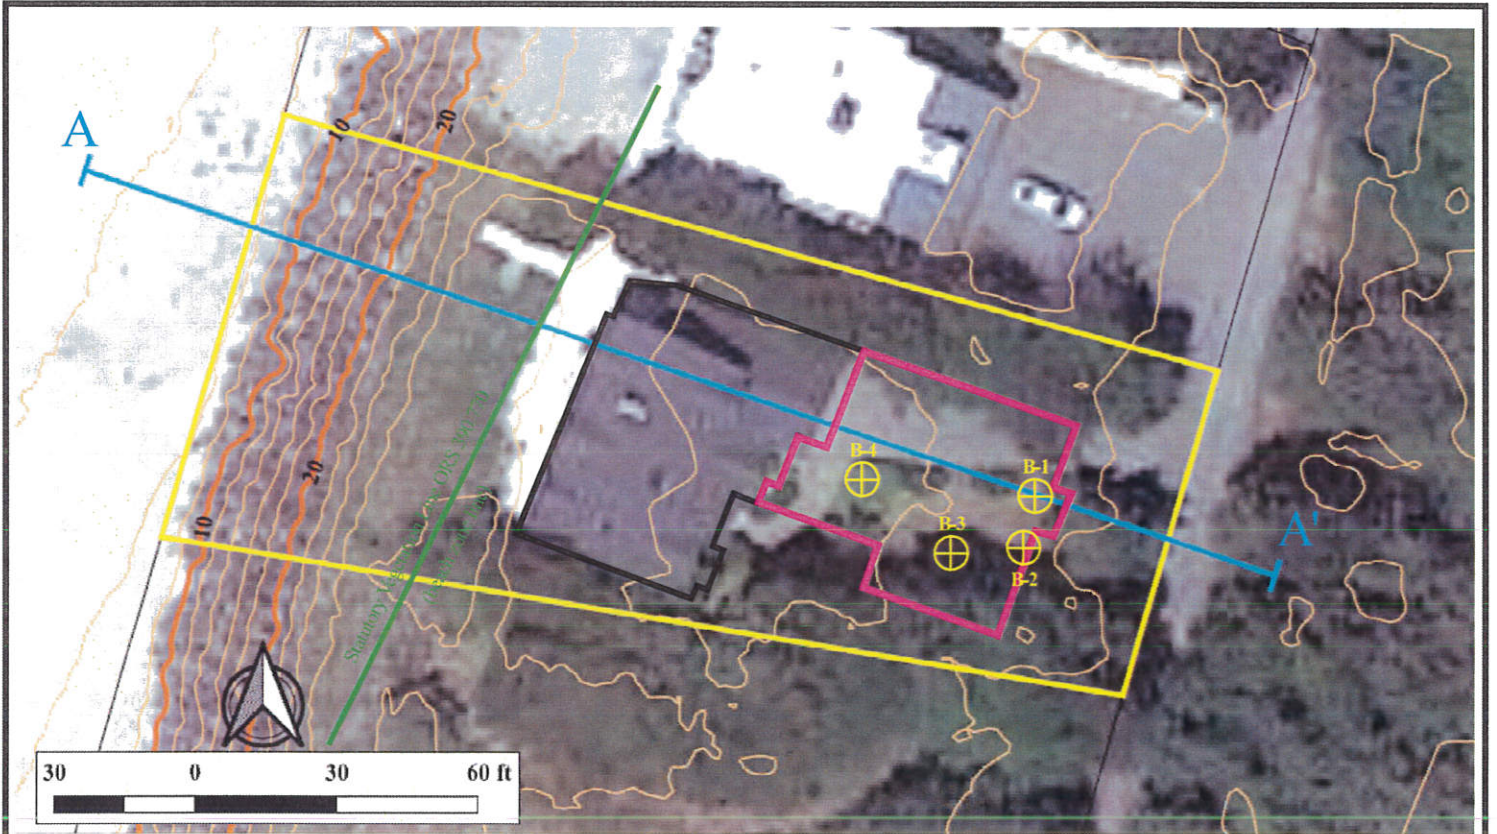
H.G. Schlicker & Associates, Inc.	<b>Figure 3</b>
Scale: 1" = 30'		Approved by: JDG	Tax Lot 1900, Map 5S-11W-36BC 49670 Surf Road, Neskeville, Clatsop County, Oregon

A — A' = Approximate trend of profile line

Lidar data from 2016 shows the junction between the beach and the revetment was at an elevation of approximately 8 feet (NAVD 88) (Figures 3 and 4). Allan and Hart (2005) surveyed the elevation of the beach/dune junction in 1997, 1998, and 2002 at approximately 20 feet, 14 feet, and 16 feet, respectively. Winter elevations primarily depend on beach profiles formed by storm conditions.

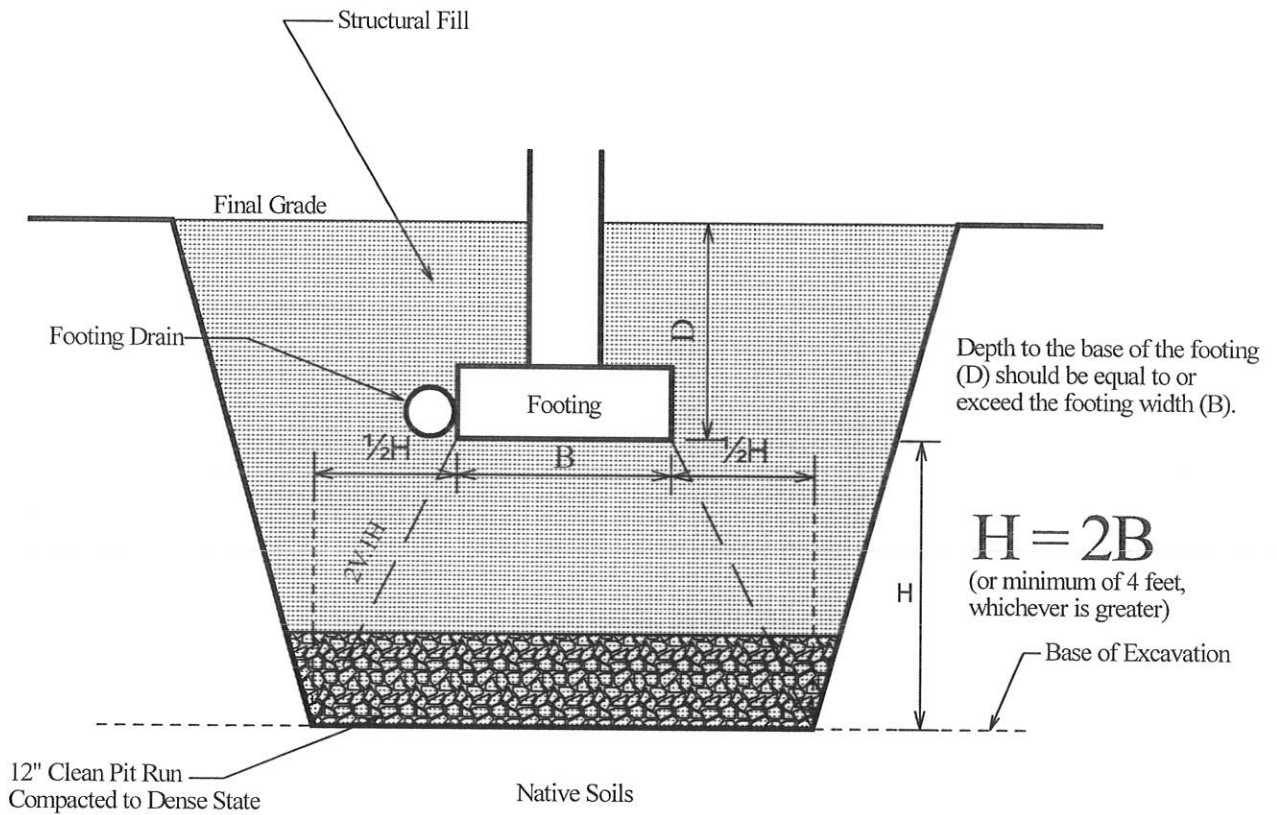
Date: 05/21/2021	<b>Project #Y214510</b>	Prepared by: AML
Scale: Not to Scale		Approved by: JDG
<b>Over-Excavation and Replacement Detail</b> Tax Lot 1900, Map 5S-11W-36BC 49670 Surf Road, Neskowin, Tillamook County, Oregon		
<b>H.G. Schlicker &amp; Associates, Inc.</b>		<b>Figure 5</b>

The base of the excavation should be constructed to a width governed by the intersection of a horizontal line and a 2V:1H line projected from the outer edges of the footing.

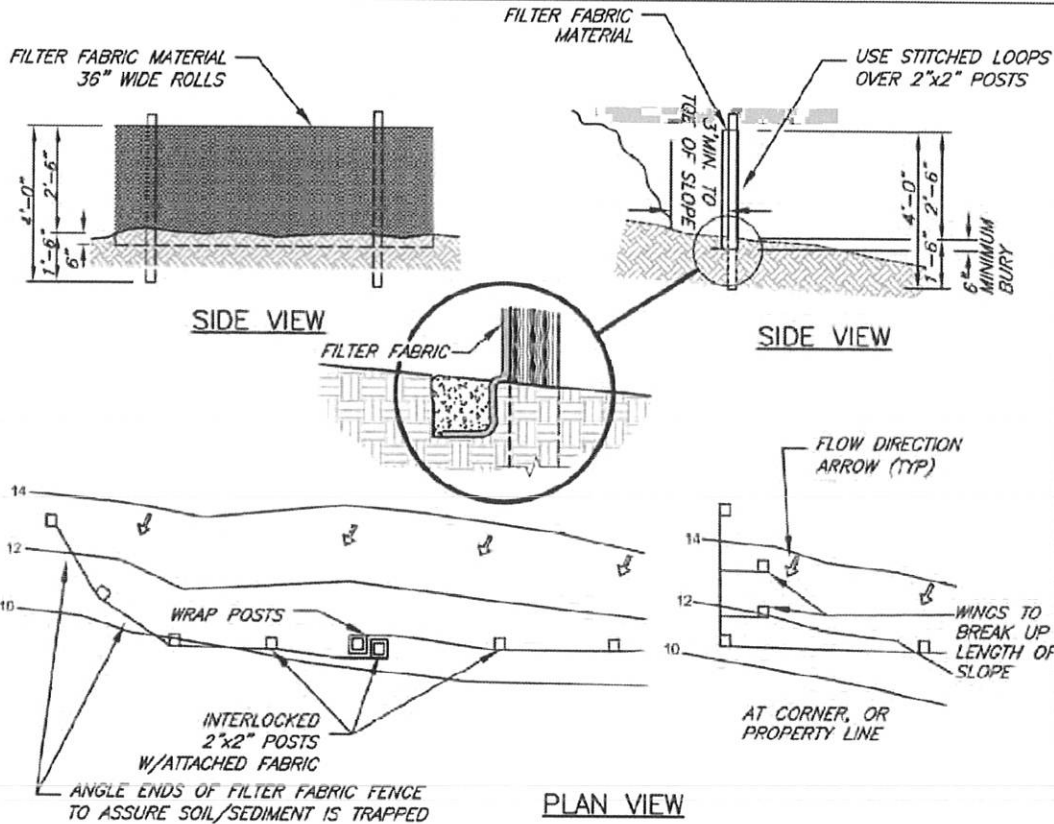
Figure 4.3-A Temporary Sediment Control (Silt) Fence

TEMPORARY SEDIMENT FENCE  
Detail Drawing 4.3-A

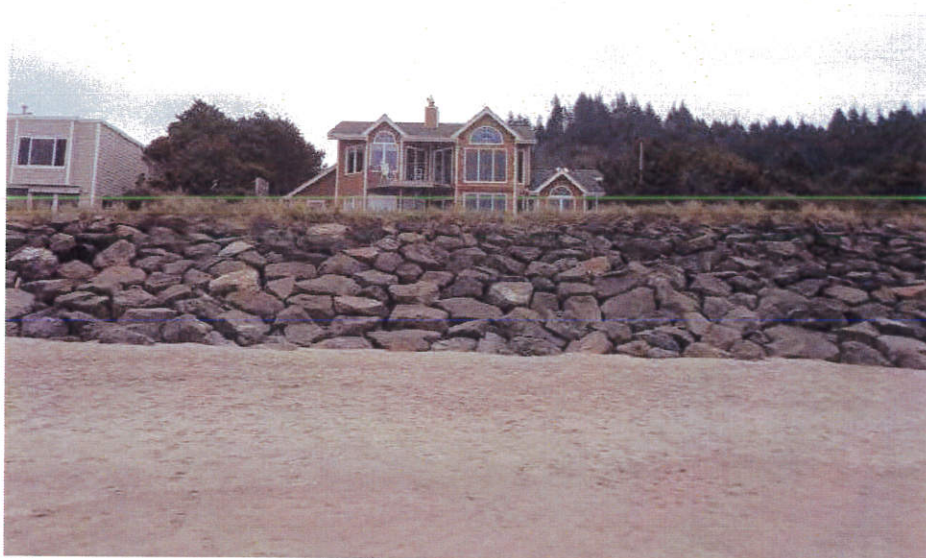
Photo 4 – Easterly view of the site and existing revetment.

The seaward front of the property is located at the crest of a younger vegetated dune. The dune crest was densely vegetated with European beachgrass and beach pea, and the seaward slope is protected by a riprap revetment. The riprap revetment appeared to be in generally good condition. The quality of the single armor stone layer used for the construction of the revetment was variable and consisted of a mixture of highly fractured basalt breccia, occasional sandstone, and relatively unfractured basalt (Appendix A). Additional observations are addressed and illustrated in Section 3.0 and Appendix A.

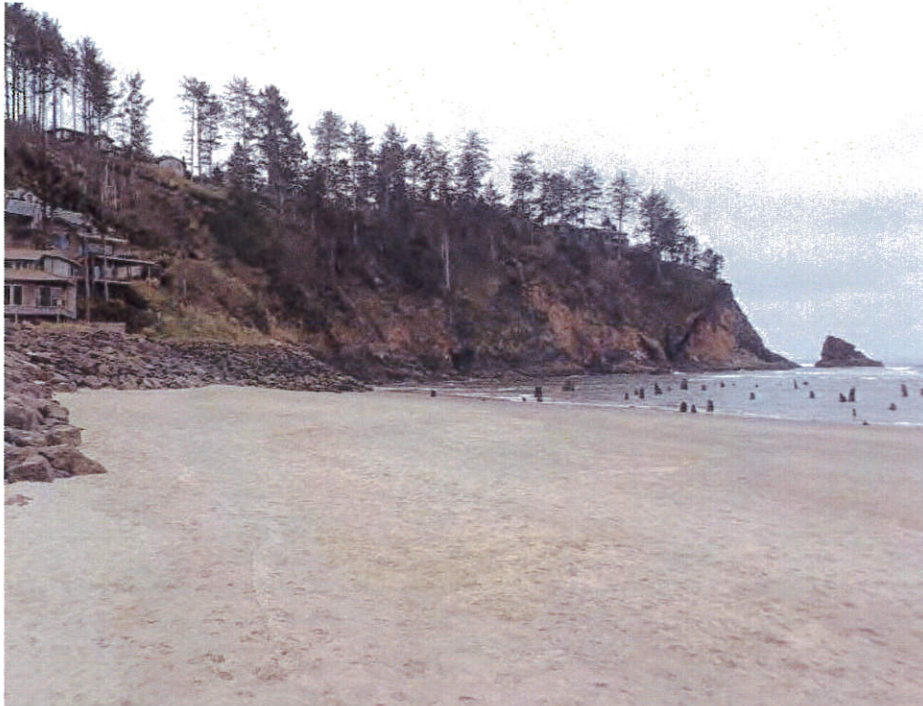
Photo 5 – Southerly view of the beach and exposed tree stumps near the site.

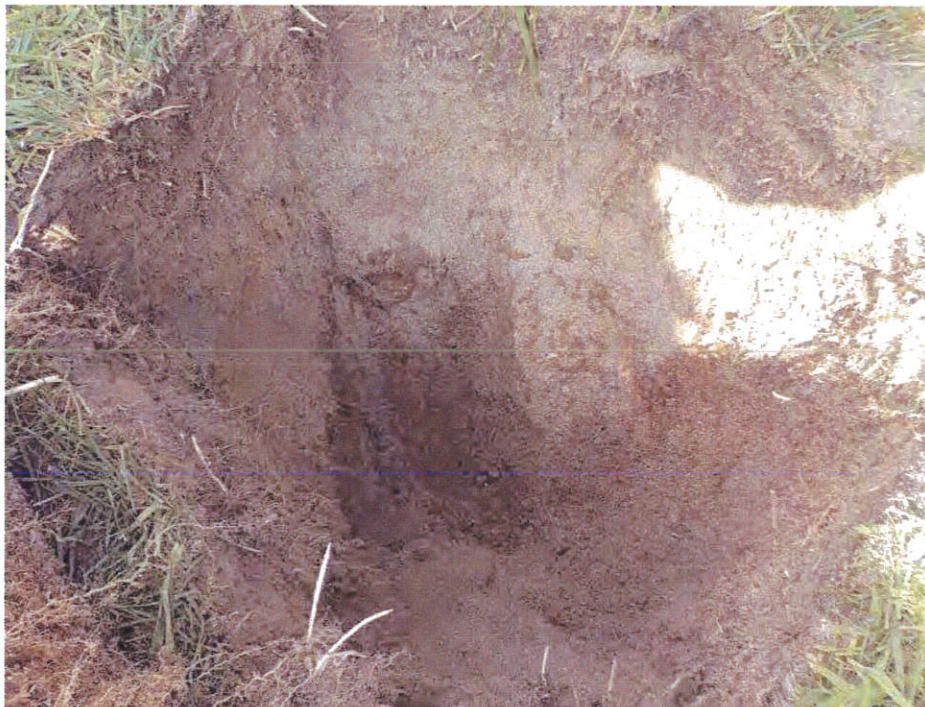
Photo 6 – View of the sandy fill soils encountered in our hand borings.

<b>B-1</b>	<b><u>Depth (ft.)</u></b>	<b><u>USCS</u></b>	<b><u>Description</u></b>
	0 – 0.33	ML (FILL)	Sandy SILT FILL; brown, dry, loose.
	0.33 – 0.75	SP (FILL)	Silty SAND FILL; light brown, dry, loose.
	0.75 – 1.25	GP (FILL)	GRAVEL FILL; dark grey, dry, dense, compacted basalt fragments up to 2" diameter. Refusal on rock fragments at approximately 1.25 feet. Free groundwater was not encountered.

<b>B-2</b>	<b><u>Depth (ft.)</u></b>	<b><u>USCS</u></b>	<b><u>Description</u></b>
	0 – 0.33	ML (FILL)	Sandy SILT FILL; brown, dry, loose.
	0.33 – 1.0	SP (FILL)	Silty SAND FILL; light brown, dry, loose. Refusal on rock fragments at approximately 1.0 feet. Free groundwater was not encountered.
<b>B-3</b>	<b><u>Depth (ft.)</u></b>	<b><u>USCS</u></b>	<b><u>Description</u></b>
	0 – 0.33	ML (FILL)	Sandy SILT FILL; brown, dry, loose.

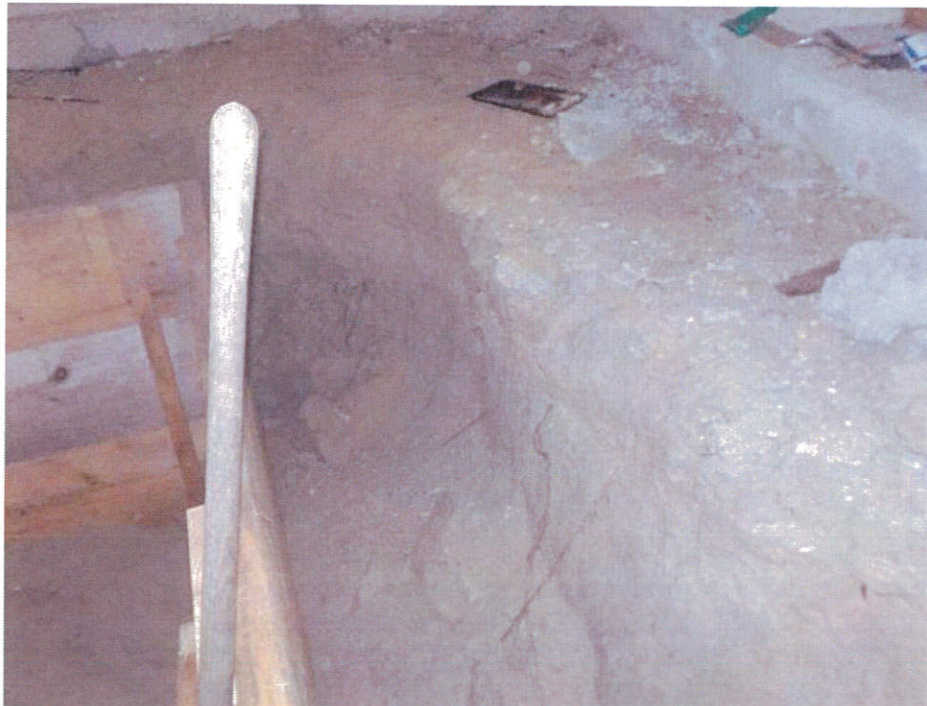
Photo 7 – View of the sand exposed in the crawlspace excavation.

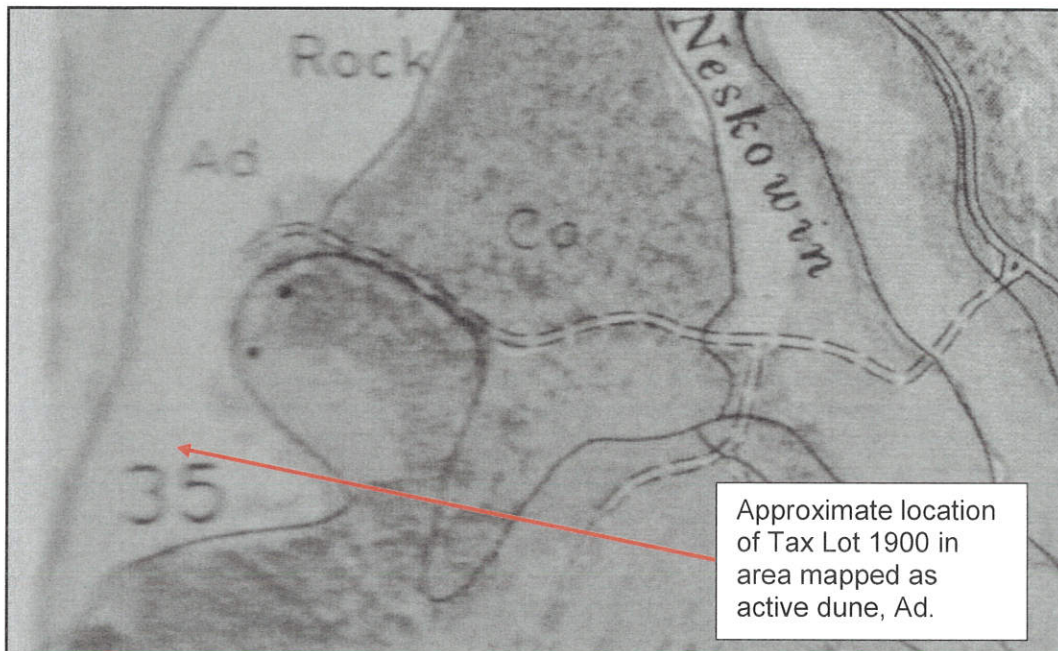
**Figure 3** –USDA Soil Survey of Tillamook Area, Oregon, 1964. Soil map photo of project area from 1953, 1954, or 1955.

Aerial photos of the project area from 1953 to 1955 were used in the 1964 edition of the USDA Soil Survey of Tillamook Area, Oregon. Figure 3 shows the approximate area of Tax Lot 1900 as open sand beach embayment and active dune sand, (soil map unit **Ad**), in the mid-1950s photo. The 1982 USGS topographic map in Figure 4 shows some homes on the northern and southern upland margins of the shoreline embayment, and likely first home, on Tax Lot 1600, on the northern edge of the infilled embayment. The existing home on Tax Lot 1900 and two others to the north are visible in the May 5, 1994 Google earth aerial image. In the 1994 photo, 10655 S.W. Park Street • Tigard, Oregon 97223 • Phone 360-903-4861 • Email warrenkrager@gmail.com

the area of Tax Lot 1900 is interpreted as a dune grass and shrub stabilized shoreline beach berm and foredune that had infilled across the embayment. The western edge of the vegetated foredune was then about 45 feet from the west side of the home visible in the 1994 air photo.

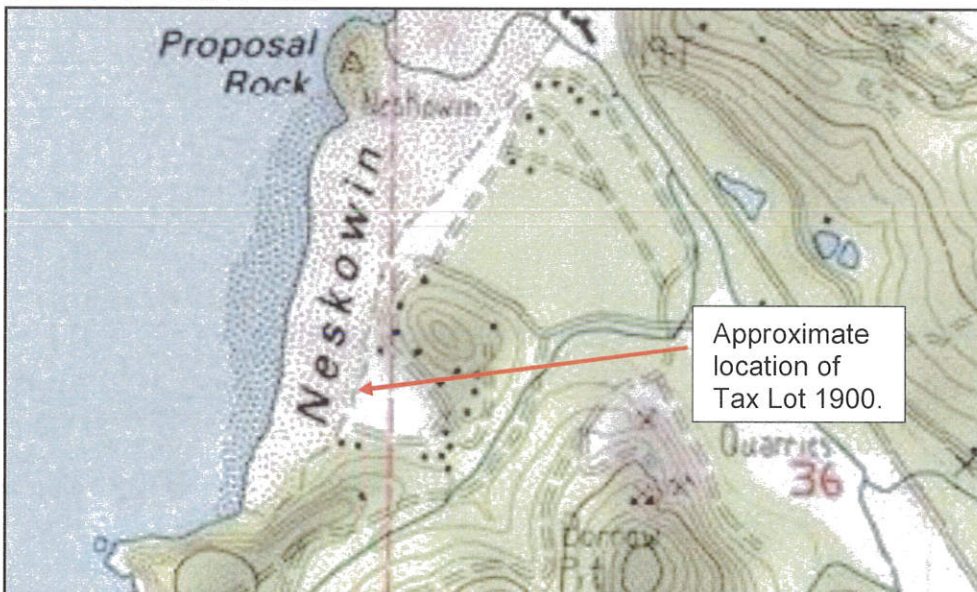
**Figure 4** – Portion of USGS 7.5-Minute topographic map of Neskowin, 1982

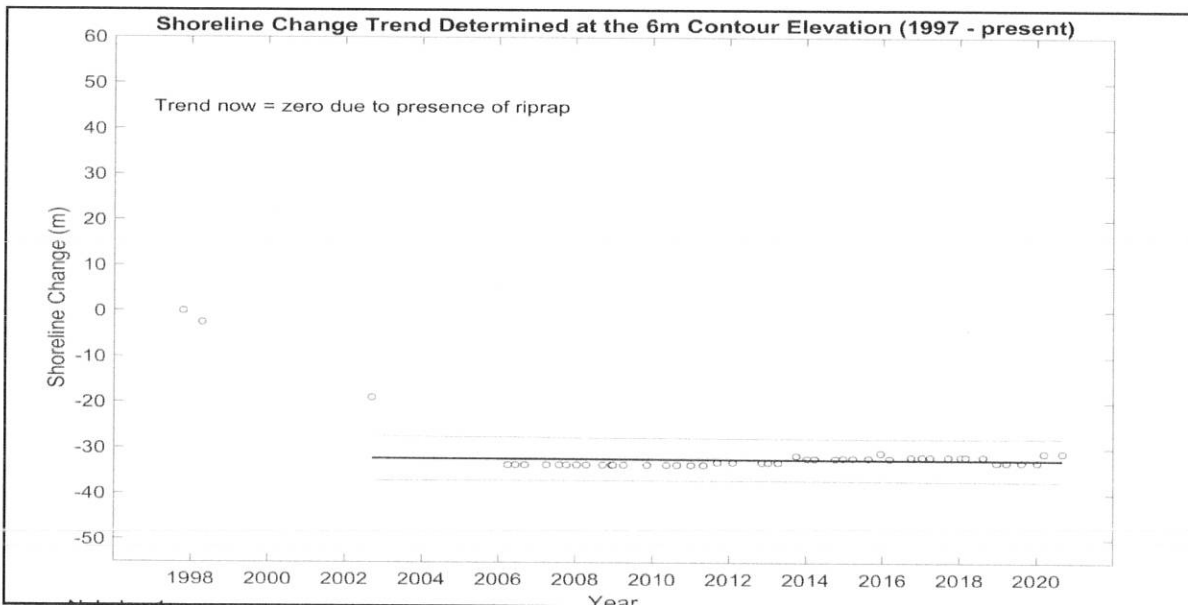
**Figure 5** – NANOOS Shoreline profile station Neskowin, OR - Nesk01.

The Northwest Association of Networked Ocean Observing Systems (NANOOS) and DOGAMI have developed the Oregon Beach and Shoreline Mapping and Analysis Program (OBSMAP), that documents the spatial variability of beach changes at various monitoring stations along beaches of the Oregon coast. The closest NANOOS monitoring station, Neskowin, OR - Nesk01, is 0.63 miles north of the subject property, near the west end of Yamhill Avenue, in Neskowin. Figure 5 plots the trend of shoreline-change for this monitoring station from 1997 to present. The data plot suggests rapid shoreline erosion between 1997 and about 2003.

The gap in survey data from about 2003 to early 2006 suggests that construction of the shoreline protection boulder revetment may have occurred during this time. After shoreline erosion protection was completed, regular profile surveys resumed in 2006 and continue to present. The data illustrate the net erosion trend halted by installation of riprap. It should be considered that shoreline erosion conditions and timing of protective boulder revetment or riprap construction at Nesk01 survey station likely vary from the erosion protection of your beachfront property to the south. However, the observed trend of shoreline change, and result of erosion abatement following rip rap installation is expected to be similar for Tax Lot 1900. Review of Google Earth satellite images suggests initial rip rap installation on Tax Lot 1900 occurred sometime between 1994 and 2000. The eastern edge of the boulder revetment is visible in the 2003 and later Google Earth air photos about 40- to 42-feet from the existing home.

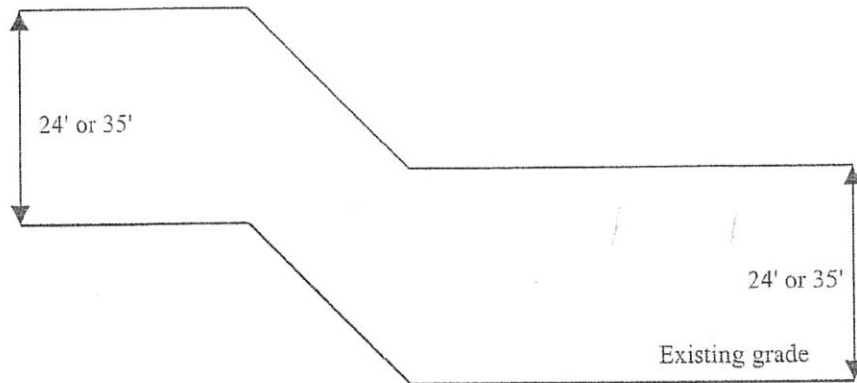
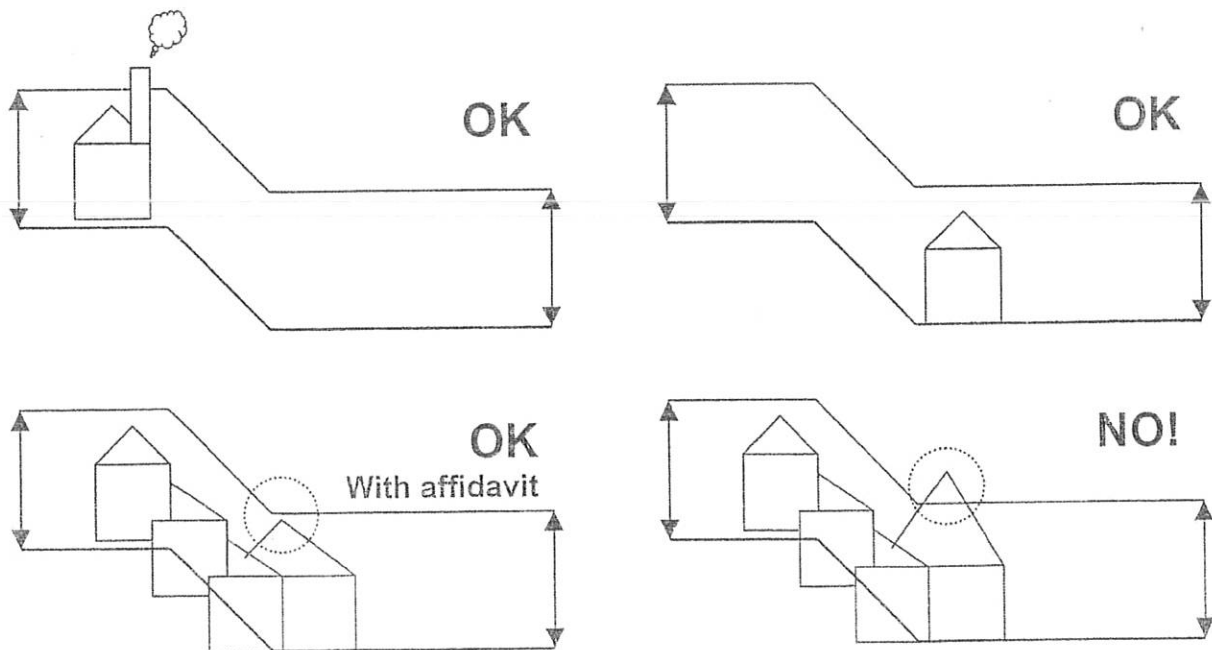
- Step 1.** Determine if your parcel is an oceanfront parcel. Oceanfront parcels have a 24-foot height limit. All other parcels have a 35-foot height limit.
- Step 2.** Determine the building envelope. In Neskowin, a plane located exactly 24 or 35 feet above the existing grade of the parcel determines the maximum height of the structure.

- Step 3.** Determine if your proposed structure will pierce the plane. Some building projections such as chimneys do not count toward the height restriction. If the building is planned to be within 3 feet of the limit, a height affidavit must be signed by the property owner.
