**NESKOWIN COASTAL HAZARDS AREA PERMIT**  
**#851-21-000254-PLNG: TRAN**

**Request:** A request for approval of a Neskowin Coastal Hazard Area Permit for the construction of a single-family dwelling.

**NESKOWIN COASTAL HAZARD AREA PERMIT REQUEST  
#851-21-000254-PLNG: Tran  
ADMINISTRATIVE DECISION & STAFF REPORT**

**RE: GEOLOGIC HAZARD ASSESSMENT AND GEOTECHNICAL EVALUATION  
MAP 5s, 11W, 35DA  
TAX LOT 3500  
NESKOWIN HEIGHTS DEVELOPMENT  
NESKOWIN, TILLAMOOK COUNTY, OREGON 97149  
Branch Engineering Inc Project No. 21-086**

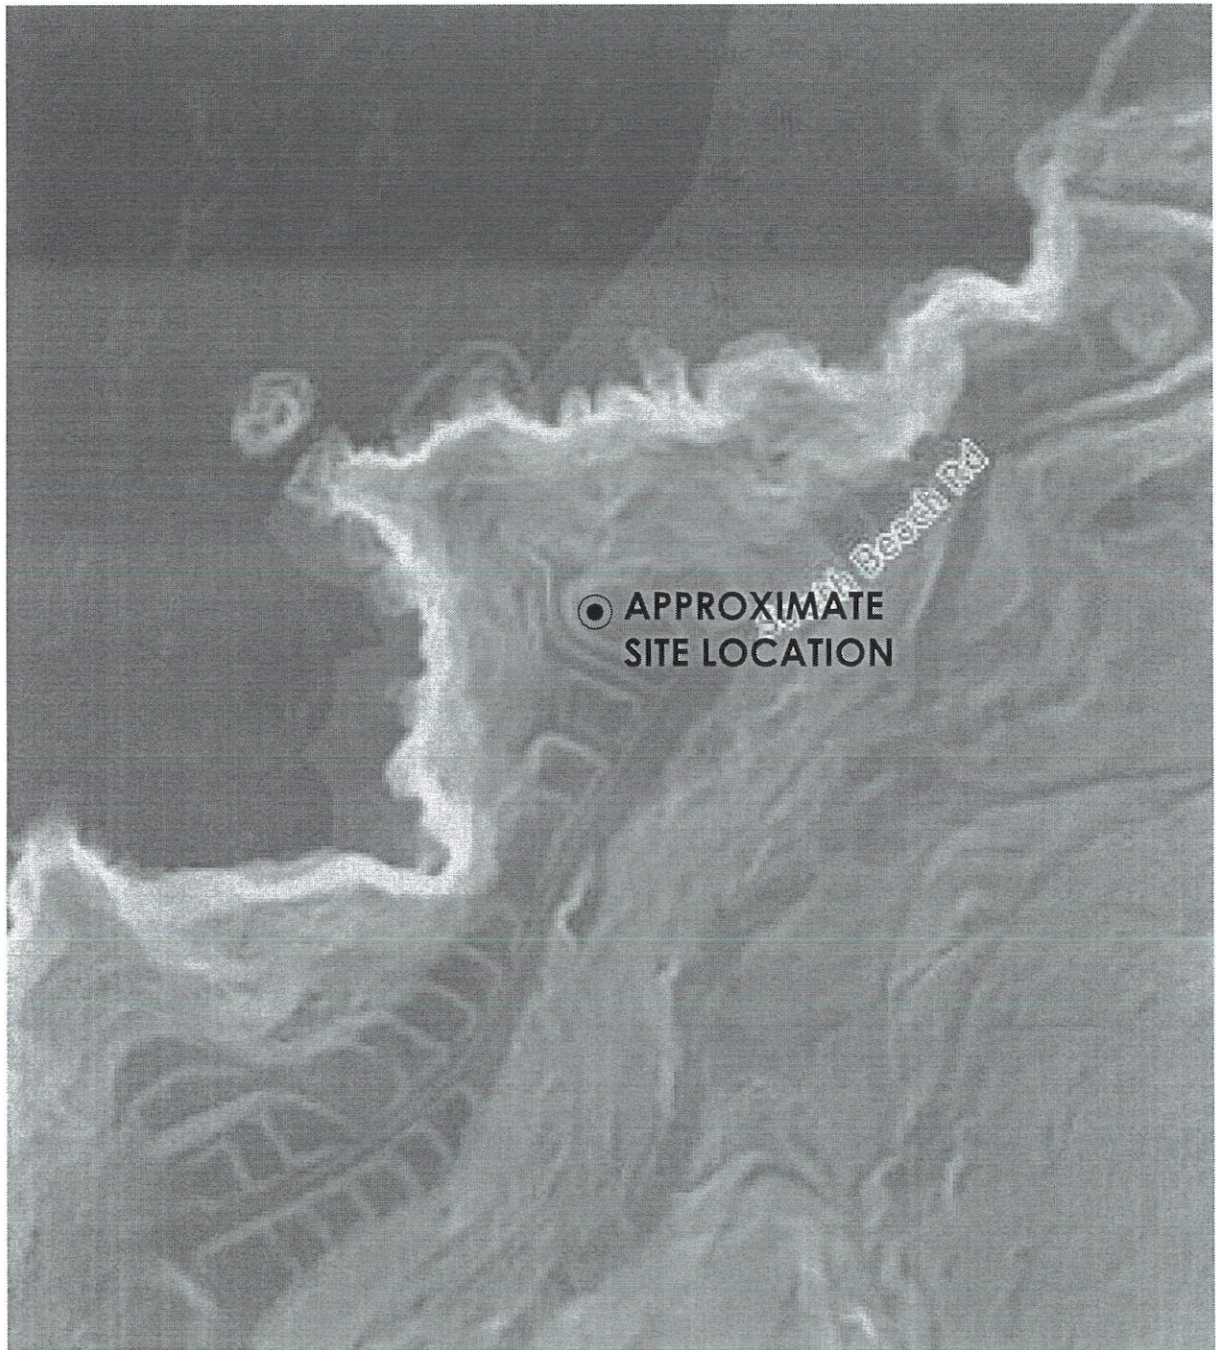
SITE LIDAR MAP - TAX LOT 3500 NESKOWIN HEIGHTS  
NESKOWIN, OREGON

NOTE: Visual by DOGAMI Lidar Viewer

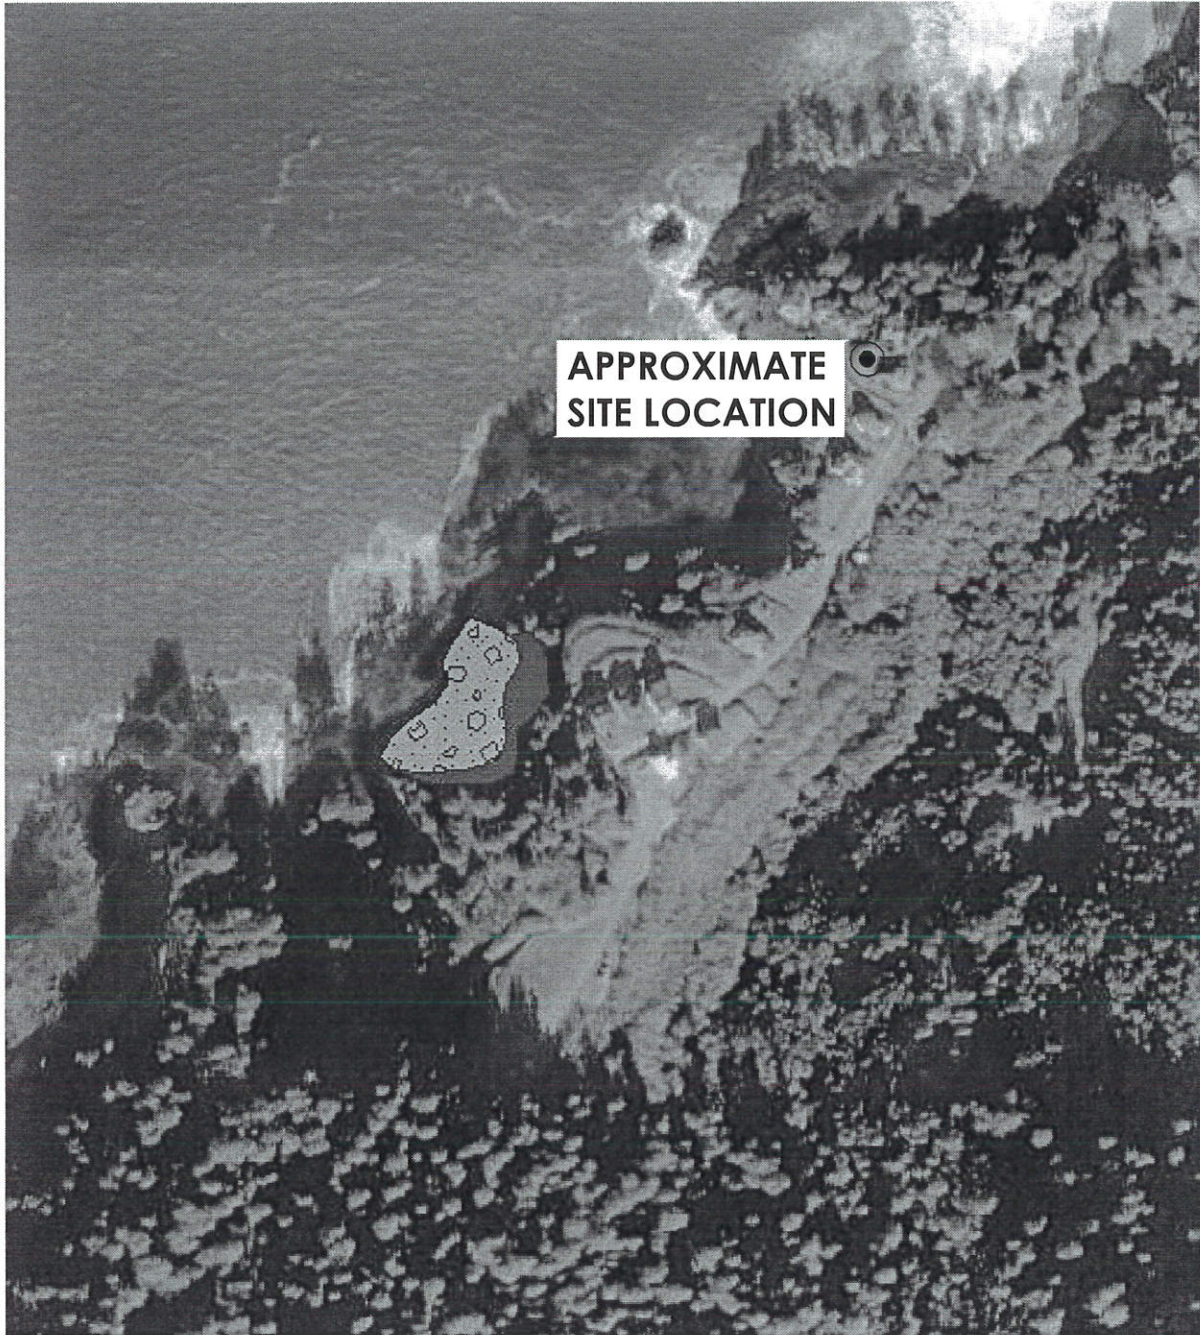
SLIDO MAP - TAX LOT 3500 NESKOWIN HEIGHTS  
NESKOWIN, OREGON

NOTE: Visual by DOGAMI Slido Viewer

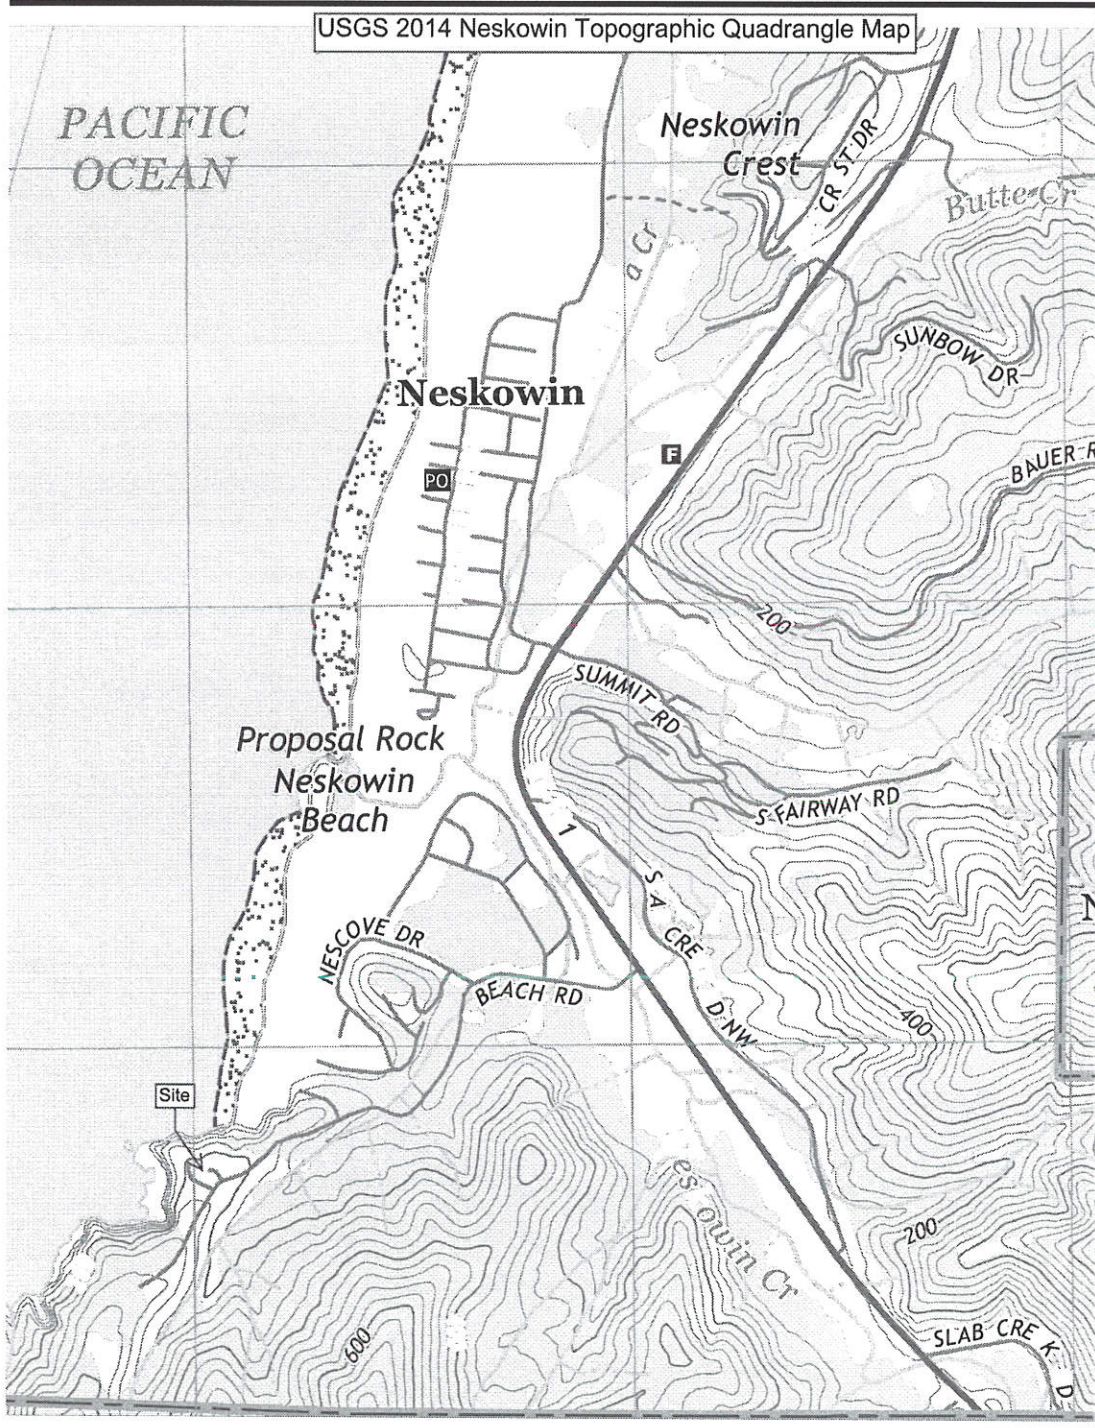
FIGURE-6

USGS NESKOWIN TOPOGRAPHIC MAP  
NESKOWIN, OREGON

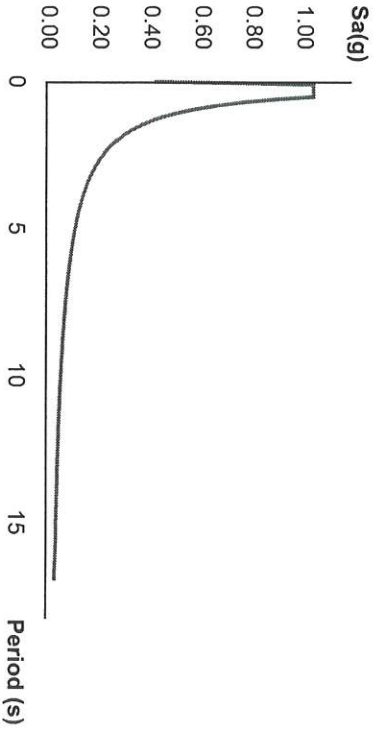
## MCER Horizontal Response Spectrum

Name	Value	Description
Ss	1.3	MCER ground motion (period=0.2s)
S1	0.678	MCER ground motion (period=1.0s)
Sms	1.04	Site-modified spectral acceleration value
Sm1	0.542	Site-modified spectral acceleration value

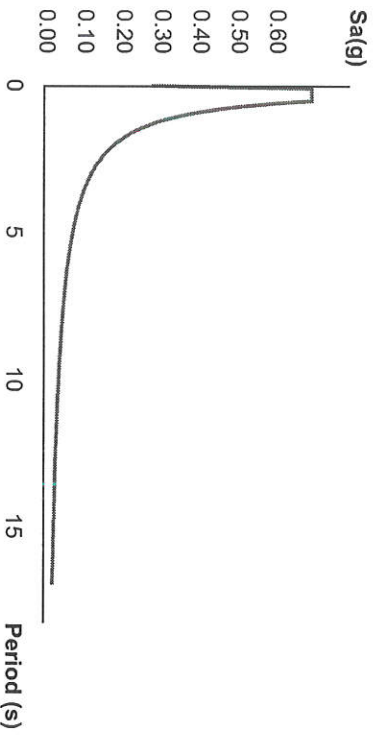
## Design Horizontal Response Spectrum

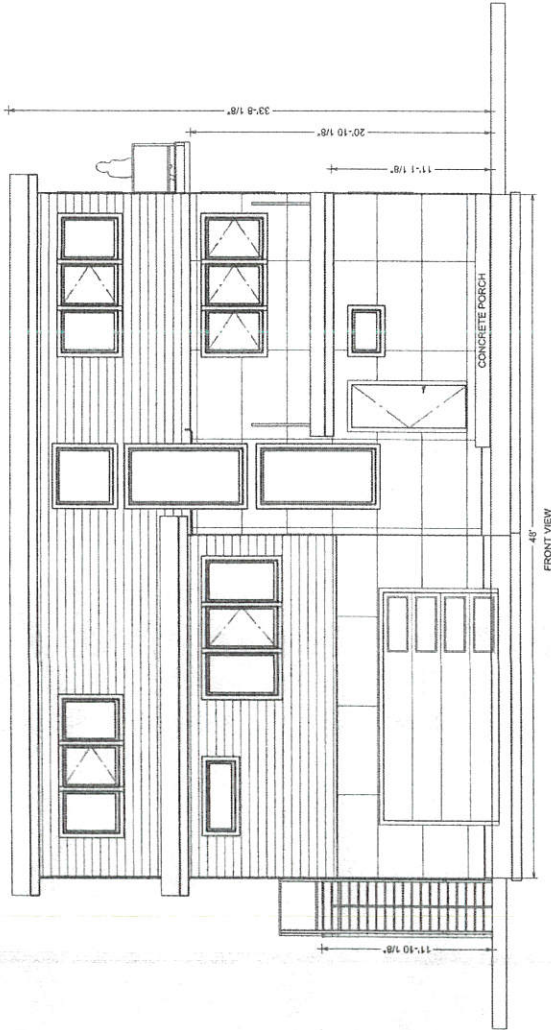
FRONT VIEW

REAR VIEW

MAIN FLOOR	1378 SQ FT
MIDDLE FLOOR	1832 SQ FT
UPPER FLOOR	1338 SQ FT
TOTAL LIVING:	4548 SQ FT
MIDDLE FLOOR DECK	606 SQ FT
UPPER FLOOR DECK	364 SQ FT
PATIO	294 SQ FT
PORCH	142 SQ FT
GARAGE	487 SQ FT

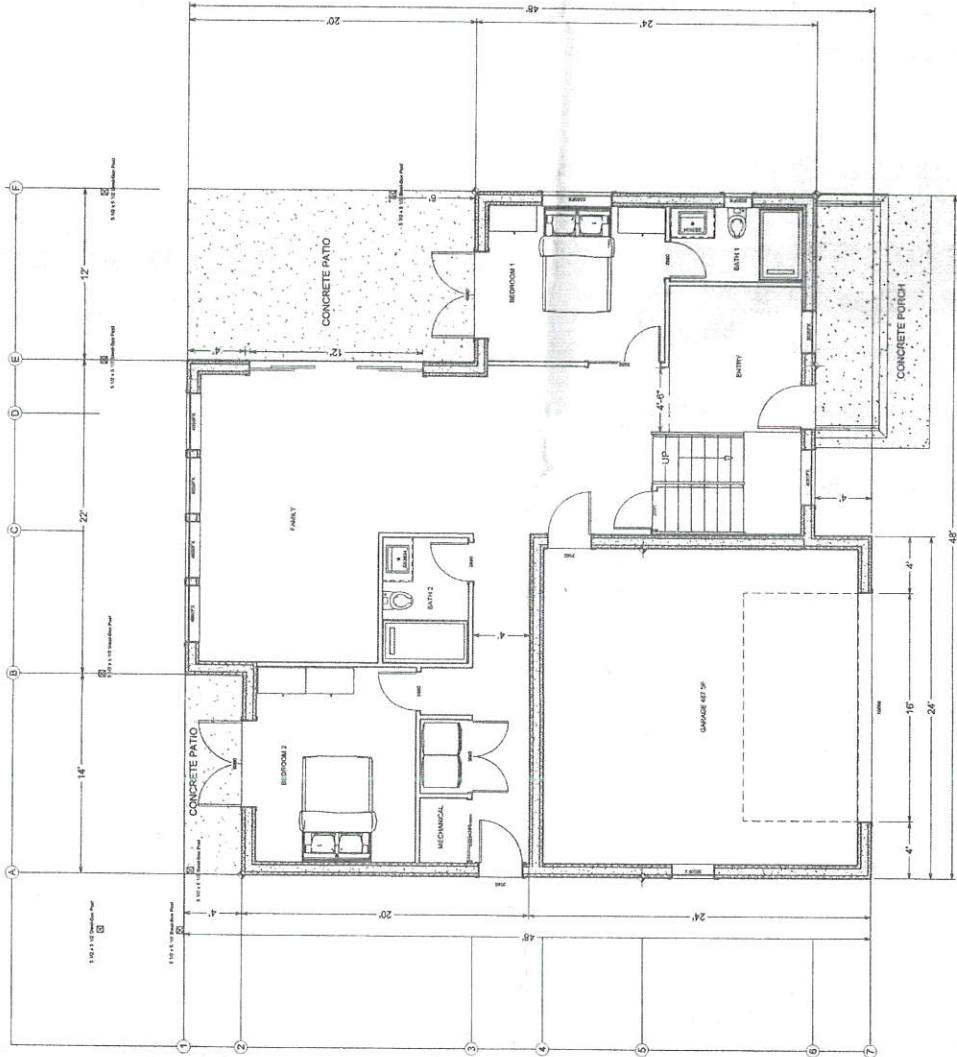
MAIN FLOOR PLAN

LIVING AREA  
1376 SQ. FT.

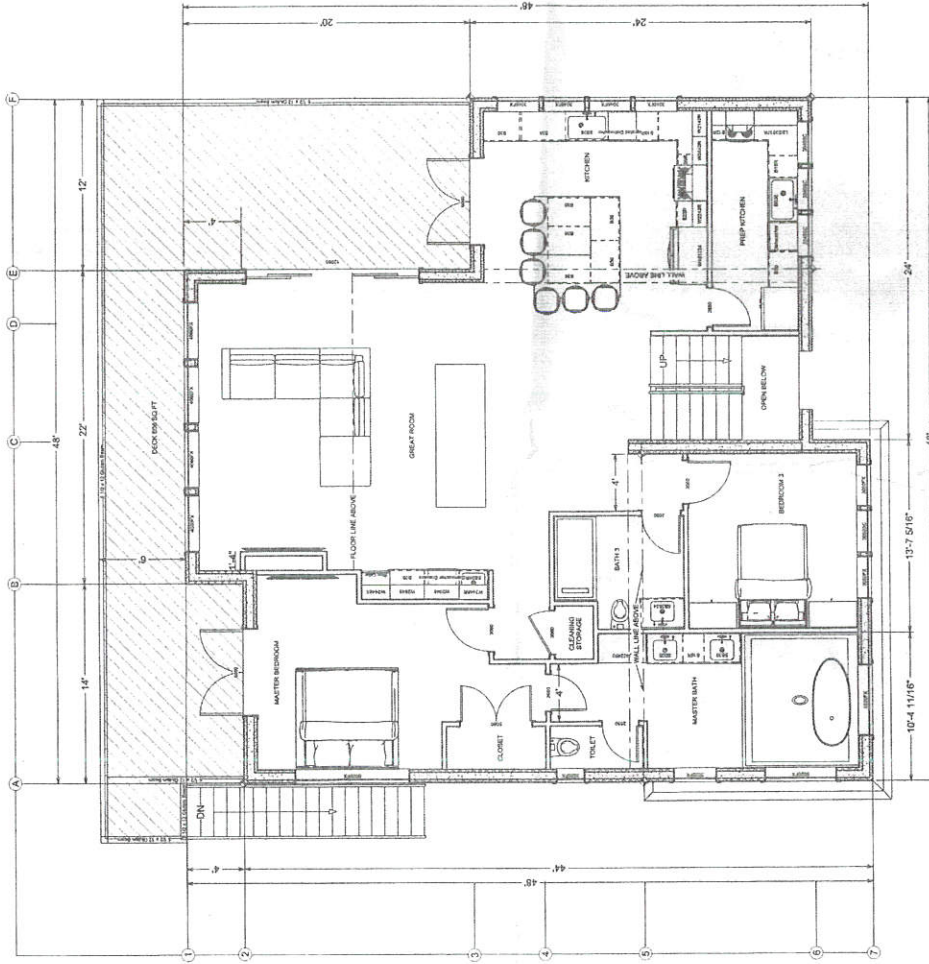
MIDDLE FLOOR PLAN

LIVING AREA  
1832 SQ FT

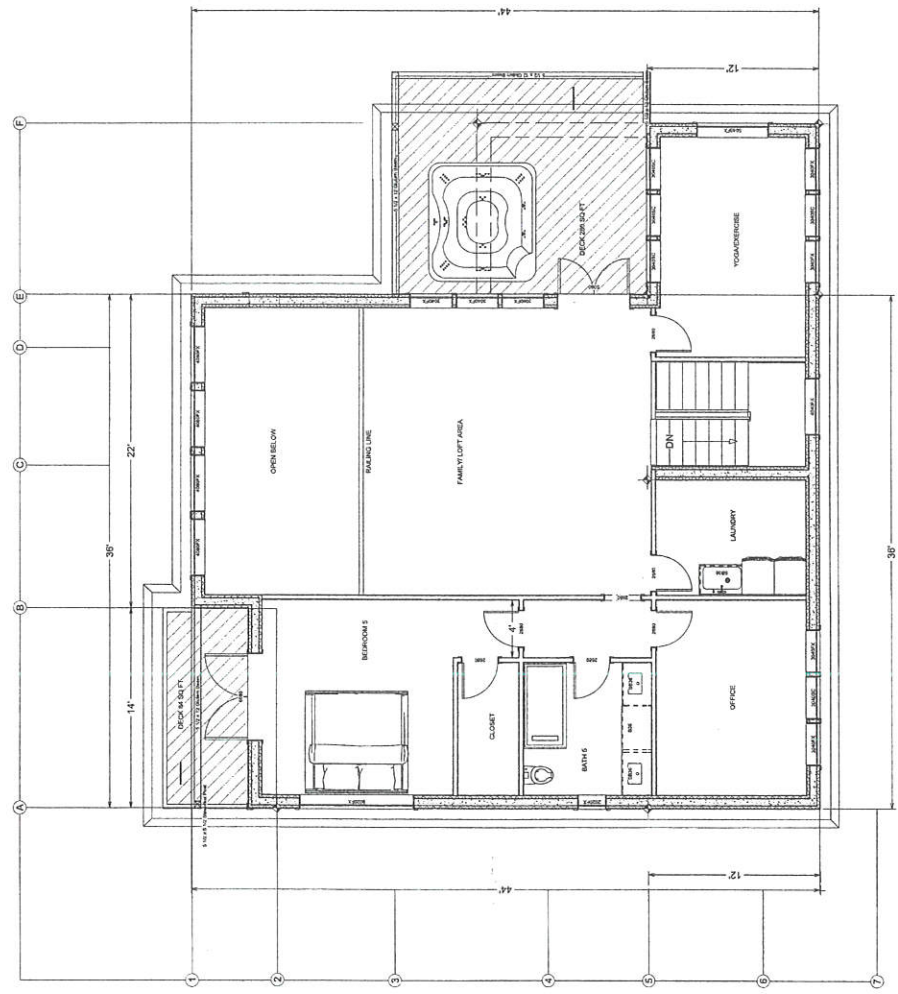
UPPER FLOOR PLAN

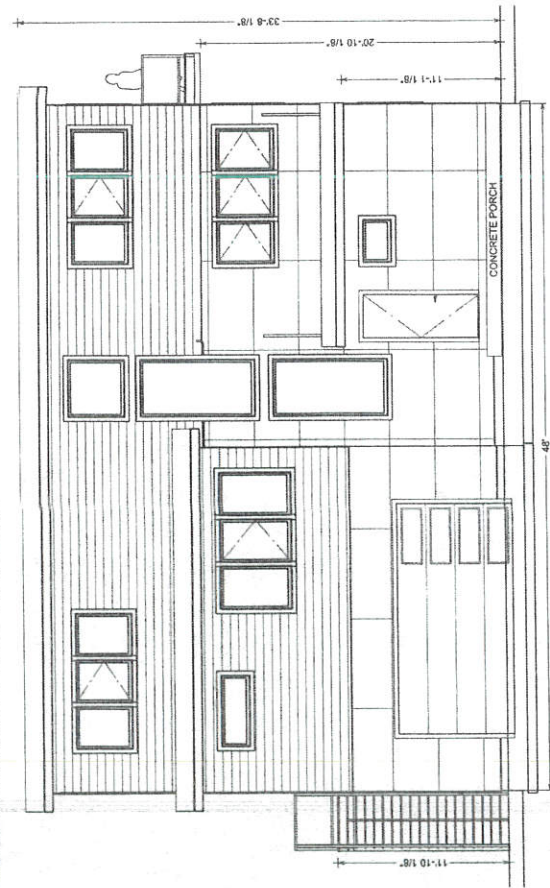
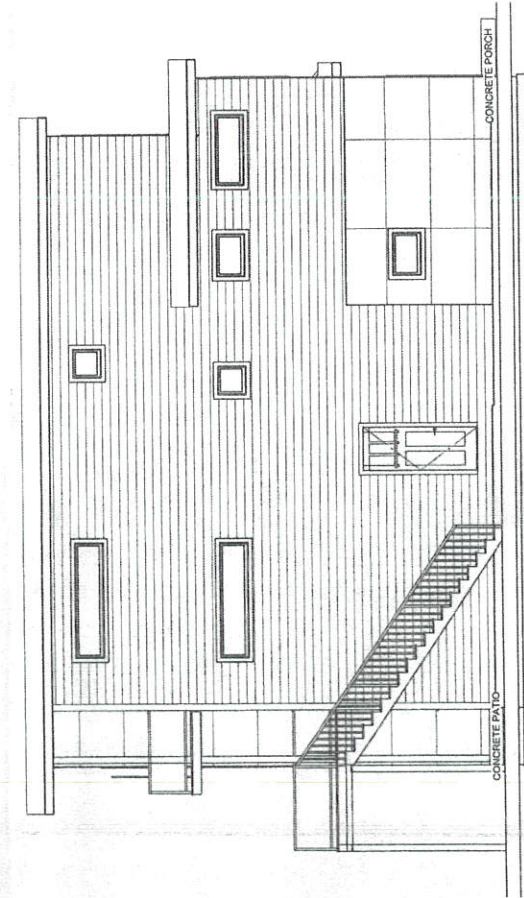
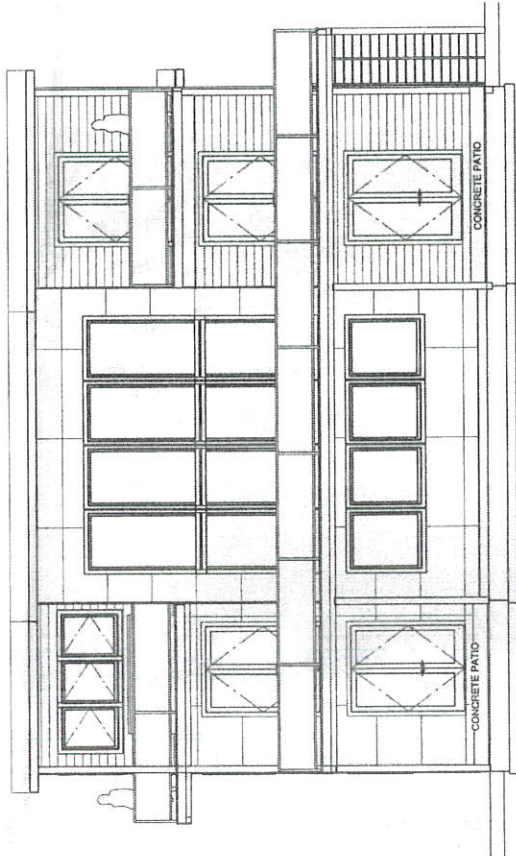
ELEVATION VIEWS

FRONT VIEW

RIGHT VIEW

LEFT VIEW

REAR VIEW
