NESKOWIN COASTAL HAZARDS AREA PERMIT
#851-21-000283-PLNG: CAPRI & MCMILLAN
NOTICE TO MORTGAGEE, LIENHOLDER, VENDOR OR SELLER:
ORS 215 REQUIRES THAT IF YOU RECEIVE THIS NOTICE,
IT MUST BE PROMPTLY FORWARDED TO THE PURCHASER

**NESKOWIN COASTAL HAZARD AREA PERMIT REQUEST
#851-21-000283-PLNG: Capri & McMillan
ADMINISTRATIVE DECISION & STAFF REPORT**

PLANNING LAND USE APPLICATION
NESKOWIN COASTAL HAZARDS OVERLAY ZONE
TAX LOT #2000, MAP 5S-11W-36BC

**Geologic Hazards and Geotechnical Investigation
Tax Lot 2000, Map 5S-11W-36BC
Neskowin, Tillamook County, Oregon**

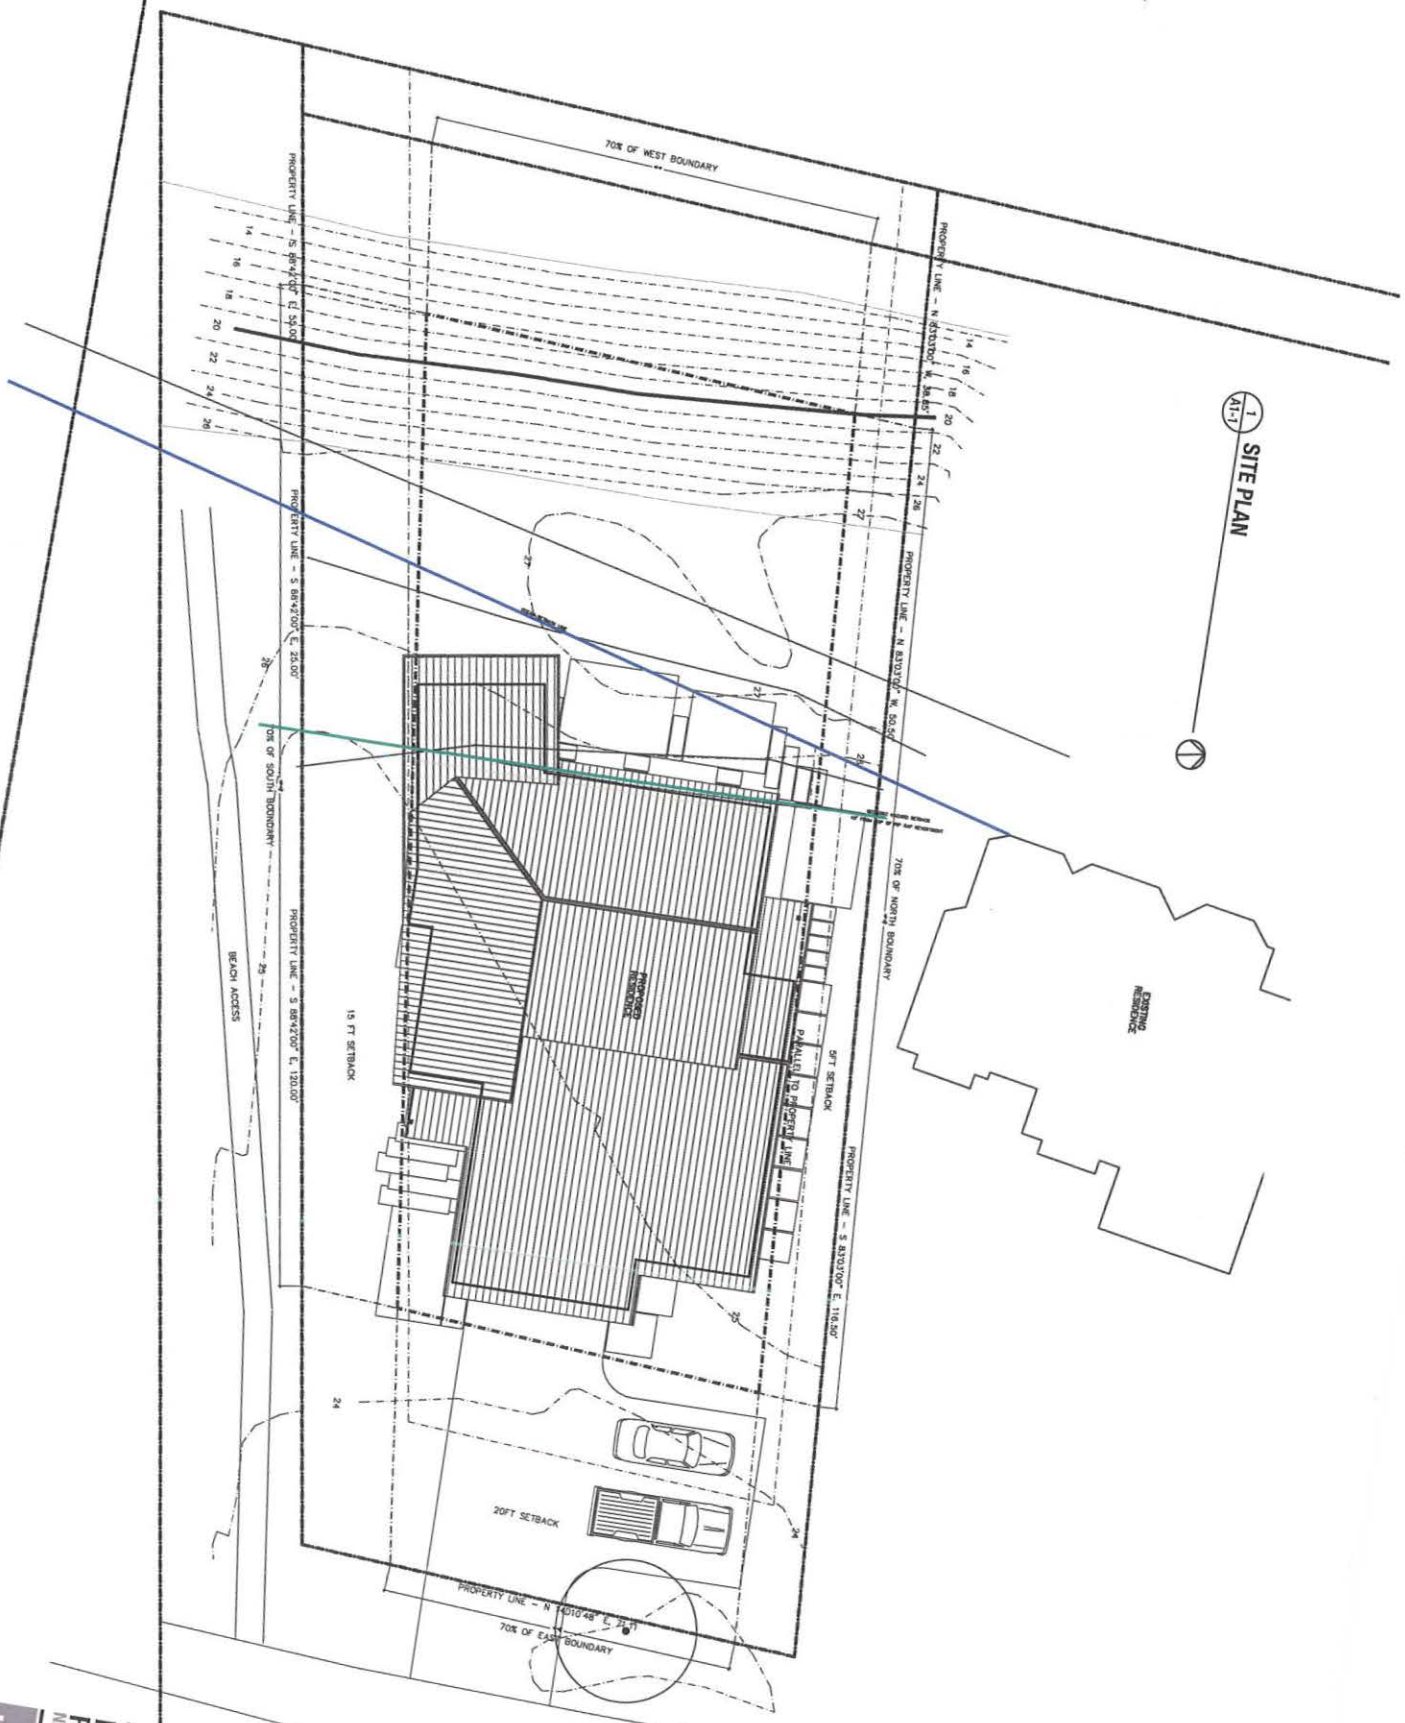
1
A1-1
SITE PLAN

EXISTING RESIDENCE

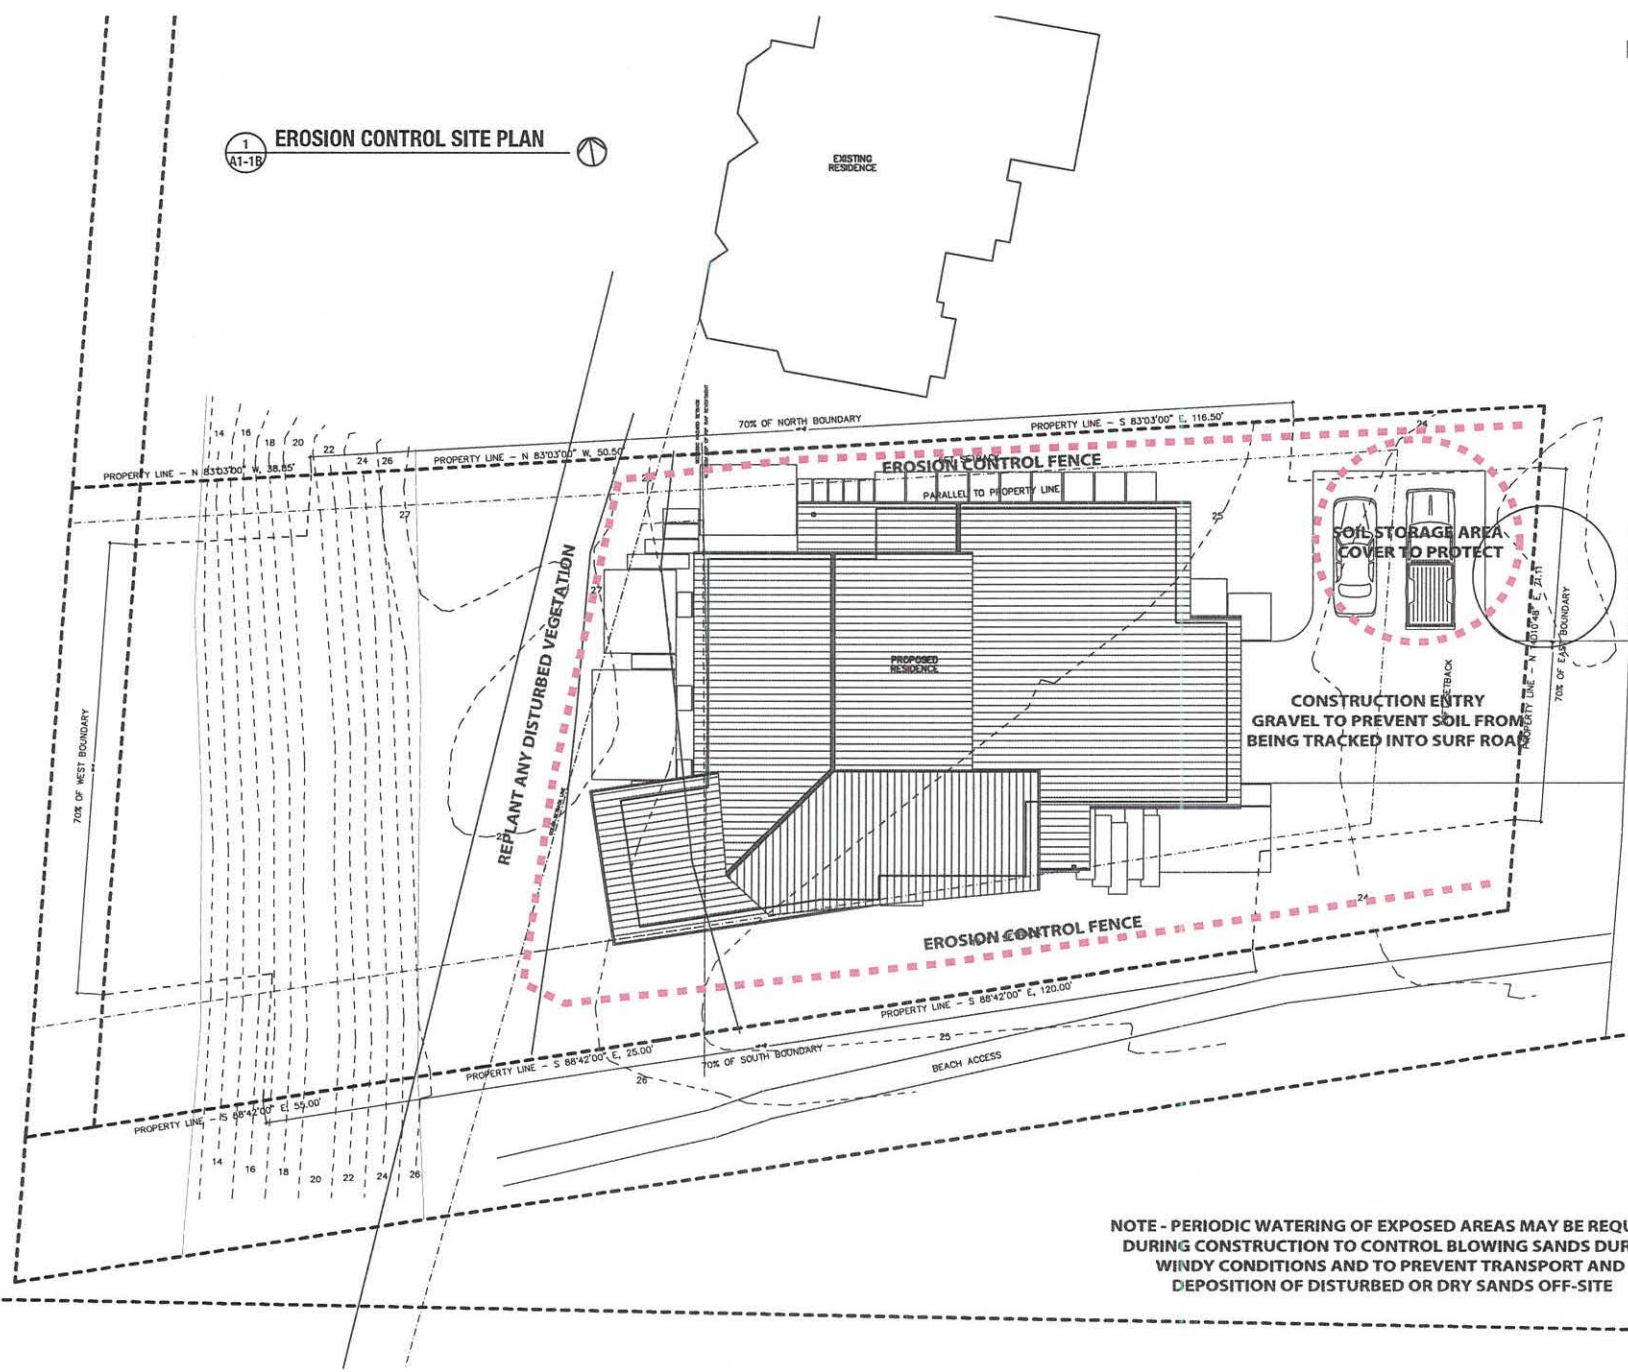
1
A1-1B
EROSION CONTROL SITE PLAN

NOTE - PERIODIC WATERING OF EXPOSED AREAS MAY BE REQUIRED DURING CONSTRUCTION TO CONTROL BLOWING SANDS DURING WINDY CONDITIONS AND TO PREVENT TRANSPORT AND DEPOSITION OF DISTURBED OR DRY SANDS OFF-SITE

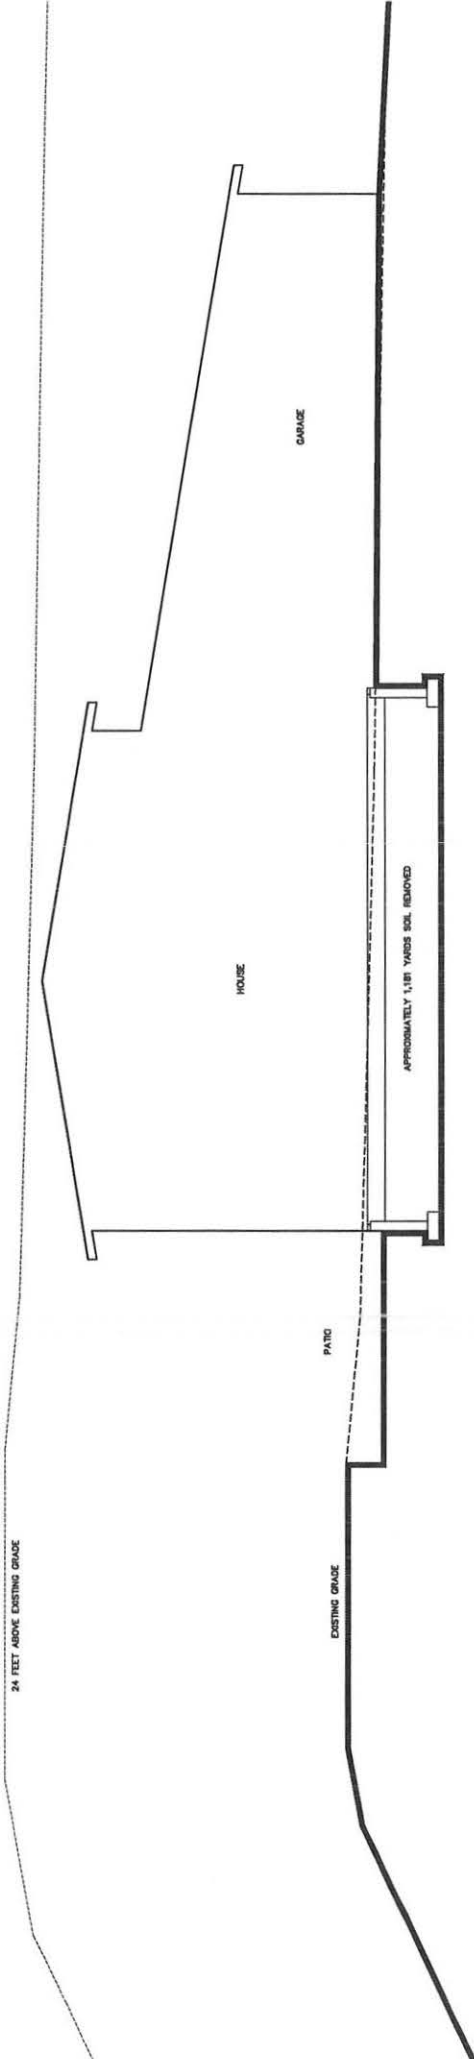
1 SITE SECTION
A1-2

EXCAVATION / FILL ESTIMATES

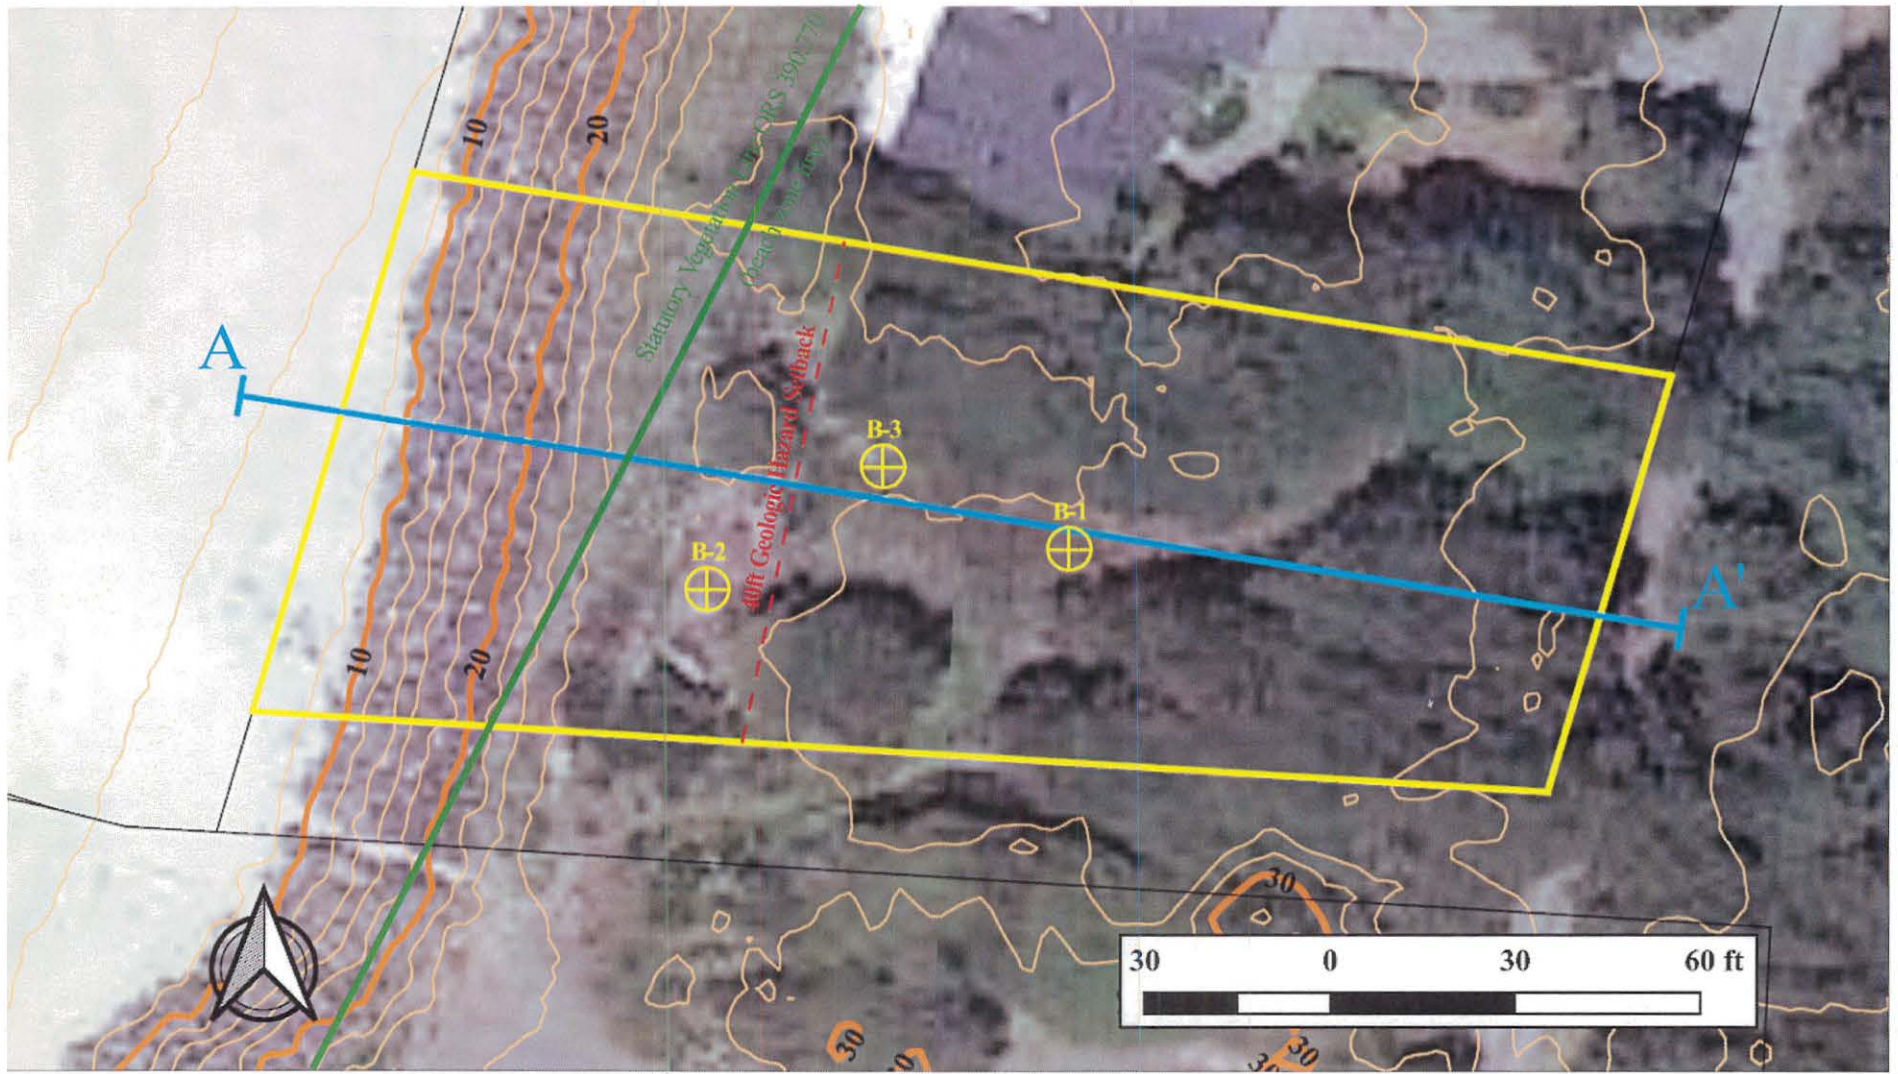
Figure 2

Modified from the Tillamook County assessor's plat
5S-11W-36BC
All locations and dimensions are approximate.

A — A' = Approximate trend of profile line

B-1 ⊕ = Approximate location of boring

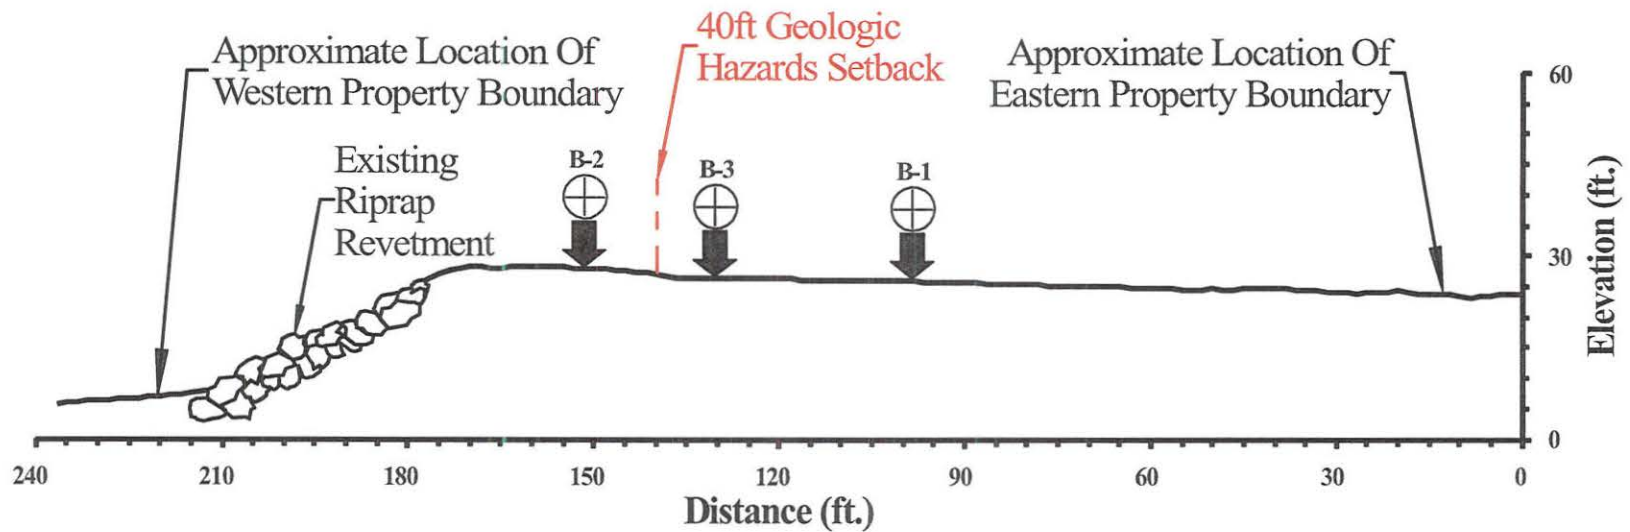
= Approximate location of boring

All dimensions, elevations and locations are approximate.
Slope profile derived from West_Coast_2016_El_Nino
Lidar data from NOAA.

The site east of the riprap revetment is gently sloping down to the east at approximately 2 to 5 degrees at elevations between approximately 24 to 28 feet (NAVD 88) (Figures 3 and 4). The riprap revetment slopes down to the beach at approximately 30 degrees. We observed an area approximately 8 feet wide near the base of the exposed revetment where it appeared that armor stone had been plucked from the revetment in the past damaging the revetment (Appendix A).

Lidar data from 2016 shows the junction between the beach and the revetment was at an elevation of approximately 8 feet (NAVD 88) (Figures 3 and 4). Allan and Hart (2005) surveyed the elevation of the beach/dune junction in 1997, 1998, and 2002 at approximately 20 feet, 14 feet, and 16 feet, respectively. Winter elevations primarily depend on beach profiles formed by storm conditions.

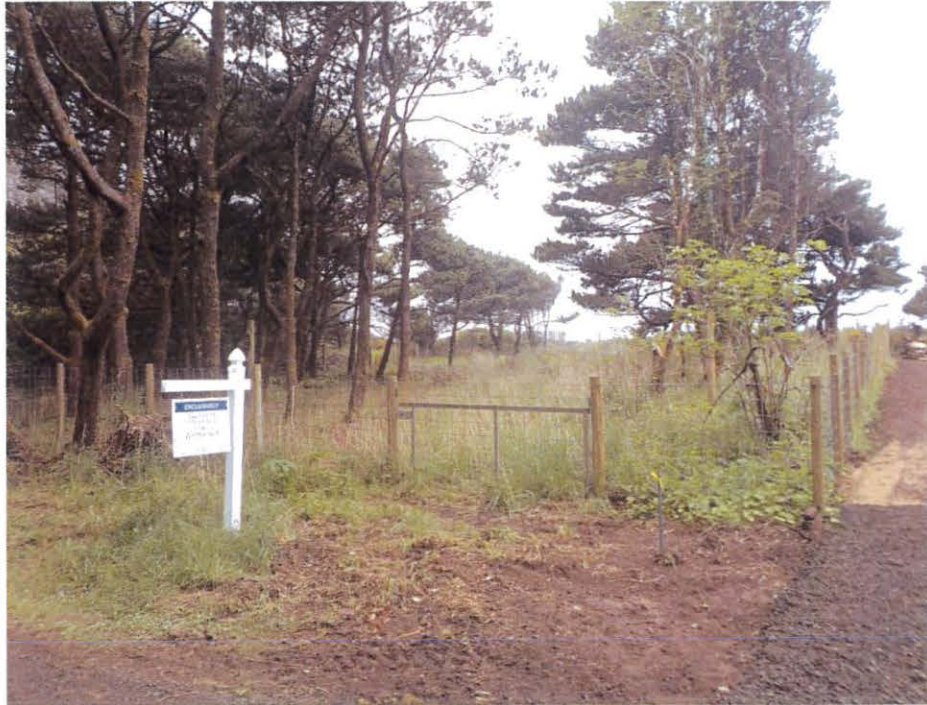
Photo 1 – Westerly view of the site from near the northeast property corner.

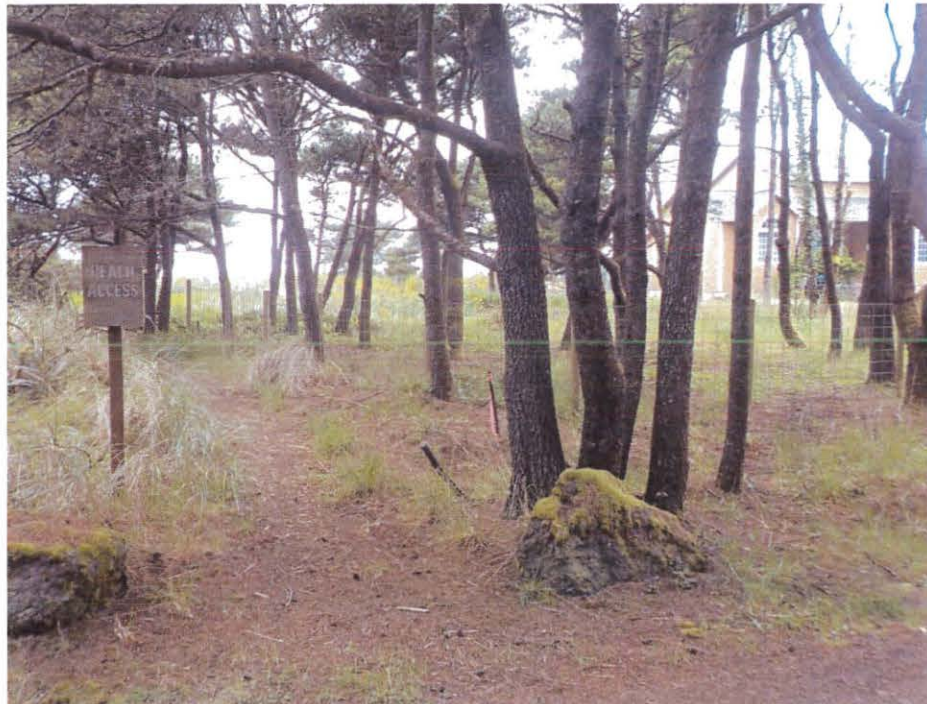
Photo 2 – Westerly view of the site from near the southeast property corner. Note the beach access path along the southern side of the site.

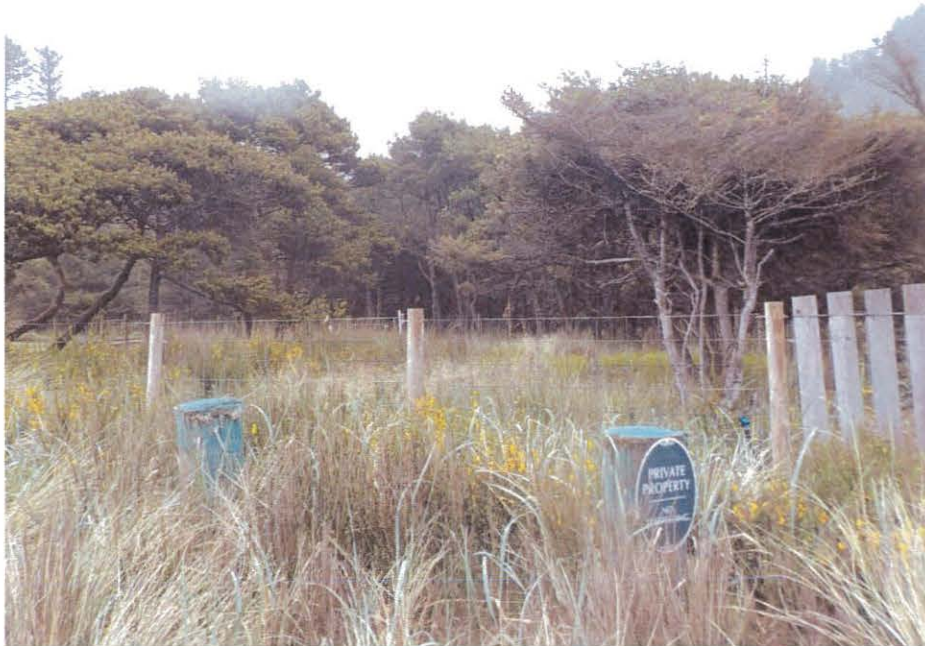
Photo 3 – Easterly view of the site from near the top of the riprap revetment.

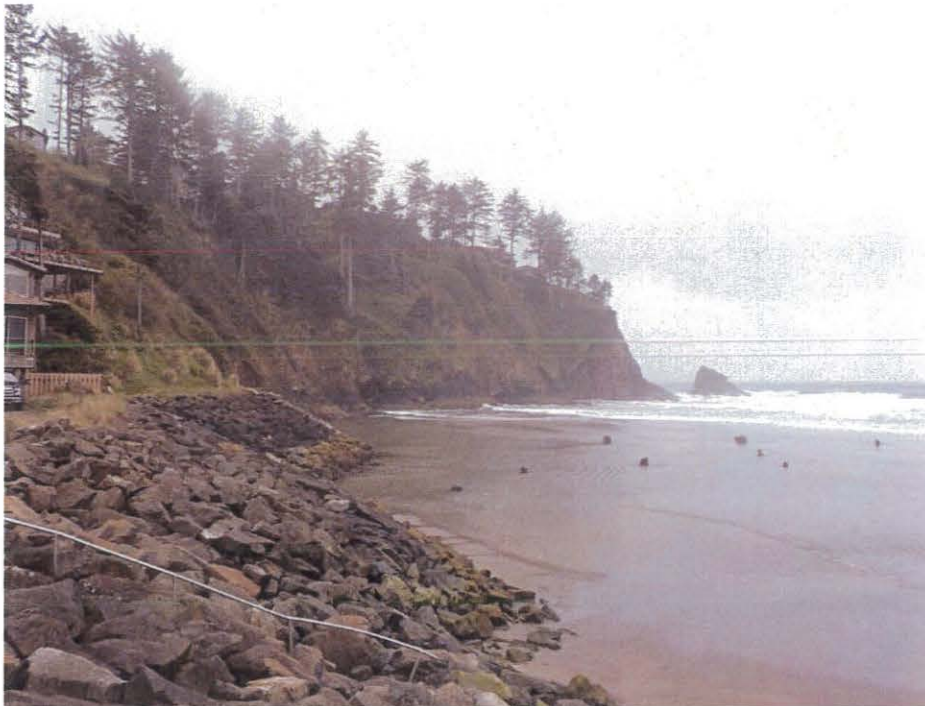
Photo 4 – Southerly view of the beach and bluff from the site. Note the stumps exposed on the beach.

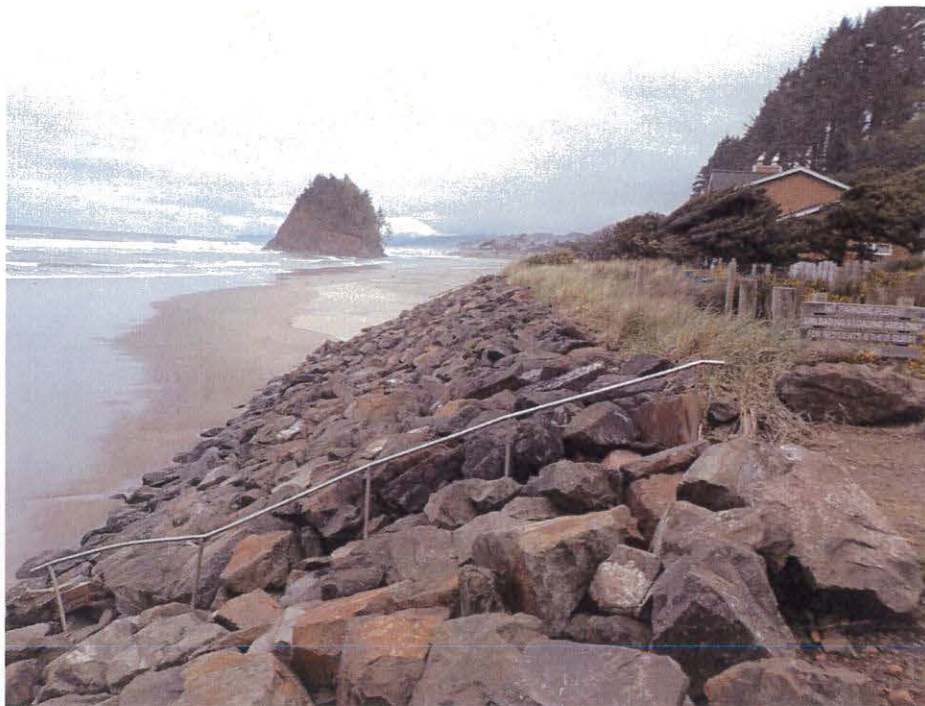
Photo 5 – Northerly view of the revetment, beach access stairs, and Neskowin Beach from just south of the site. Note the continuous riprap revetment along the dune slope.

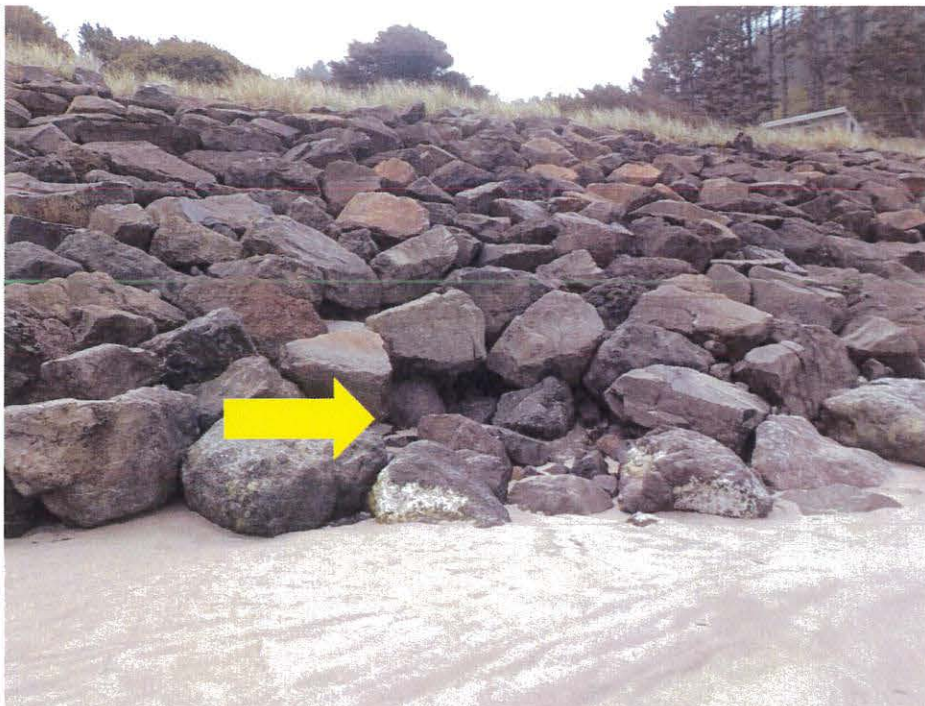
Photo 6 – View of the riprap revetment at the base of the slope immediately west of the site. Yellow arrow indicates where larger armor stone has become displaced and the revetment is damaged.

The existing revetment located on the western portion of the subject site slopes down to the beach at approximately 30 degrees and consists of angular basalt boulders approximately 4 to 7 feet diameter on its lower portion and approximately 3 to 5 feet diameter on the upper portion (Figure 3; Appendix A). An approximately 8 feet wide area of the revetment appears to have been previously damaged and is missing armor stone near the base (Appendix A). Severe storms in the winter of 2007–2008 partly undermined the revetments in areas located along Neskowin Beach. The riprap revetment greatly reduces the potential for erosion when maintained and repaired as necessary.

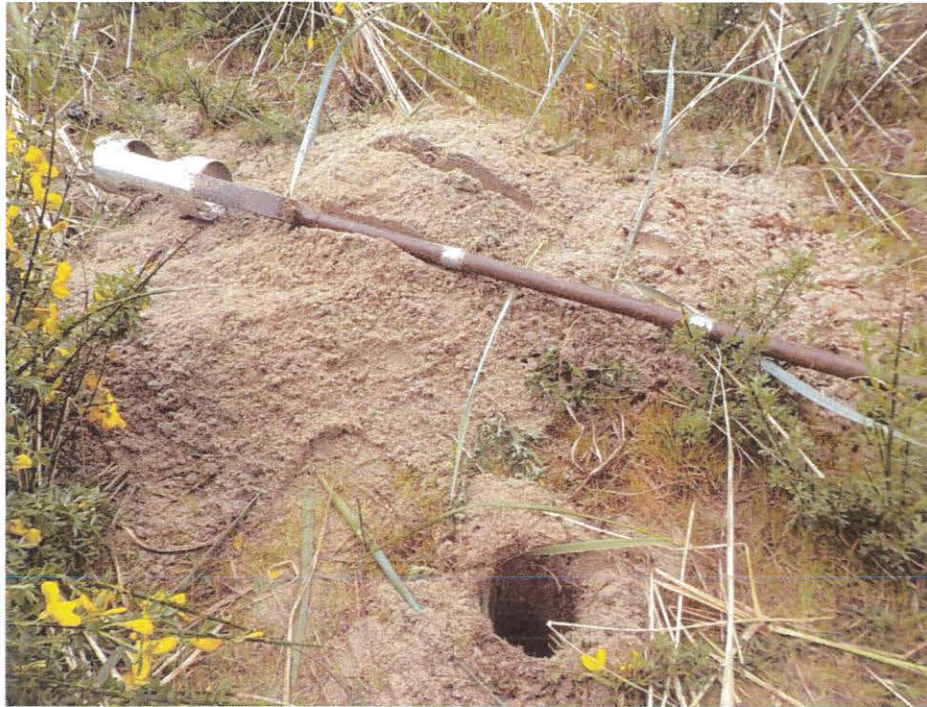
Photo 7 – View of the dune sand encountered in boring B-2 to a depth of approximately 13 feet below the ground surface.

B-2	<u>Depth (ft.)</u>	<u>USCS</u>	<u>Description</u>
	0 – 3.0	SP	Disturbed SAND; tan, wet, loose. Fine to medium-grained dune sand with grass roots in top 2 inches and occasional rock fragments up to 3-inch diameter.
	2.5 – 9.0	SP	SAND; tan, wet, medium dense to dense. Fine to medium-grained dune sand. Boring terminated in dense sand at approximately 9.0 feet. Free groundwater was not encountered.
