Porter Tract Restoration

Kilchis Estuary Preserve

Basis of Design Report

Final Design

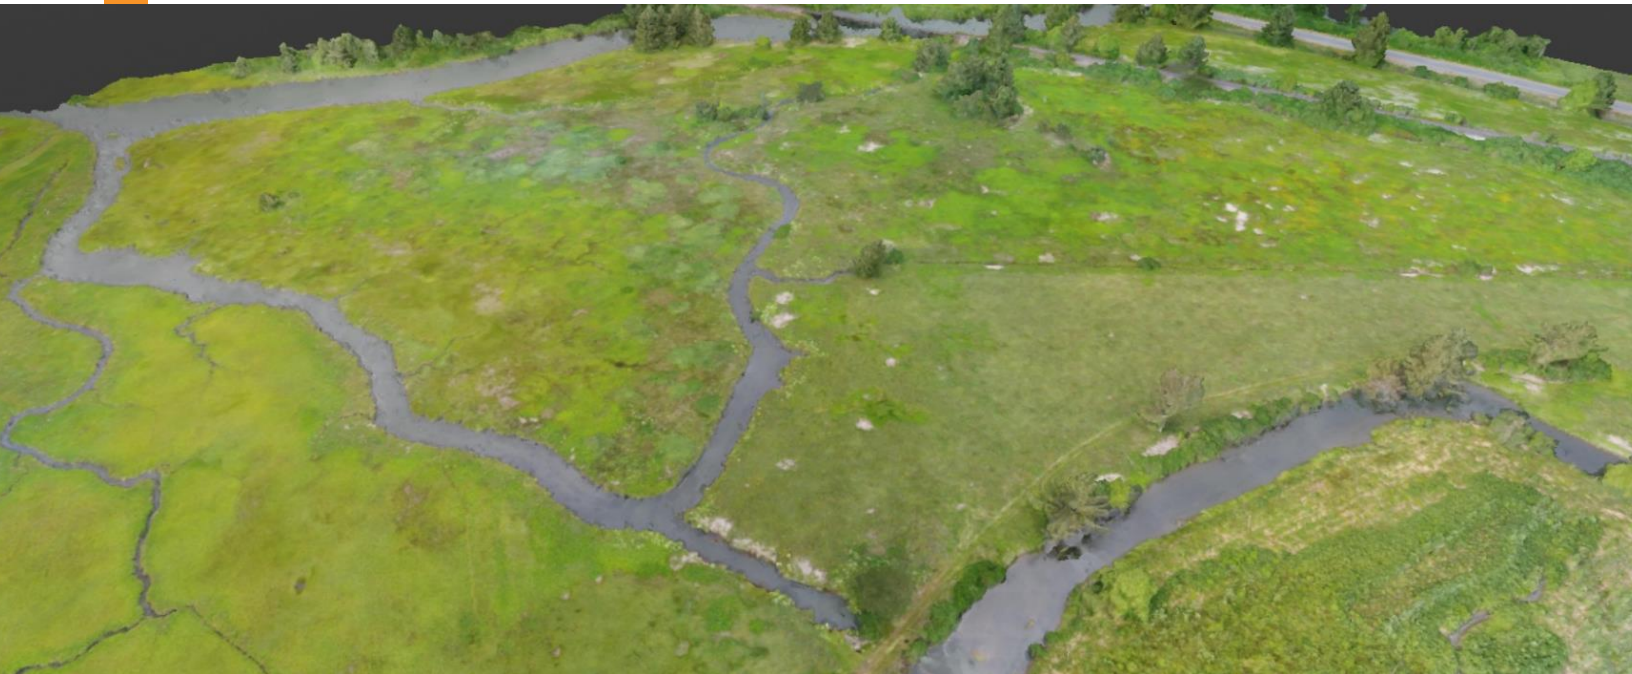
Cover photo:

Isometric aerial photograph of the Porter Tract of the Kilchis Estuary Preserve with the Connector Channel and Stasek Slough in the foreground and Hathaway Slough in the background.

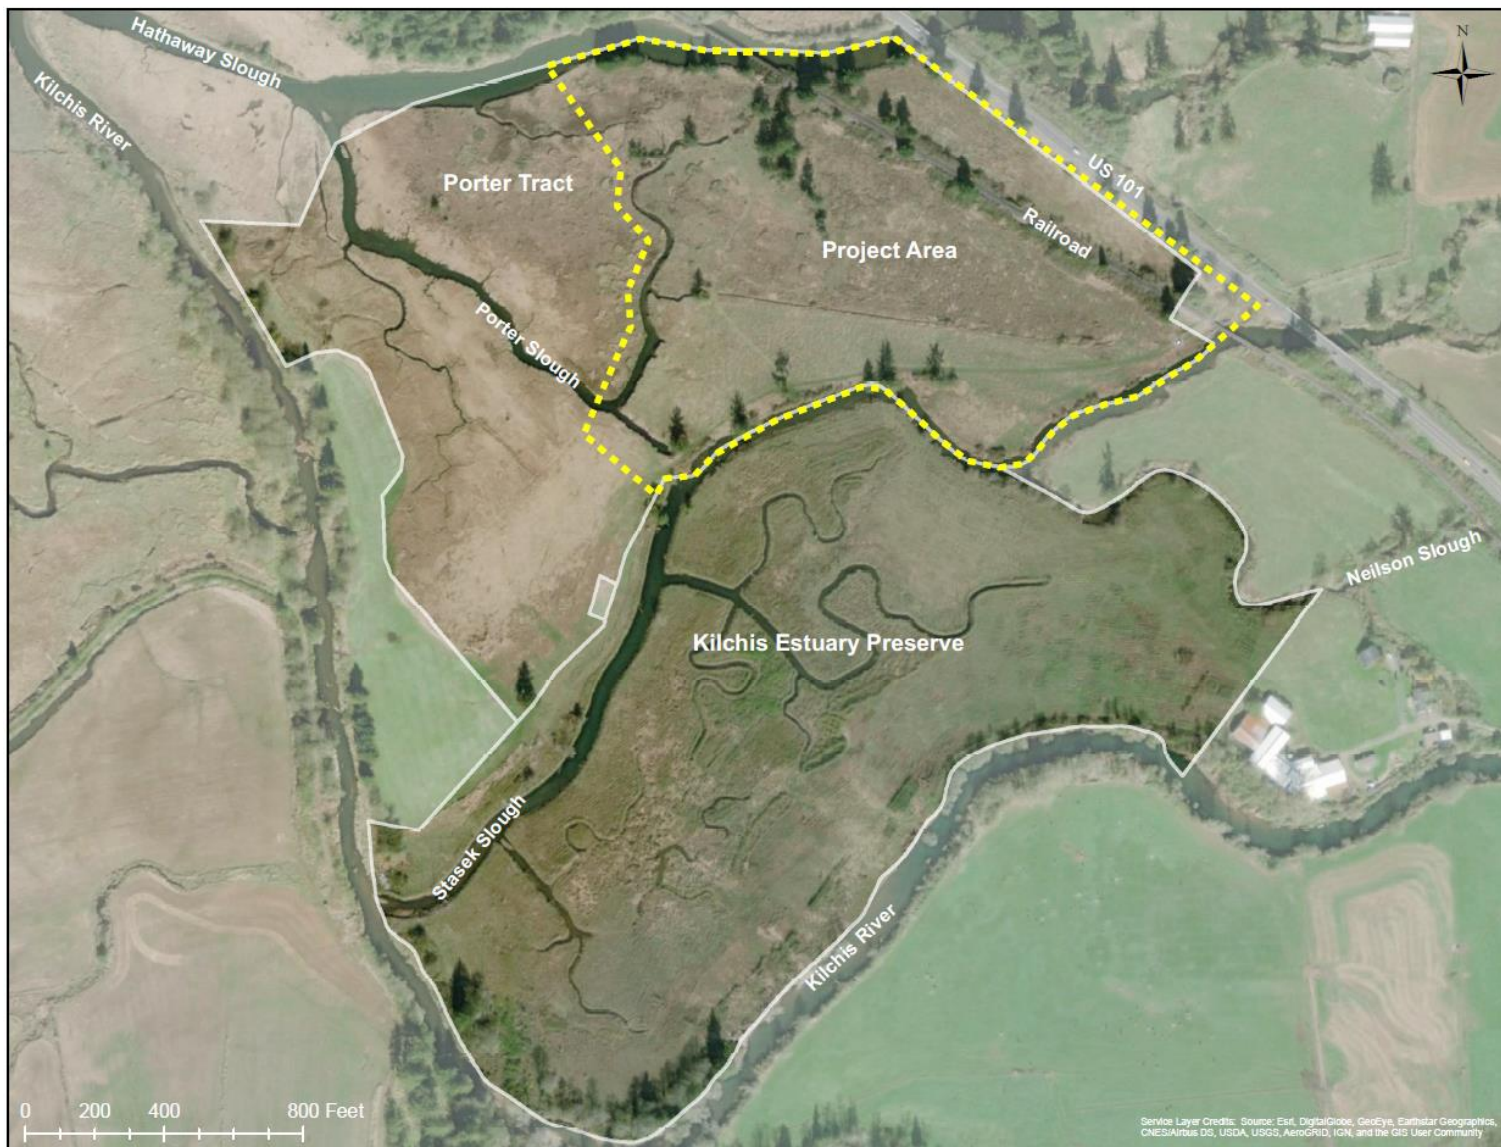
Figure 1. Porter Tract to the north and adjacent Doohar Property which comprise the Kilchis Estuary Preserve.

This scope of this report includes documenting the basis of the design for the various project elements included in the restoration of the Porter Tract (Figure 1). This engineering design phase follows the recently completed Porter Tract Feasibility Report (Feasibility Analysis and Conceptual Restoration Plan Report; W2r 2017). Restoration elements include removing water control structures, filling linear ditches, removing dikes, excavation of new and tidal channels and enhancement (widening and deepening) of existing channels, beneficial reuse of excavation material placed onsite in low mounds, two new pedestrian bridges across tidal channels for access to maintain vegetation, and plantings throughout the site.

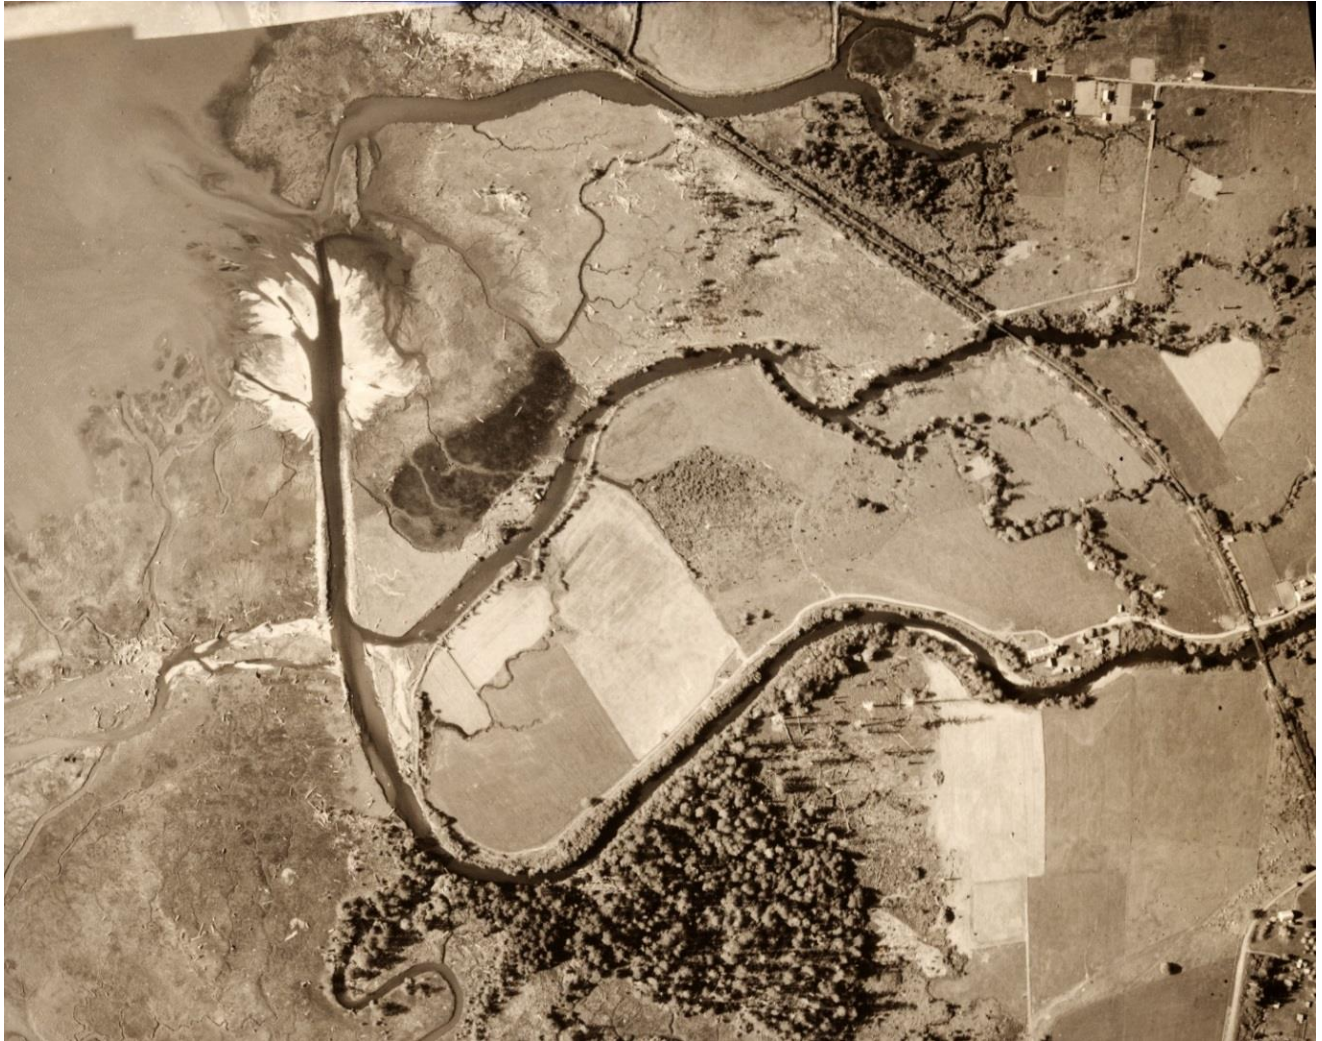
Figure 2. Historic 1939 photograph of the Porter Tract and Kilchis Estuary Preserve.

The earliest available aerial photograph from 1939 (see Figure 2) show numerous tidal channels across much of the site, especially the northwest portion of the tract. This more natural hydrologic condition contrasts with linear ditches and farmed areas in the southwest and east portions of the property. As with much of this region, this property was subject to timber operations and wetland conversion to pasture or other agricultural uses.

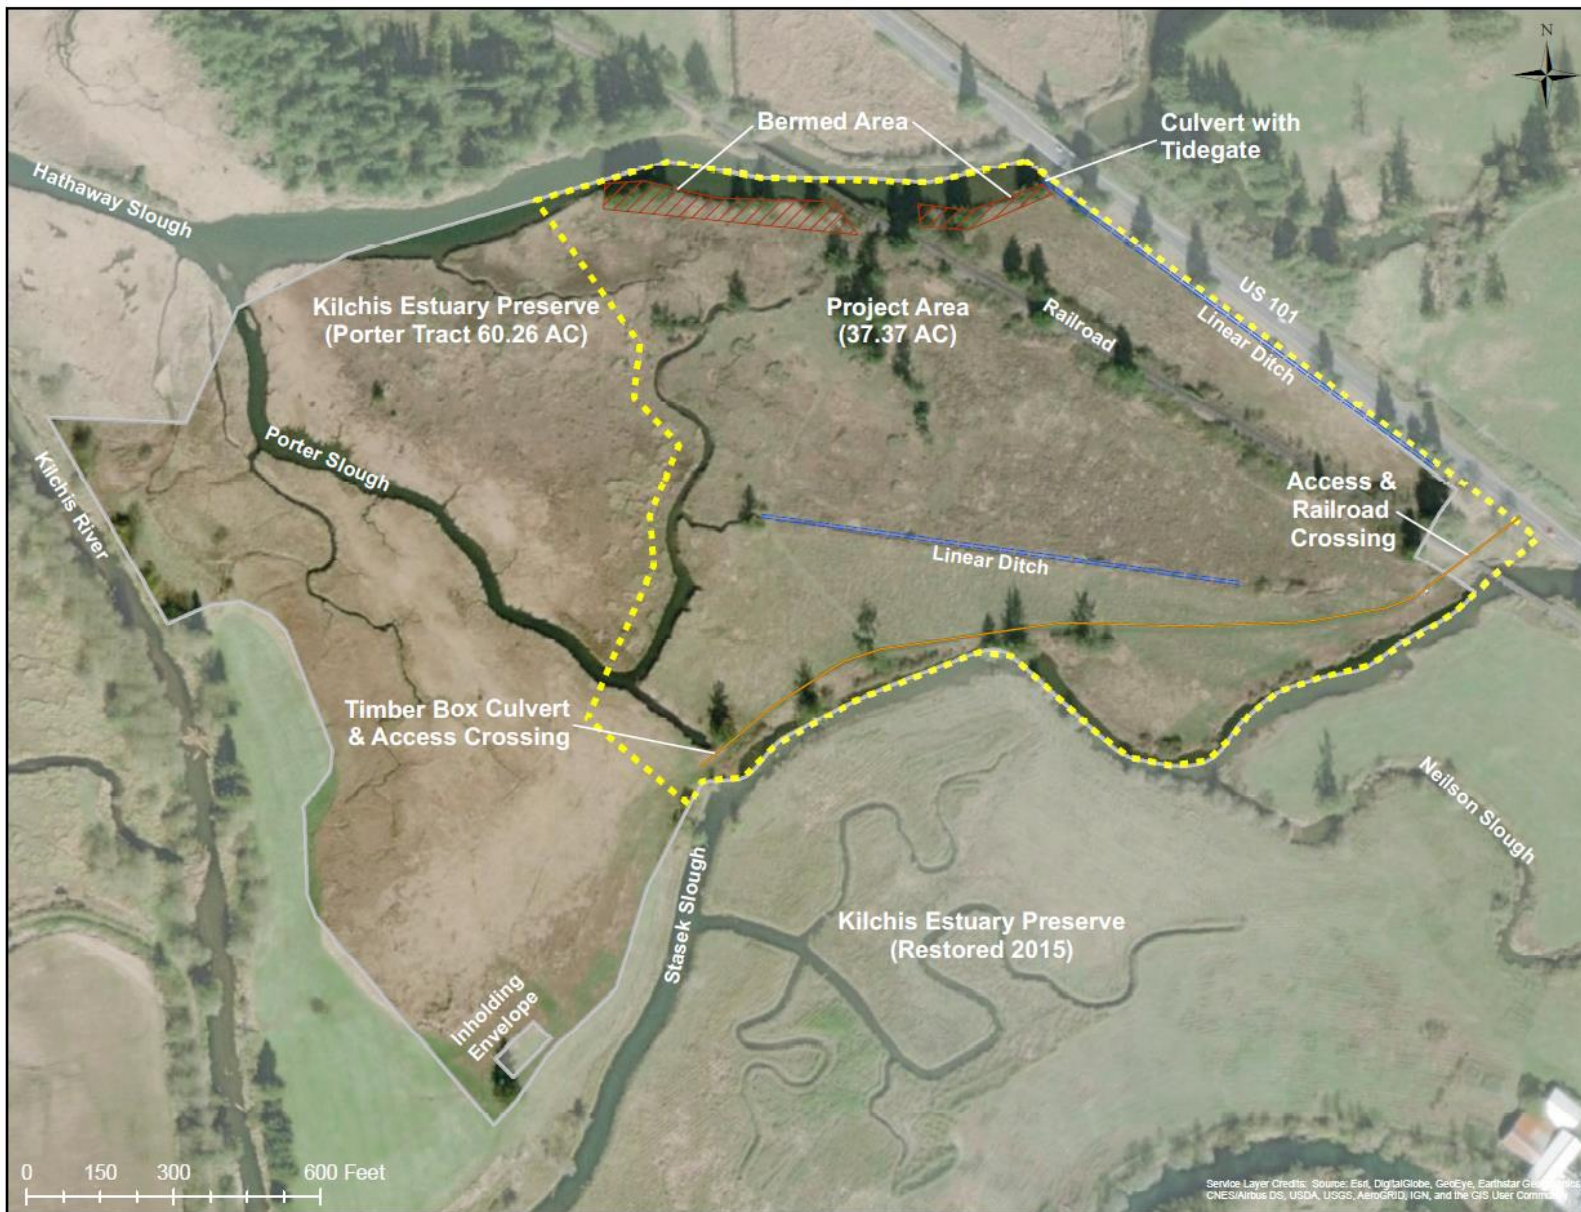
Figure 3 Existing Conditions Map for the Porter Tract.

There are several flow control structures located within the project area (see Figure 3). Two culverts facilitate crossing of ditches / channels along the northern portion of the site near Hathaway Slough. There is also a water control structure (culvert with dilapidated closure gate) in the interior of the site that drains much of the eastern portion of the property into Porter Slough.
