Porter Tract Restoration

Kilchis Estuary Preserve

Feasibility Analysis and Conceptual Restoration Plan

Revised
November 2017

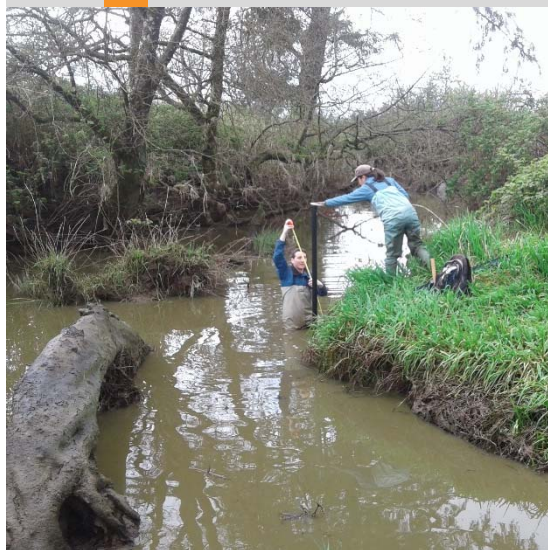
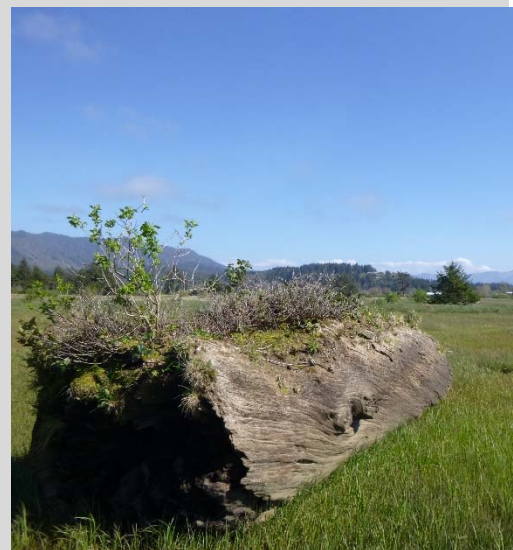
Cover photos:

Level logger installation near Hathaway Slough
Tributary of Hathaway Slough
Nurse log in the mid-marsh habitat within the Porter Tract
