Kilchis Estuary Preserve Management Plan 2013-2023

Project/Site Name: Kilchis Estuary Preserve

Location: Lower Kilchis River, Tillamook County Oregon

The Nature Conservancy

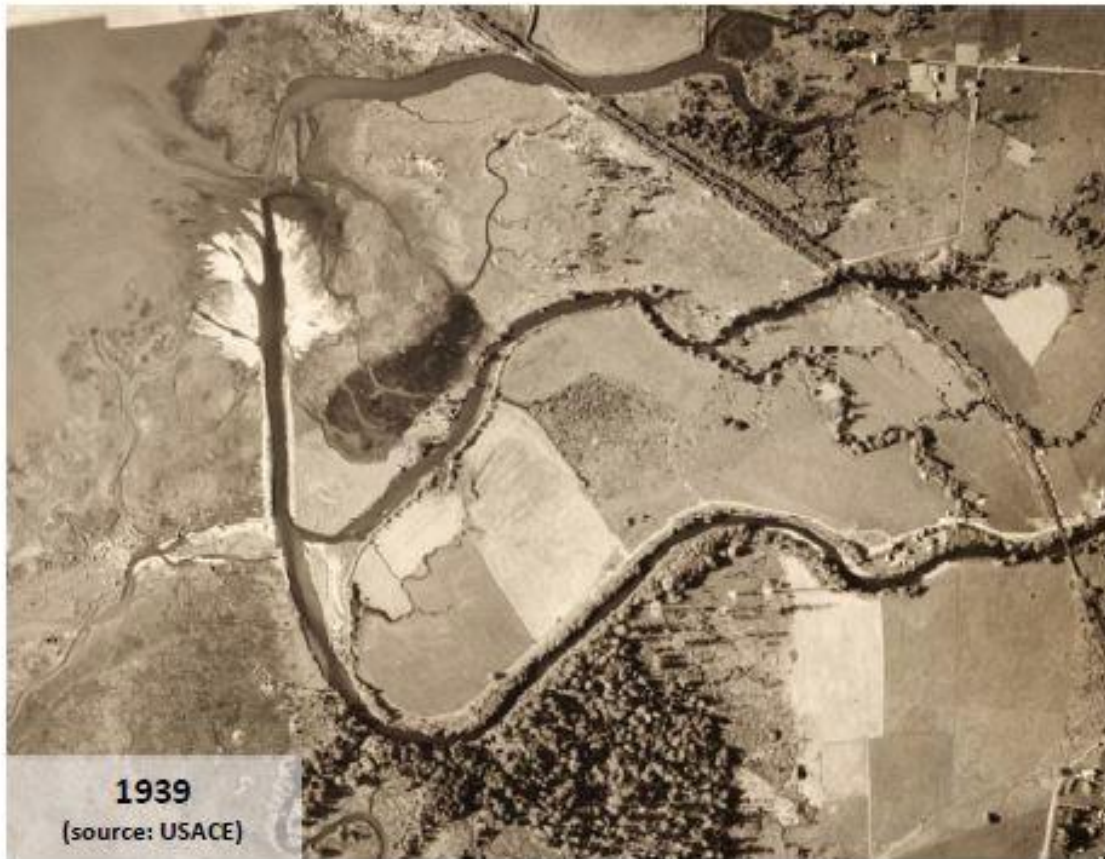
Figure 4. 1939 and 1955 air photos of the mouth of the Kilchis River

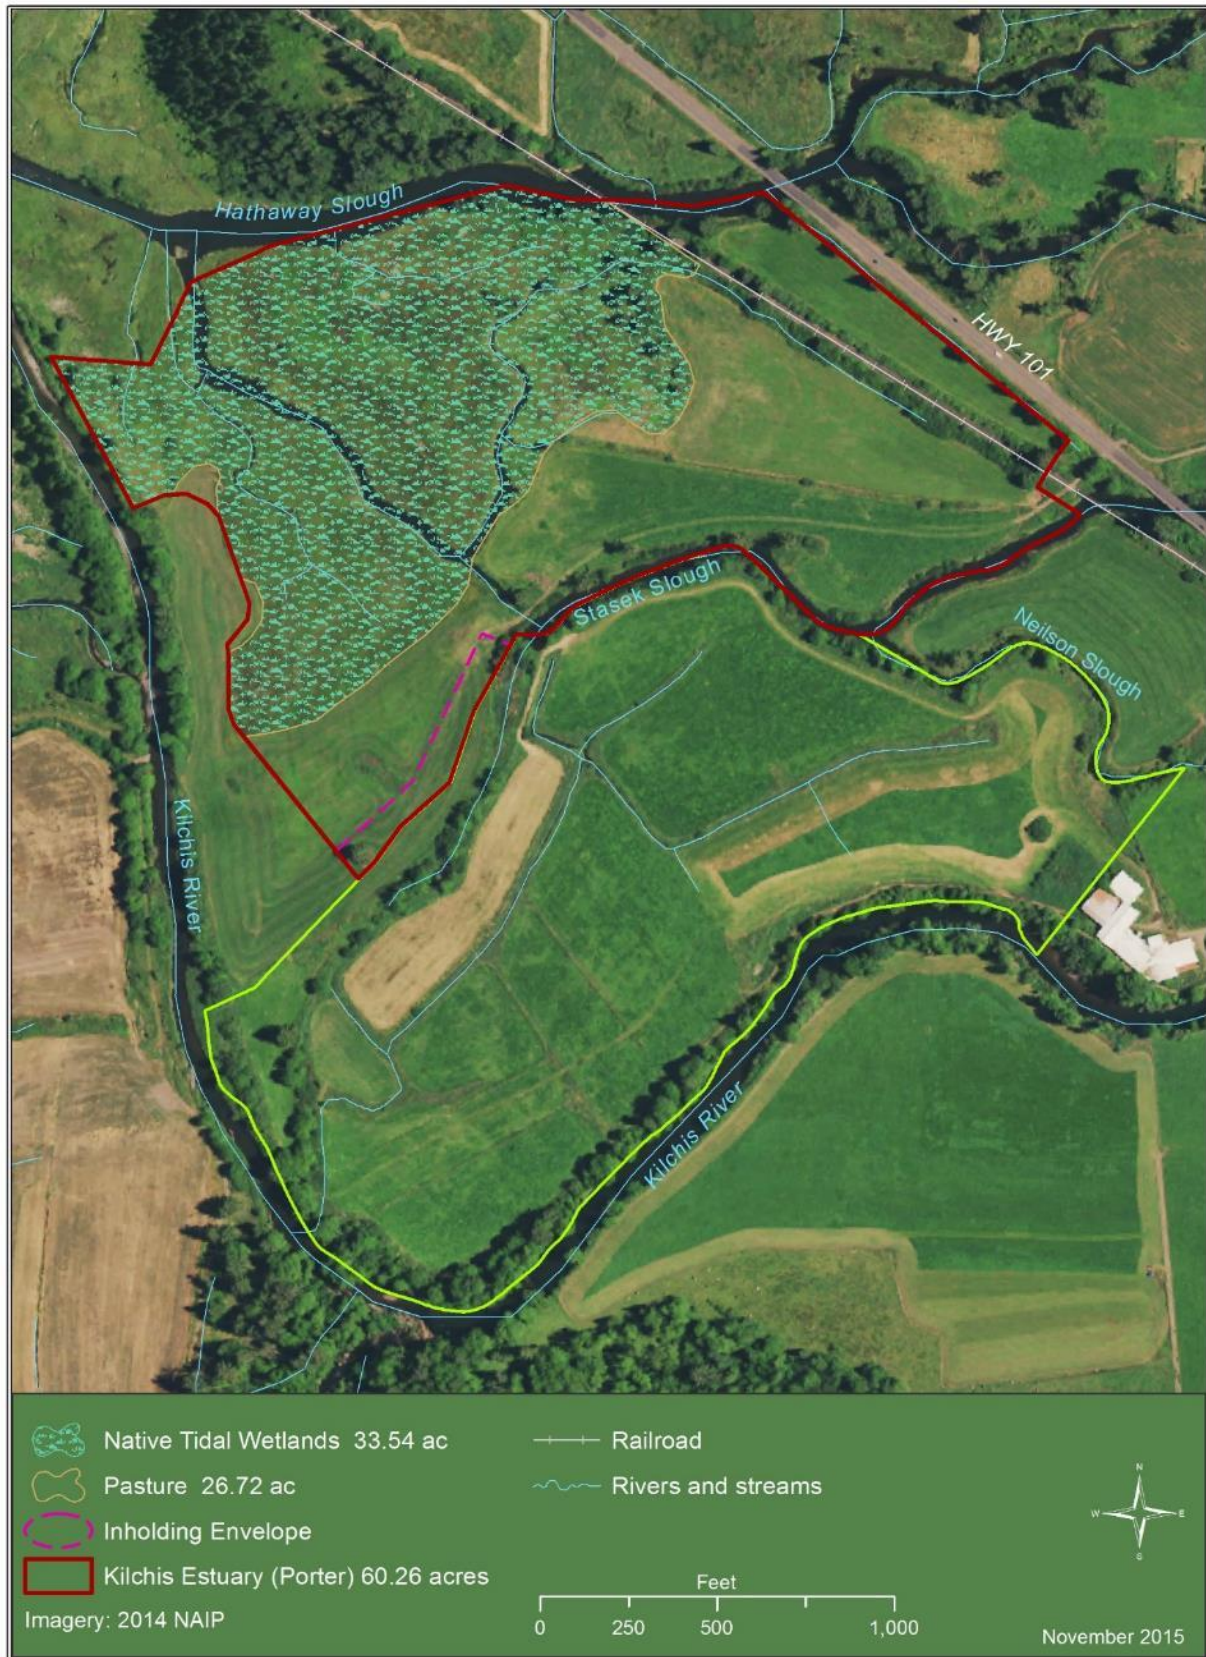
Figure 10. Native Tidal Wetlands on Porter Tract

The 126-acre site initially consisted of mostly pastureland that was diked from the Kilchis River and sloughs since prior to the 1930s. Native wetlands were present on approximately half of the Porter tract (Figure 10) but the remaining lands on the Porter tract and all the Dooher tract were covered by non-native pasture grasses. Pre-restoration vegetative conditions are described in the conceptual restoration plans (ESA 2012 and W2R 2017) from various locations on the project site and included in Table 2. Plant species names from this inventory are summarized in Table 3.

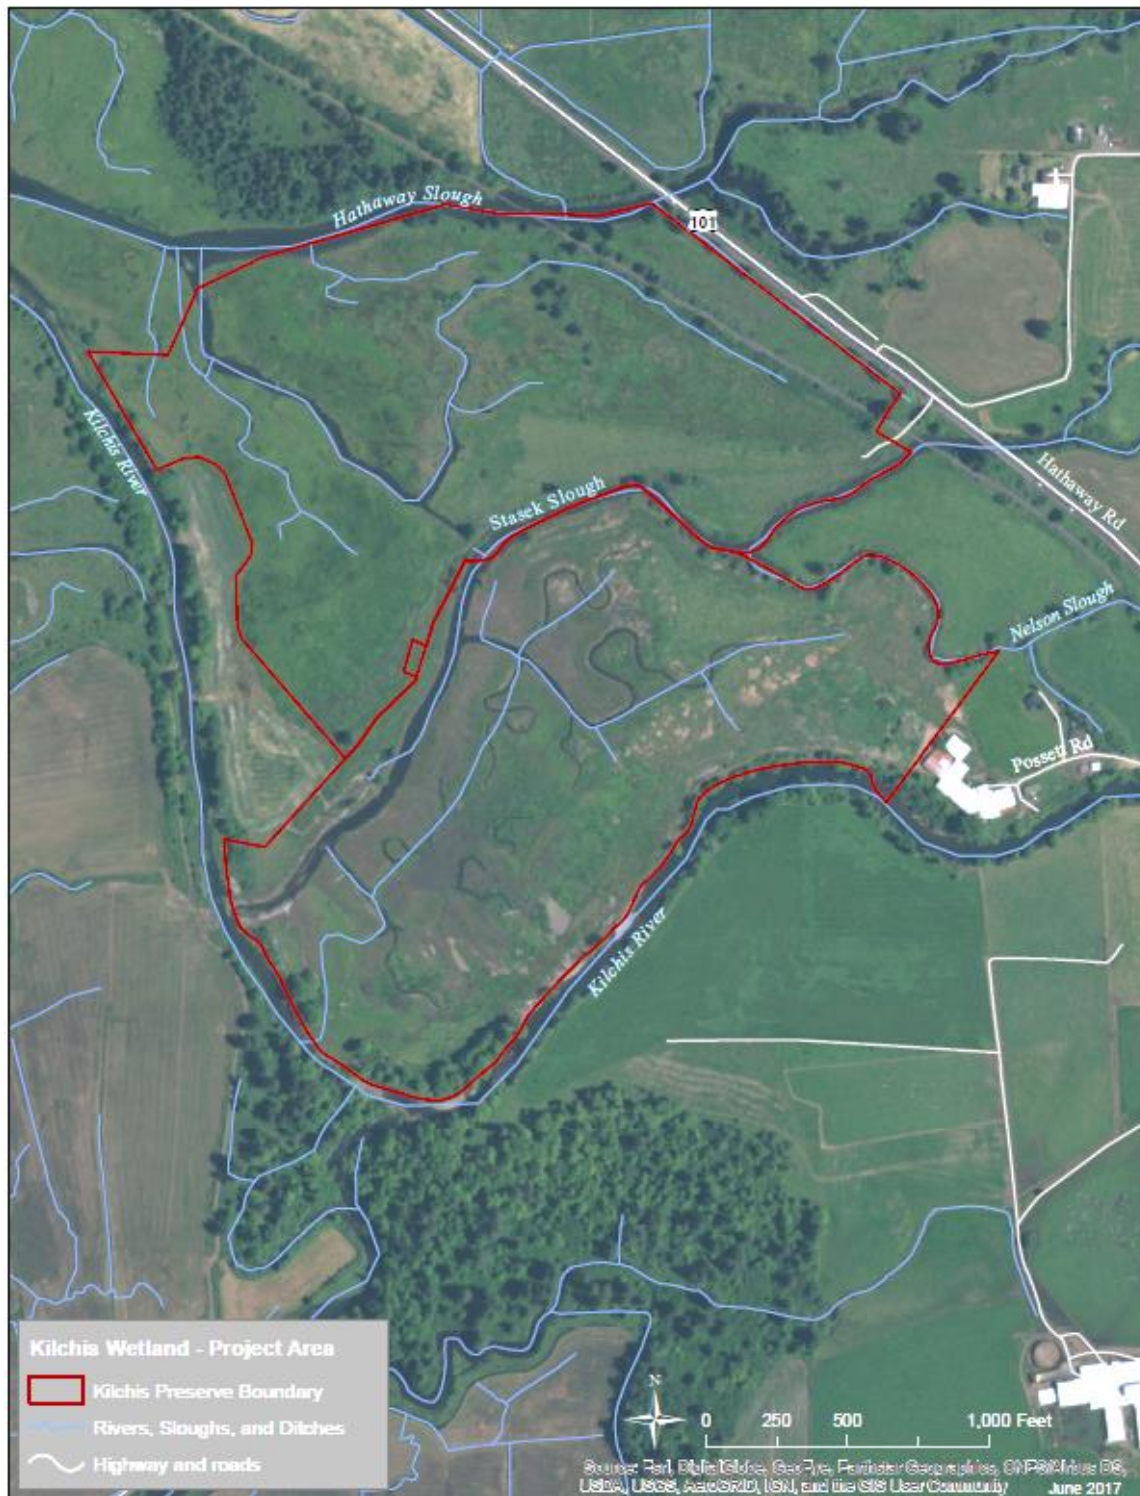
Figure 11 Porter Tract 0.1 acre Inholding shown as small rectangular area on southern boundary adjacent to Stasek Slough

The Porter tract has a 0.1 acre private inholding owned by Ben and Marylou Hathaway located along the banks of Stasek Slough that does not have a legal access easement attached to it (Figure 11). The small inholding is marked on the ground with corner fence posts and has been located by a recorded survey. The Porter tract is crossed by the Port of Tillamook Bay railroad line that includes a defined ownership along the line that runs parallel to Highway 101 on the eastern edge of the tract. Access to the Porter tract is from Highway 101 and across the railroad tracks at an unimproved crossing (Figure 11). The western edge of the Porter tract borders farmland owned by Gienger Farms. The 8 acre farmland is managed for grass production and is accessed by Geingers by crossing the Kilchis River at a shallow ford during low flows. The northern boundary of the Porter tract lies along Hathaway Slough, a natural tidal waterway that connects with the Kilchis River and Tillamook Bay. Properties on north side of Hathaway Slough include farmland and natural wetlands.

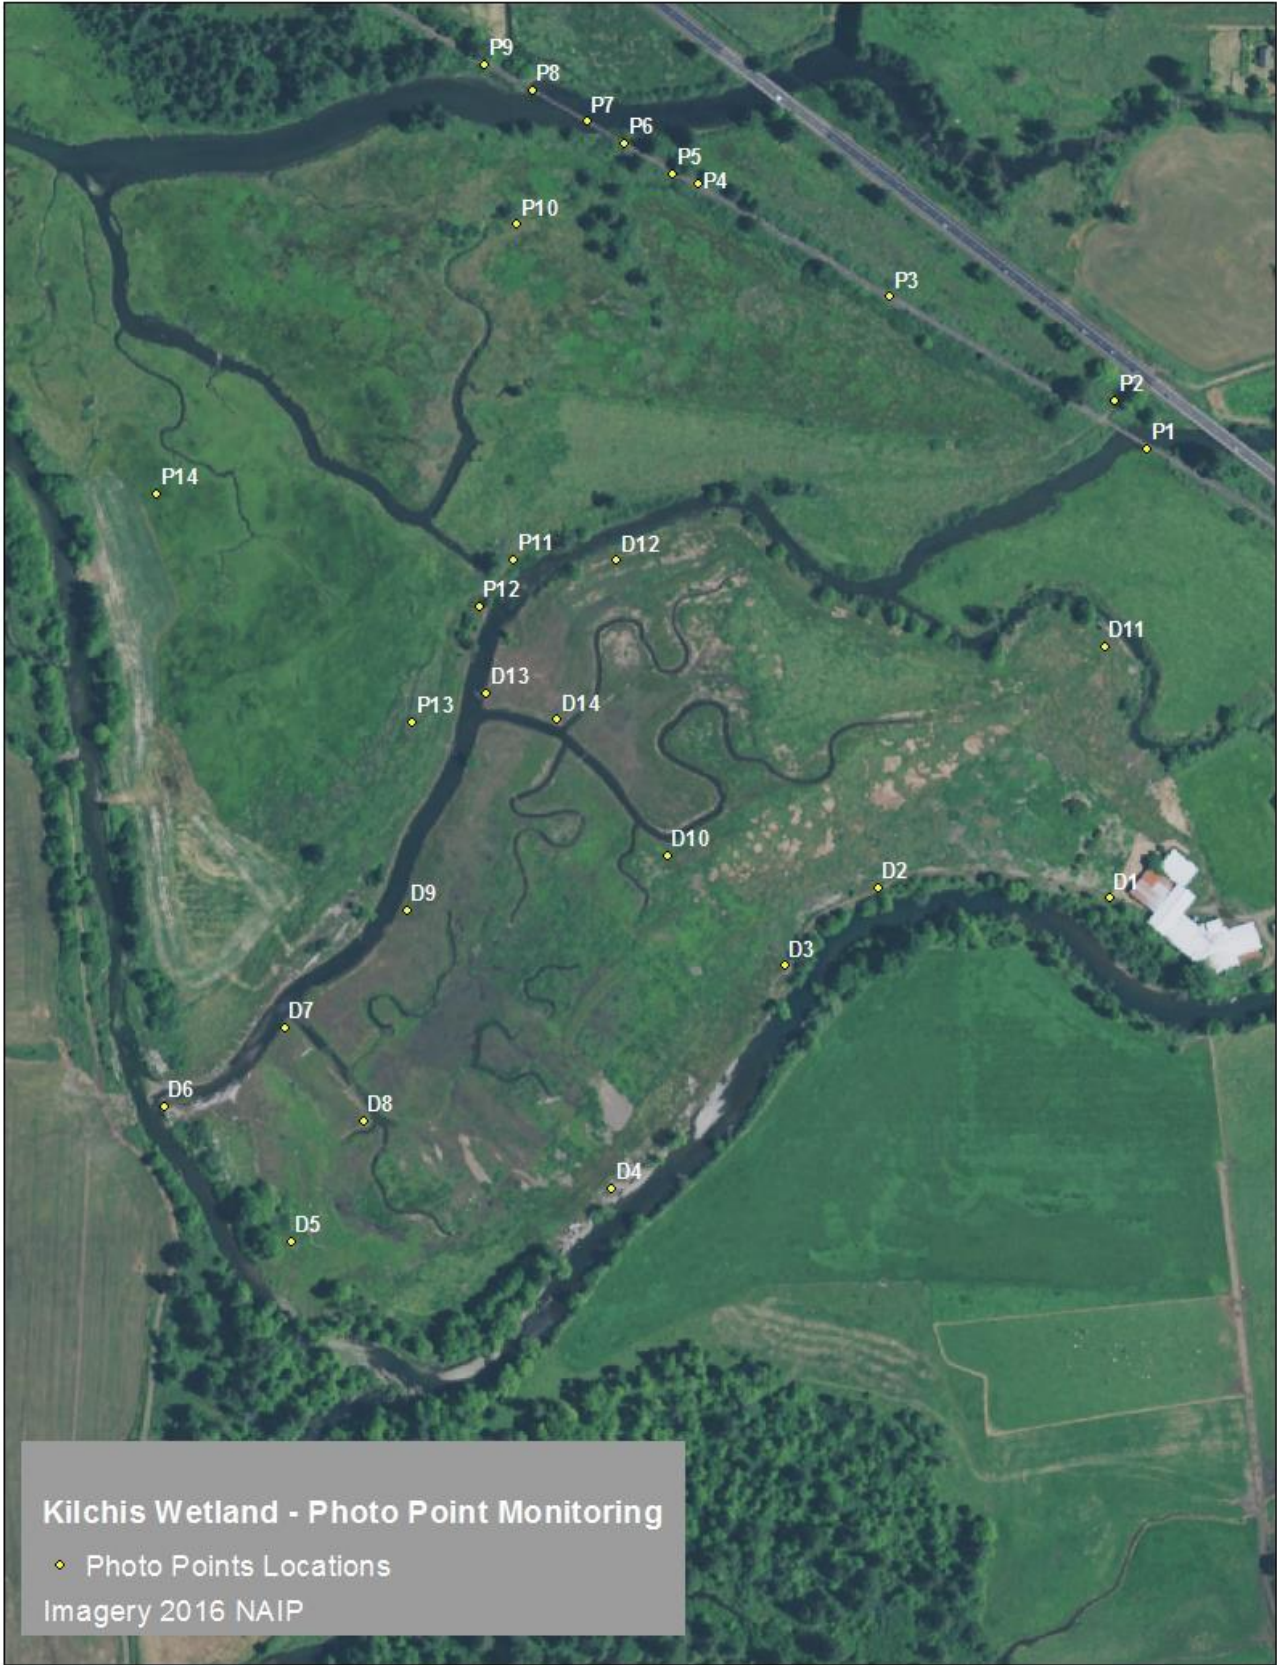
Figure 12. Photo Point Monitoring Locations for Doohar and Porter Tracts

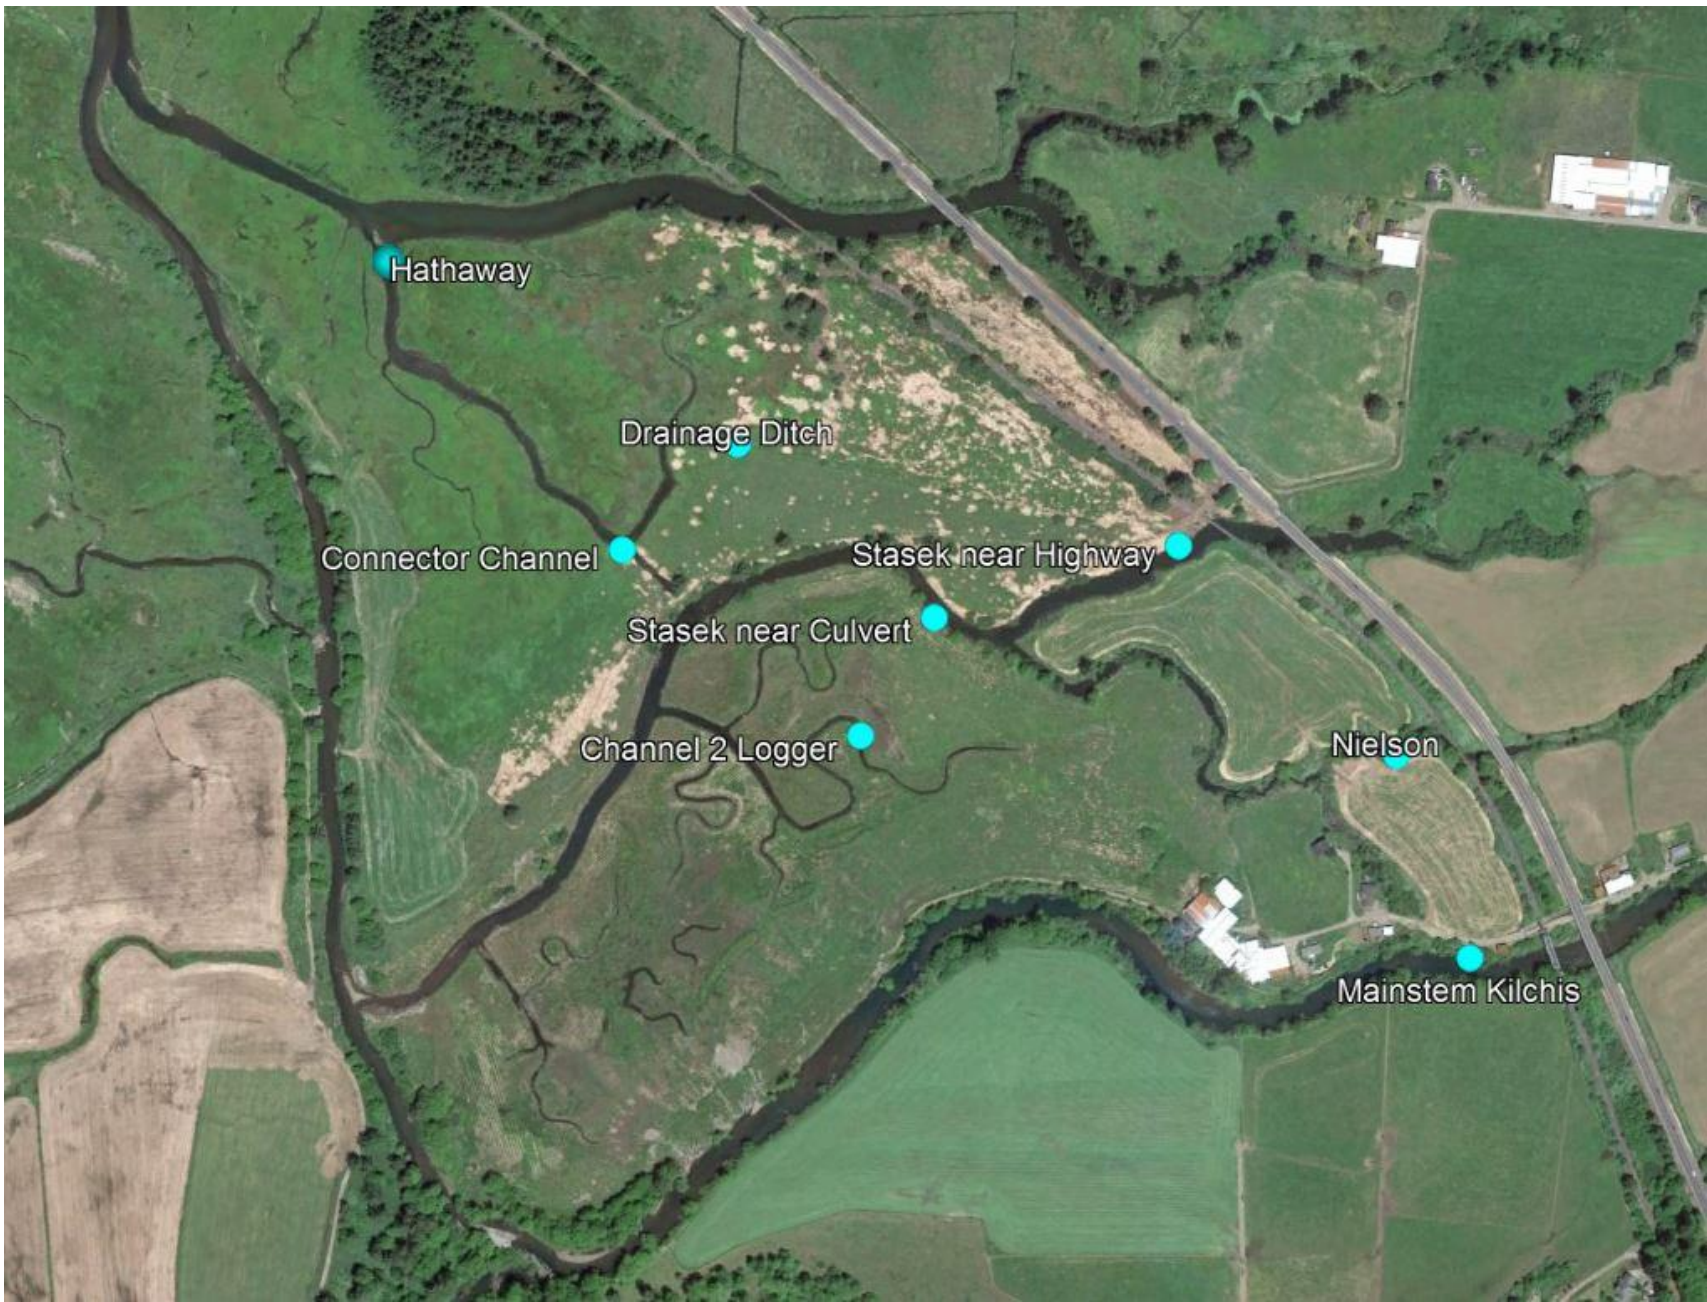
Figure 17. Locations of Water Level Loggers at Kilchis Preserve for Hydrologic Monitoring

- 1) Hydrology: monitored through recording water level logger gages in the river and in tidal channels on the tract (Figure 17). Water levels and temperature are monitored to determine tidal and river connections within the wetlands. Four additional transducers were installed on April 6, 2017 to collect baseline data for the Porter tract. After restoration activities are completed on the Porter tract, water level logger locations may change to meet site conditions.
