Introduction

**TWO CAPES LOOKOUT
CAMPGROUND**

**Subject: Geologic Conditions and Geologic Hazard Report
Proposed Two Capes Lookout
Tax Lot 600
Tierra Del Mar, Tillamook County, Oregon
EEI Report No. 22-113-1**

**GEOLOGIC CONDITIONS
AND
GEOLOGIC HAZARD REPORT**

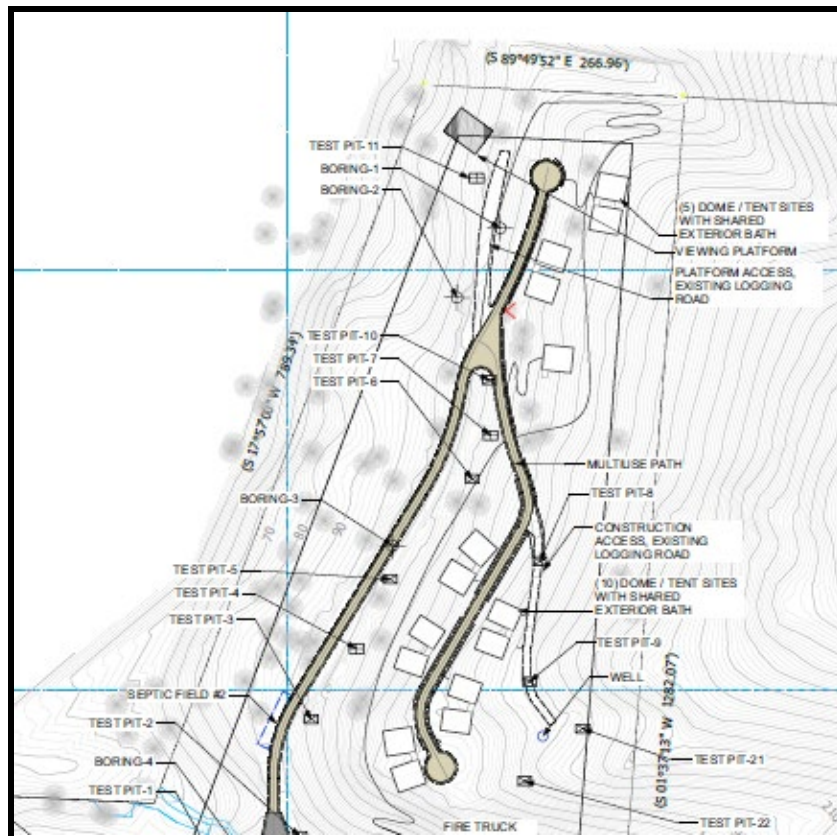
Figure 2: Site plan for the proposed Two Capes Lookout development (north portion); Source: Revised CUP Site Plan L0-01 (Site Plan) by Studio Campo, dated February 2023

Briefly, we understand the plan is to construct a boutique campground that consists of property access roads, a camping support structure, approximately 19 camp sites, a viewing platform, surface parking, pedestrian trails, and a bathhouse. Based on information provided by the design team, our understanding is that the individual camping sites will either consist of tent platforms (15) and small (approximately 400 sq ft) cabins (4). The proposed site plan sketch is shown below in Figure 1 and Figure 2.

- (b) Locations for structures and roads: The location of the proposed camp sites, cabins, other ancillary structures, and infrastructure improvements, as shown in Figures 1 and 2 above, are acceptable when considering the impact of geologic hazards.

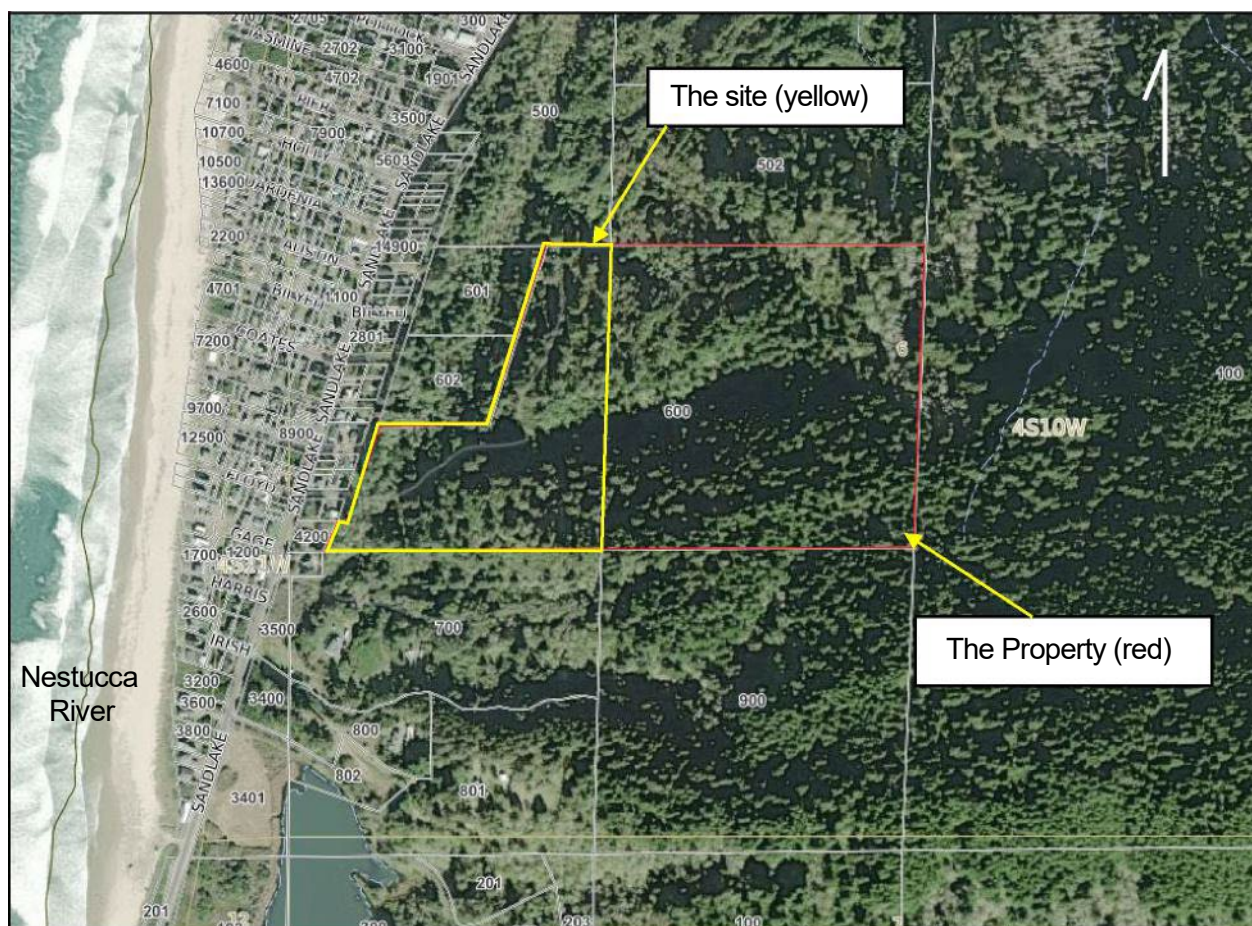
Figure 3: Property location, outlined in red and the site located in yellow. (base image source: <http://tillamookcountymaps.co.tillamook.or.us/geomoose2/geomoose.html>)

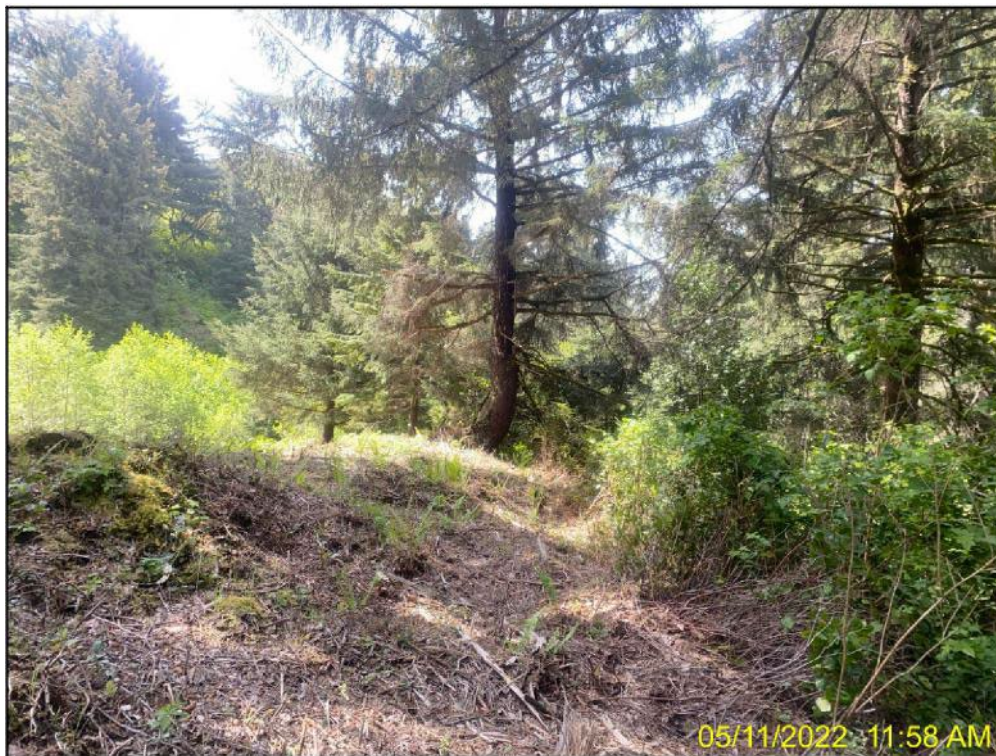
Photo 1: A tree with a curved trunk, as observed along the access road (photo center).

The vegetation at the site generally includes understory consisting of deciduous trees, blackberries, grasses and ferns. The canopy generally consists of large Sitka spruce and fir trees. A few curved tree trunks were observed, indicating local soil creep or shallow landsliding.

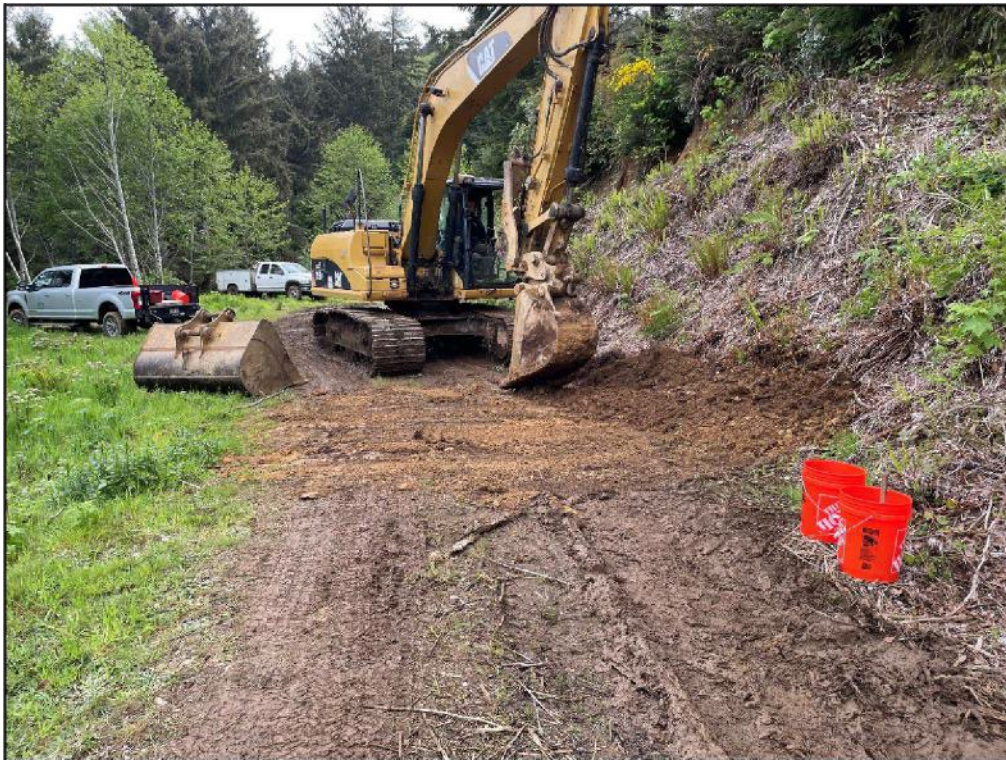
Photo 2: Photo looking northeast along the existing road before the creek. Note that the existing road cut has an oversteepened slope.

Broadly, the subject property slopes downward to the west at an average slope of approximately 2H:1V (Horizontal:Vertical). Excluding the site's west facing slopes, the site's topographic relief is largely dominated by an unnamed creek that roughly bisects the site from east to west. There is also an old rock quarry where the existing access road crosses the creek. Locally, slopes are generally steeper than 2H:1V where the road is cut into the hillside, on the downhill side of the road, and in the old rock quarry area. We generally consider slopes steeper than 2H:1V to be oversteepened.

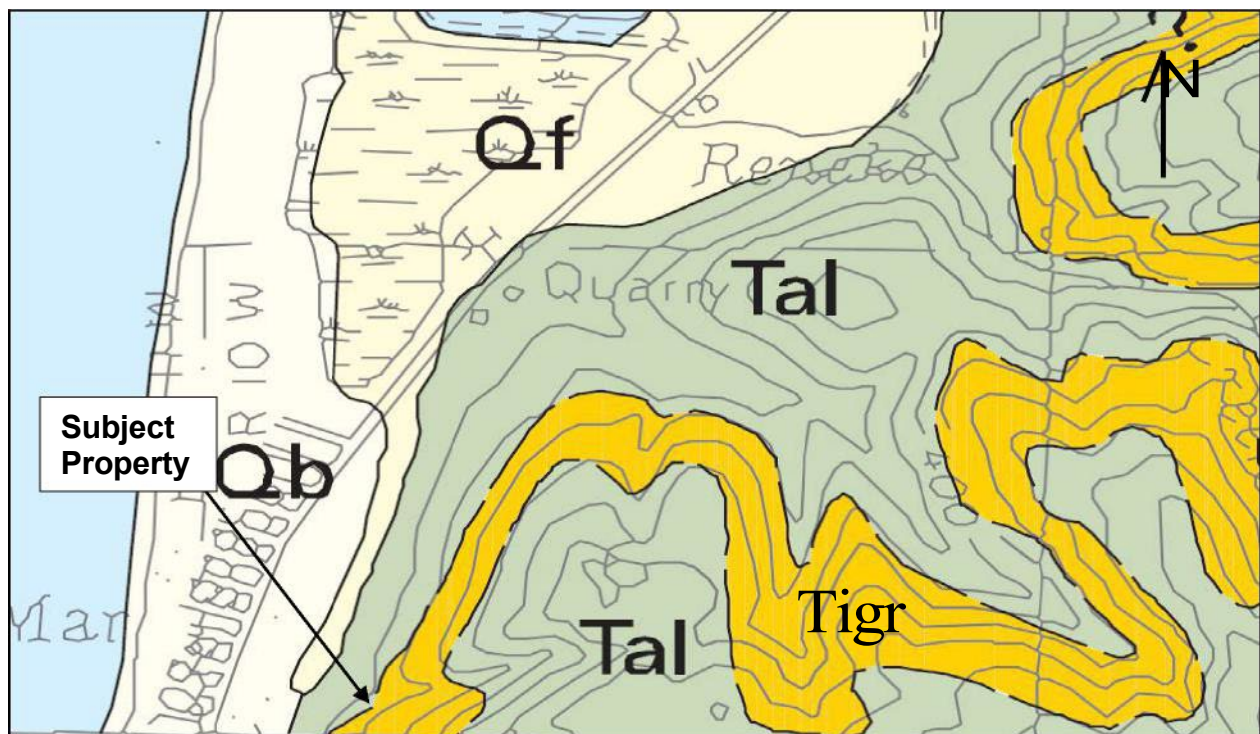
Figure 4: Geologic map of the area (source: Wells and others, 1994).

The 1994 U.S. Geological Survey (USGS)² geologic map of the project area indicates the site is underlain by a lower Miocene and Oligocene-aged tuffaceous siltstone Member of the Alsea Formation (Tal) and immediately adjacent, a middle Miocene-aged Grande Ronde Basalt (Tigr). The tuffaceous siltstone material is described as “massive and bioturbated, containing abundant white tuff beds, calcareous concretions, and sparse thin feldspathic sandstone beds”. The Grand Ronde Basalt is described as “Sheet-like and irregular bodies of aphyric, columnar jointed tholeiitic basalt and diabase intruded into and overlain by baked sedimentary strata” See Figure 4 below for the 1994 mapped area.

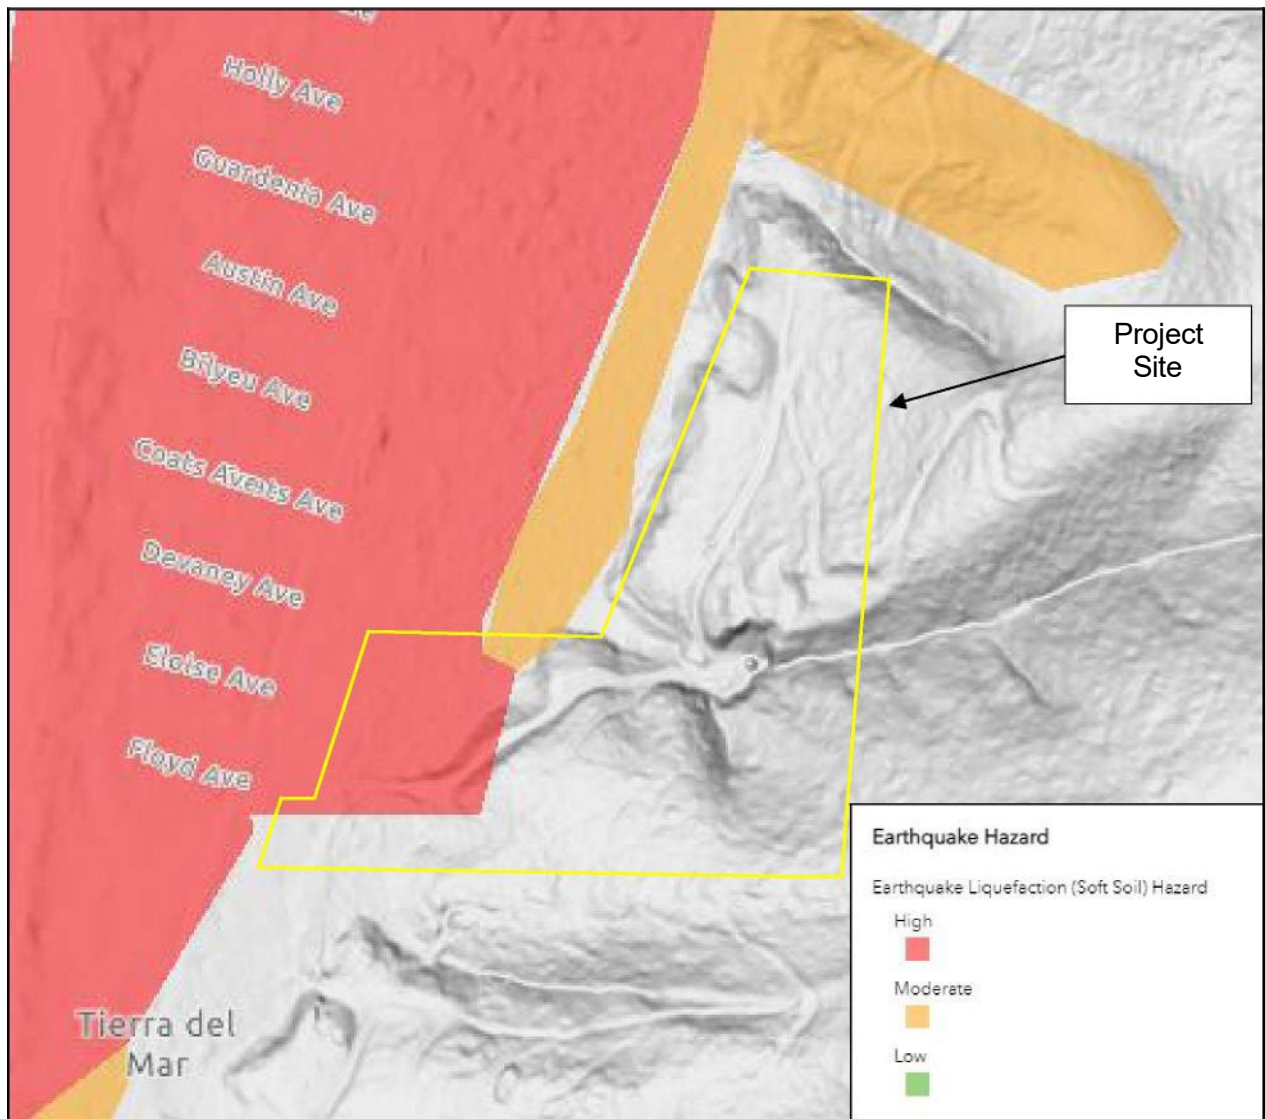
Figure 8: HazVu map showing extent and degree of liquefaction hazards.

It should be noted that liquefaction was not a mapped hazard on or near the property. Figures 5 through 8 below show mapping of the geologic hazards presented by Oregon's HazVu, Figure 9 shows the mapped landslide inventory presented by Oregon's SLIDO, and Figure 10 shows modeled tsunami inundation predictions from the website <http://nvs.nanoos.org/TsunamiEvac>.

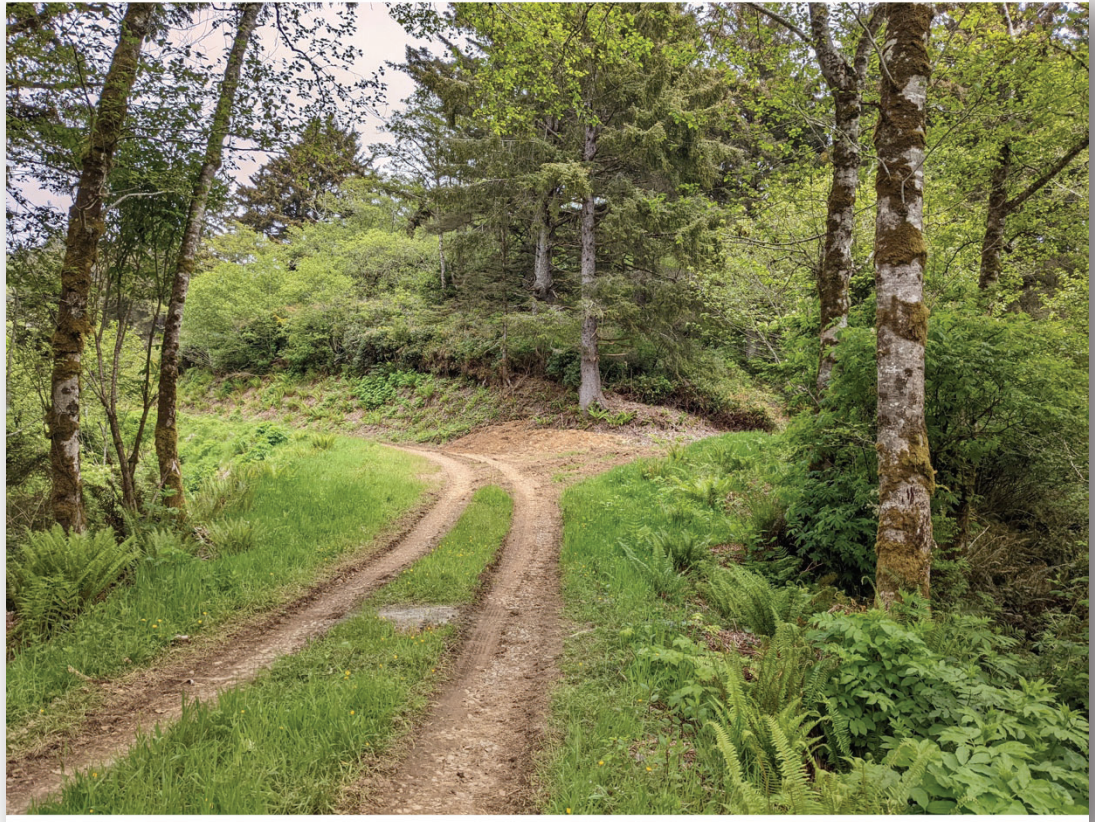
Figure 1. At culvert crossing on Floyd Avenue looking east (P-1)

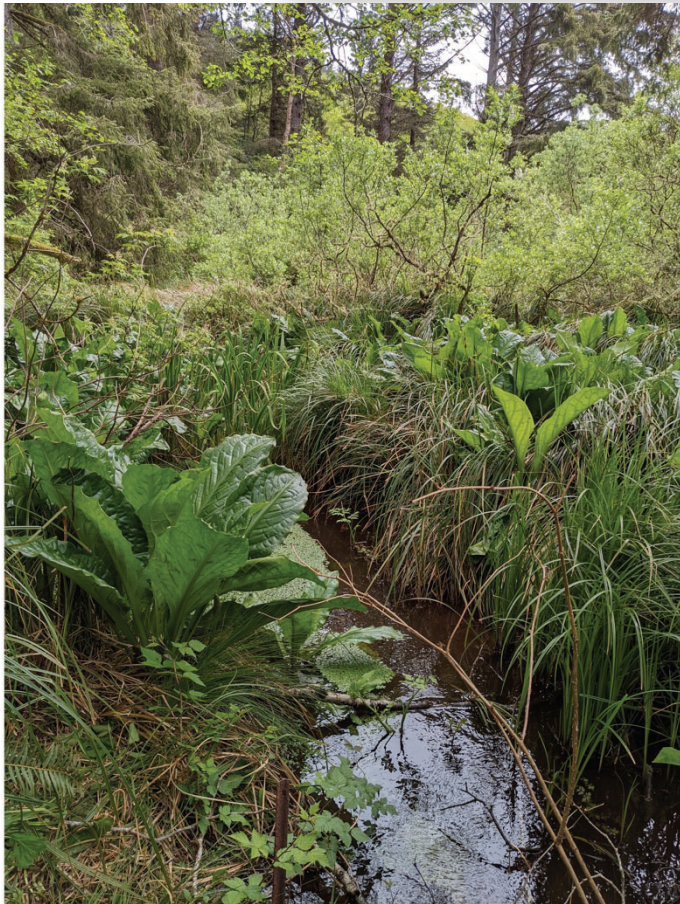
Figure 2. View From culvert crossing on Floyd Avenue looking south into wetland and Beltz Creek (P-2)

The mountains stream S2 is a first order intermittent stream. This stream is a narrow high gradient channel. The stream confluence with S1 is below the waterfall at the quarry. Hydrology within the mountain streams S1 and S2 are overland flow and drainage basin concentration and flow, direct precipitation, ground water, and seepage. Table 1 summarizes stream characteristics by stream segment. See photos P-2, P-7 and P-9 in Figure 5.

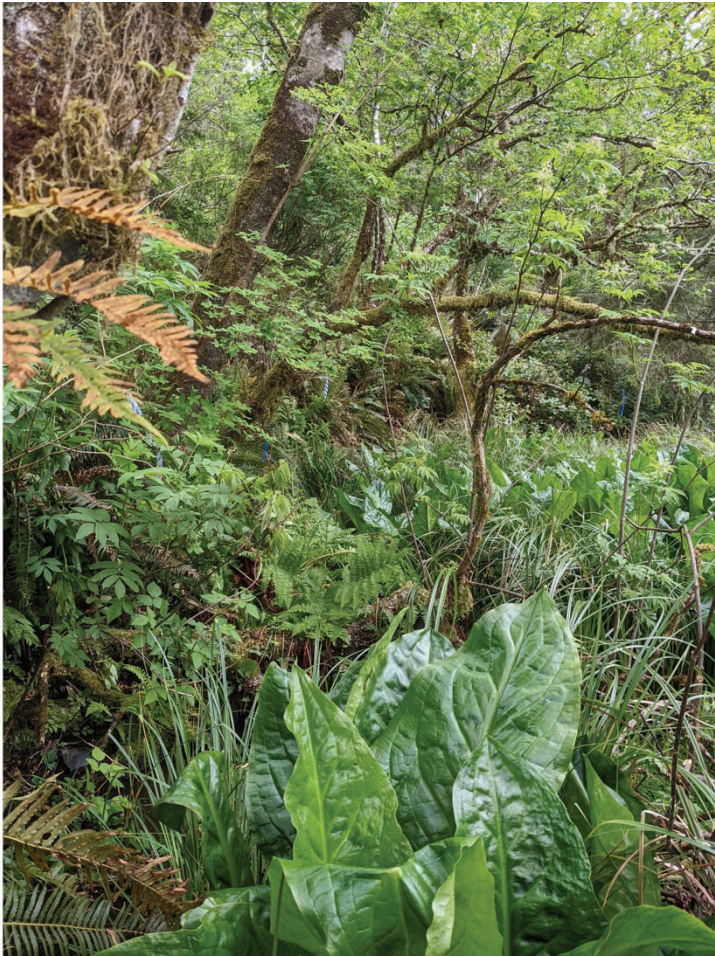
Figure 3. Looking south along the wetland boundary. (P-3)

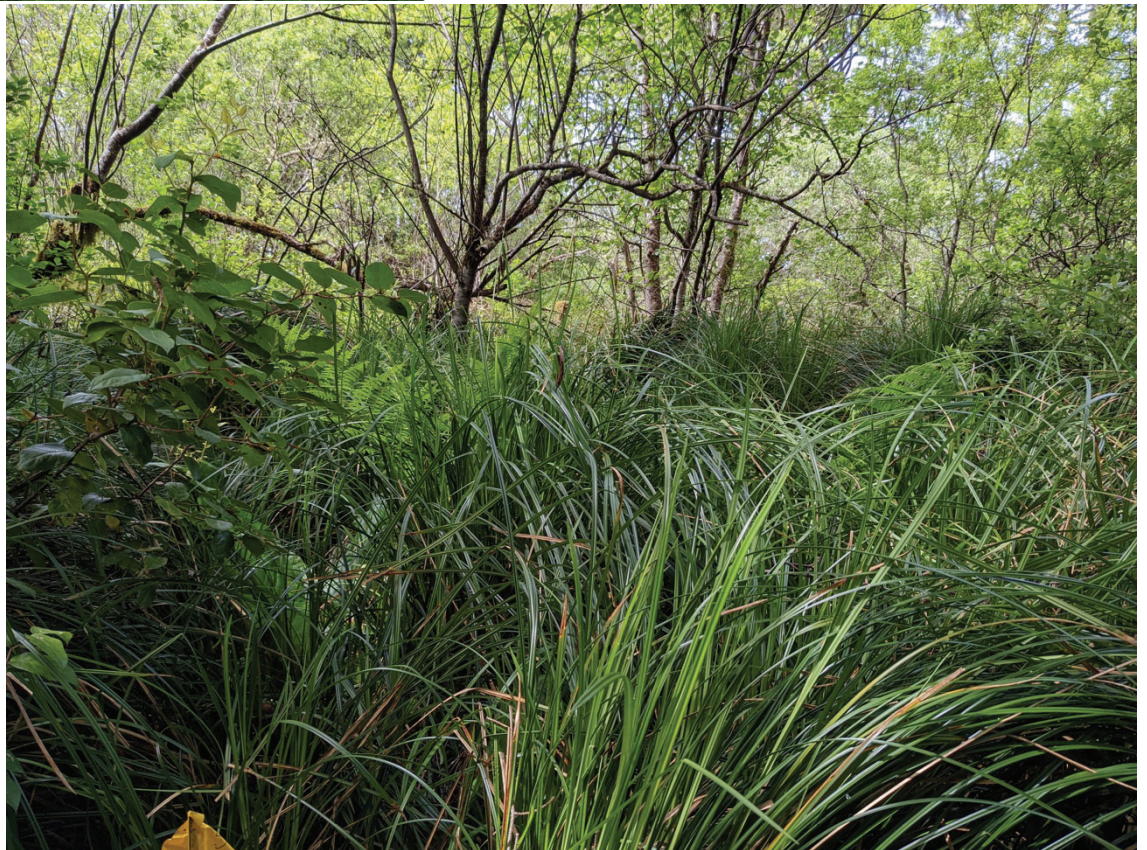
Figure 4. View of the lowland wetland looking north from SP-18 (P-4).

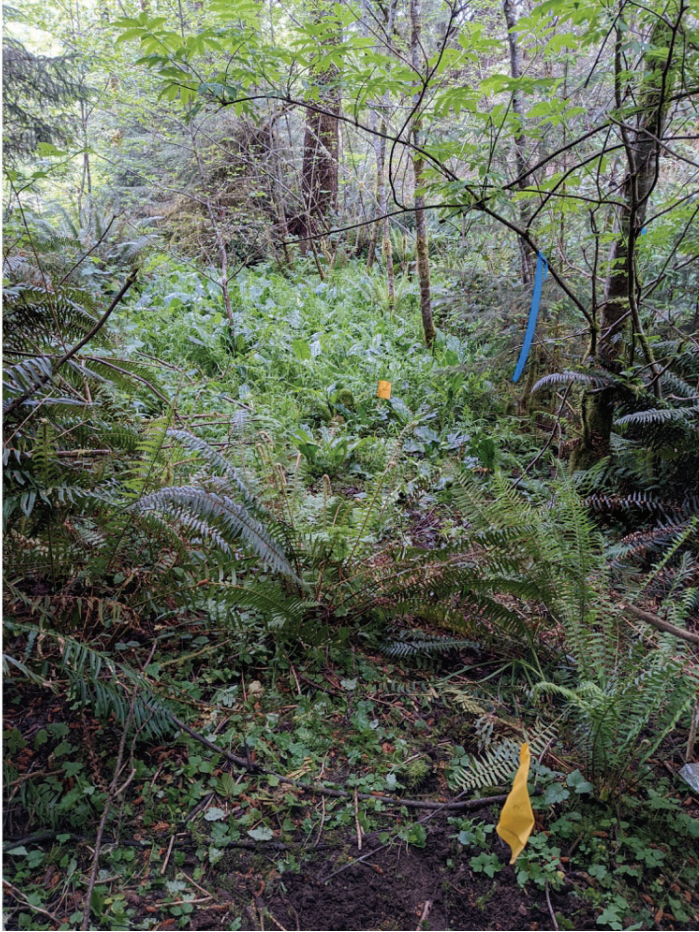
Figure 5. Blue flag is at Wetland C boundary. Yellow flag in the background at SP-10 and SP-11 in non-wetland in the foreground. View is to the northwest (P-5).

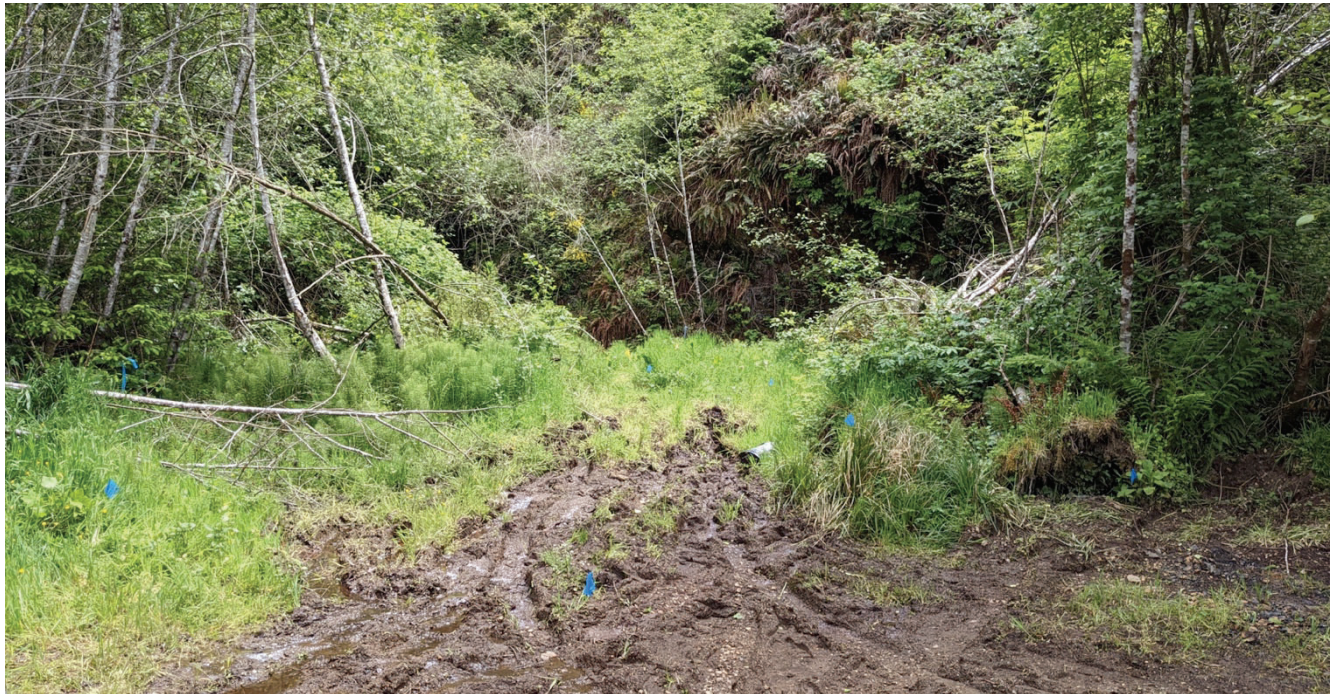
Figure 6. Wetland D at Quarry looking east from forest road (P-6).

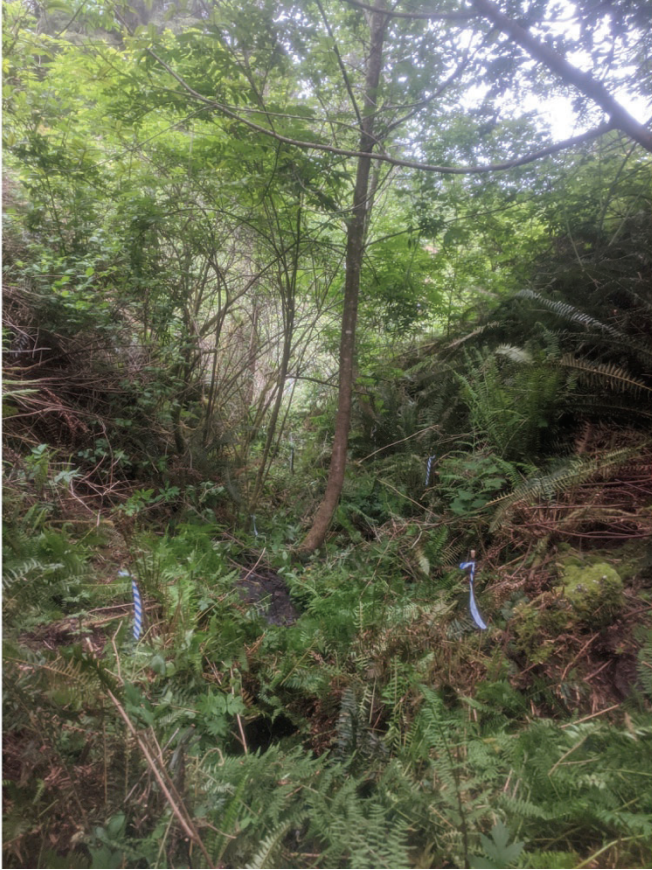
Figure 7. S1 Stream above the Quarry 1 Looking d/s west (P-7).

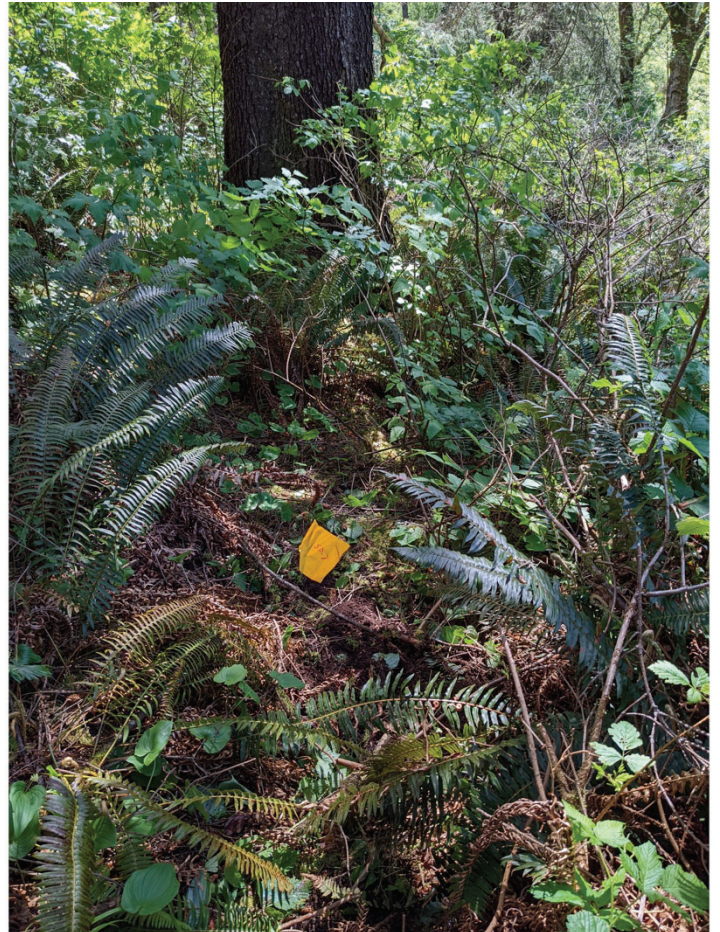
Figure 8. View of the upland at SP -7 (P-8).

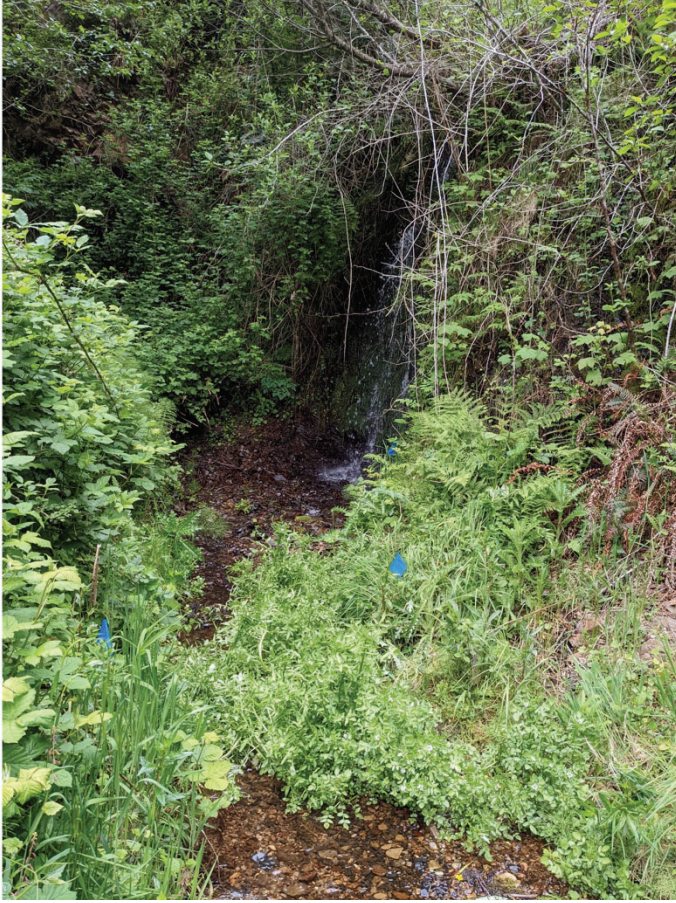
Figure 9. From S2 Channel looking d/s to waterfall above the quarry (P-9).

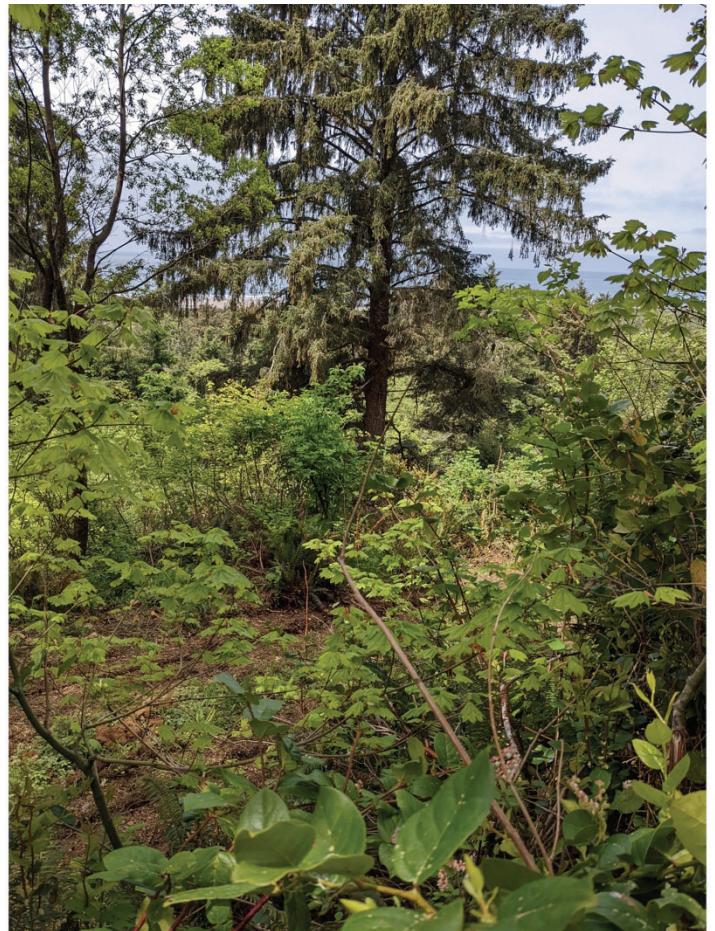
Figure 10. View to the west from SP-16. (P-10).

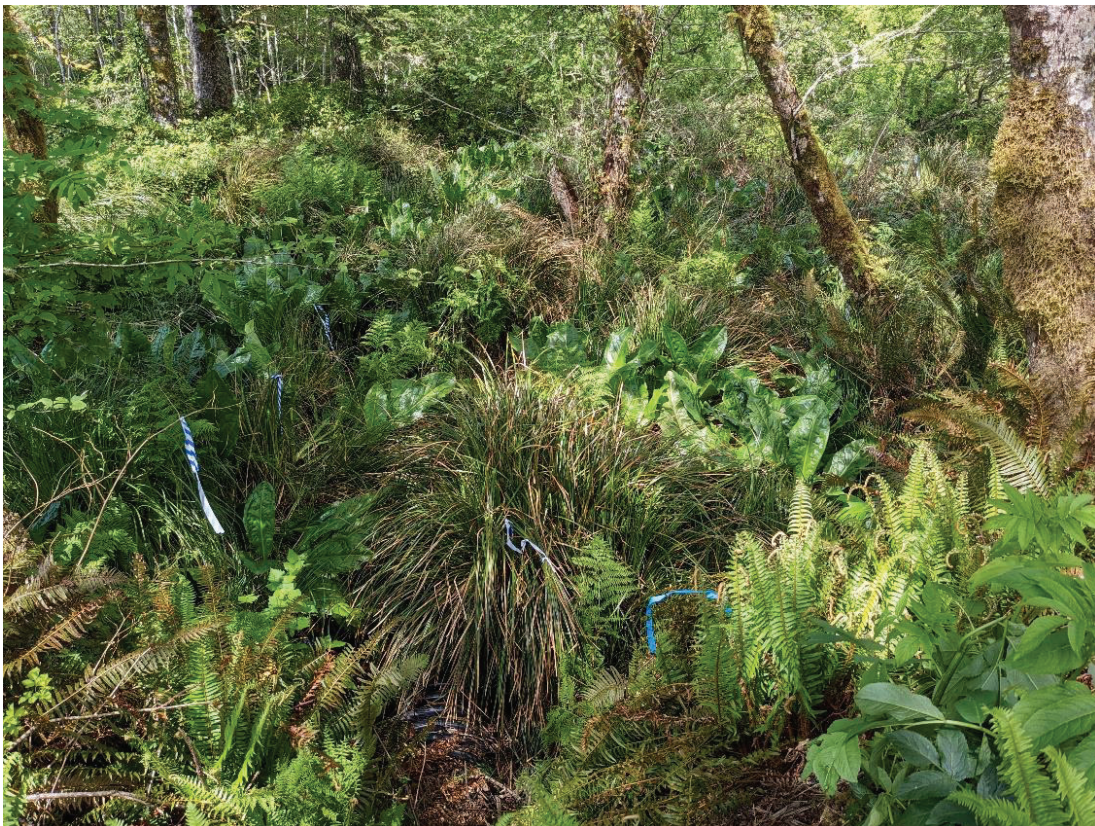
Figure 11. Blue and White flagging is edge of Beltz Creek Channel. The blue flagging is wetland boundary. Looking d/s to the north into wetland B (P-11).

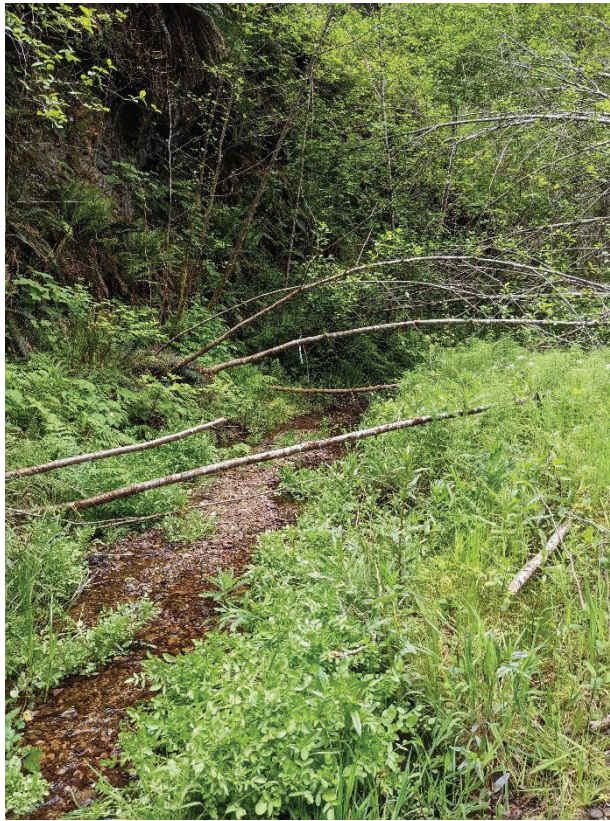
Figure 12. S1 stream at Quarry looking d/s (P-12).

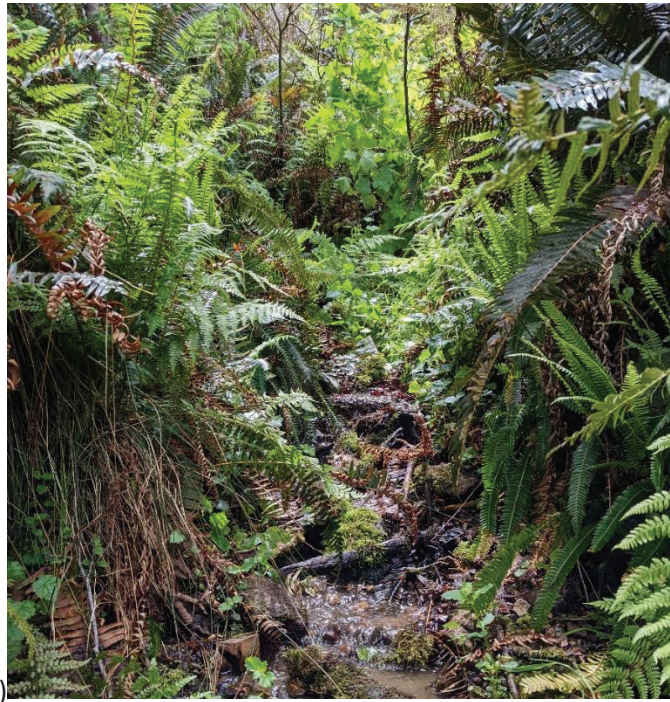
Figure 13. S2 stream looking u/s to the south at confluence with S1(P-13)
