OREGON PUBLIC LAND CORNER REPORT / RESTORATION REPORT
Tillamook County Surveyor's Office

SECTION: 1 & 6	TOWNSHIP: 2 South	RANGE: 9/10 West
COUNTY: Tillamook	DATE: 4/17/2024	
CORNER DESIGNATION: The Quarter corner common to Sections 1 and 6, Township 2 South, Range 10 West; Willamette Meridian	(Please check one)	
	Condition Report Only	
	Restoration	
	<input checked="" type="checkbox"/> Rewitness	
	Unrecorded	
	Reset at surface	
Referenced Out

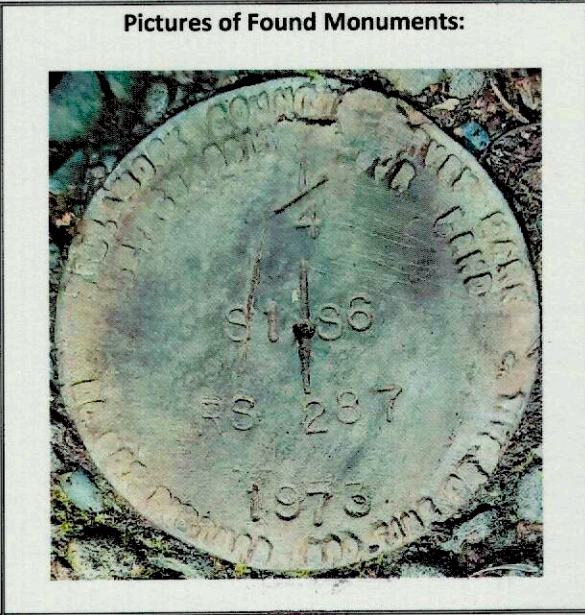
Found: (Rewitness Bk. 4 Pg. 36) 14" dia. spruce South 4' (Rewitness Card #364) 40" dia. with healed face. Now badly rotted stump only half remaining with white do not cut tag. Stump root is abutting monument on the south side. The stump has a large nail with a number 56 on the top of nail head S40°W 1.57' from monument unknown origin.

Large metal nail with the number "56" on top of nail head in spruce root S40°W 1.57'
