OREGON PUBLIC LAND CORNER REPORT / RESTORATION REPORT
Tillamook County Surveyor's Office

SECTION: 7 & 12		TOWNSHIP: 2 South	RANGE: 9/10 West
COUNTY: Tillamook		DATE: 4/17/2024	
CORNER DESIGNATION: The Meander Corner along the line common to Sections 7 and 12, Township 2 South, Range 9 and 10 West; Willamette Meridian		(Please check one)	
		X	Condition Report Only
			Restoration
			Rewitness
			Unrecorded
			Reset at surface
			Referenced Out
Previous Rewitnesses, Restorations and Surveys, etc... BLM-OREGON Field Note Volume: OR-R0053 Page 0117.00 (1857), Rewitness Bk.4, Pg.36 (1929), Rewitness Bk.4, Pg.52 (1949), Rewitness Bk.4 Pg.101 (1964), Karl Foeste Field Note Bk. Sect. 1 Pg.8. (1973), B-700 (1975), Rewitness Card #365 (1978)			
History, condition, and sources In 1857 (BLM-Oregon Field Notes) a post was set for the Meander Corner along the line of Sections 7, T.2S, R9W and Section 12, T.2S, R.10W, and two bearing trees were established. In 1929 (Rewitness Bk.4 Pg.36) W.E Anderson established a new bearing tree. In 1949 (Rewitness Bk.4 Pg.52) W.E Anderson established three new accessories. In 1964 (Rewitness Bk.4 Pg.101) W.E Anderson establishes three new accessories. In 1973

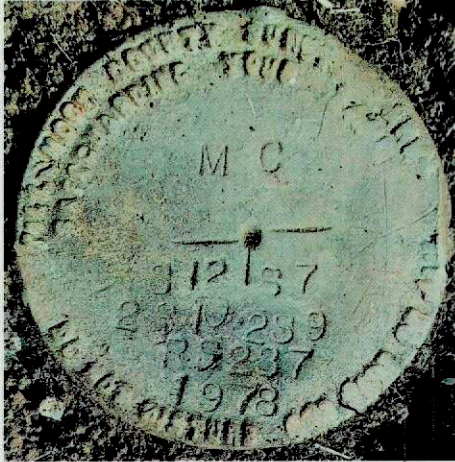
New accessories set: The corner was tied directly using GPS established control in Oregon North Zone NAD 83/91 grid coordinates in US survey feet. Coordinates are provided here in WGS 84 Latitude and Longitude. Latitude: 45°25'07.49837" Longitude: -123°50'42.04016" No bearing trees available.		Pictures of Found Monuments:
