OREGON PUBLIC LAND CORNER REPORT / RESTORATION REPORT  
Tillamook County Surveyor's Office

SECTION: 12 & 7	TOWNSHIP: 2 South	RANGE: 9 & 10 West
COUNTY: Tillamook	DATE: 4/17/2024	
CORNER DESIGNATION: The North 1/16 corner common to Sections 12, Township 2 South, Range 10 West; and Section 7, Township 2 South, Range 9 West; Willamette Meridian	(Please check one)	
	Condition Report Only	
	Restoration	
	<input checked="" type="checkbox"/> Rewitness	
	Unrecorded	
	Reset at surface	
	Referenced Out	
Previous Rewitnesses, Restorations and Surveys, etc... B-873 (1979), Rewitness Card #368 (1979), B-3386 (2010)		
History, condition, and sources  In 1979 (B-873) John Carlich the Tillamook County Surveyor set a 2" iron pipe with a 3" brass cap in 10" tile and concrete stamped "N 1/16 S12 S7 RS 287 1979" no bearing trees were established. In 1979 (Rewitness Card #368) the Tillamook County Surveyor's office wrote up the corner in the Rewitness card files. In 2025 (Field Bk. MR 18 Pg. 7-8) the Tillamook County Surveyor's office found a 3" Tillamook County brass cap in tile and concrete stamped as shown hereon. Found accessories are listed below.  Found: (Rewitness Card #368: 86" hat section pos

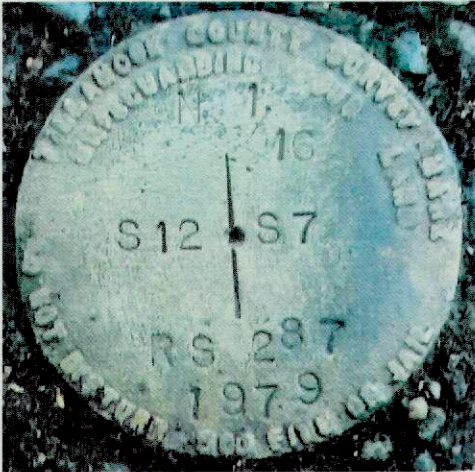
New accessories set:  The corner was tied conventionally using GPS established control in Oregon North Zone NAD 83/91 grid coordinates in US survey feet. Coordinates are provided here in WGS 84 Latitude and Longitude.  Latitude: 45°24'57.51397" Longitude: -123°50'42.01670"  40" dia. spruce N88°W 48.3' scribed "T2SR10WS12N1/16BT" with yellow metal location tag.  15" dia. alder S89°E 16.55' scribed "XBT" with yellow metal location tag.  Nail with washer between the scribed B and the T on all new bearing trees		Pictures of Found Monuments:
